# Tree Felling Accident – Learning Review

Site: Emigration Parking lot/Emigration Campground culinary water system/pump house, Montpelier Ranger District, Caribou-Targhee National Forest.

Date/Time: July 31, 2012, approximately 0930 hours.

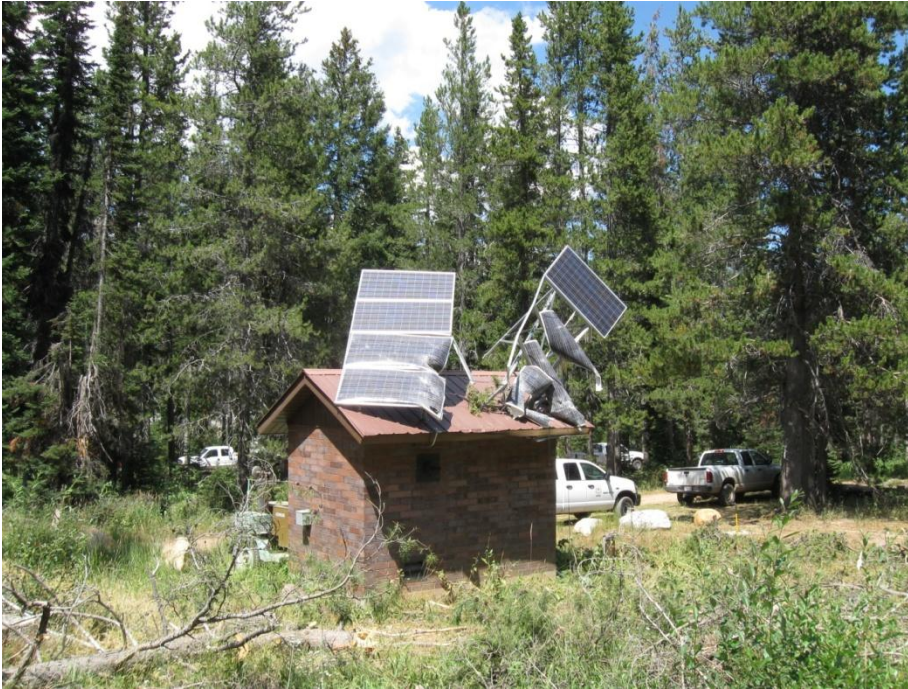
**Figure 1: End result to pump house and solar panels from tree felling incident.**

On the second tree the sawyer had a procedure in place, felling the tree upslope and away from the pump house, similar to that of the first tree. All the cutting was done from the uphill/ opposite side of the pump house. The tree had a slight lean in the desired direction although the majority of the limb weight was towards the pump house. With the tree being alive and green this added more weight than anticipated. Using the gunning sights, a face cut was put in facing roughly 90° away from the pump house. Unlike the first tree there wasn't a dutchman. The back cut was done in whole, dogging in on the upslope side of the tree, behind the holding wood and then pivoted. The sawyer anticipated that the tree would begin to start falling, which didn't happen since the weight of the limbs was pulling in a different direction. The sawyer continued cutting through the back cut and eventually through the majority of the holding wood. Once the holding wood was severed the weight of the limbs broke the remainder of the holding wood and the tree fell towards the pump house and solar panels on top.

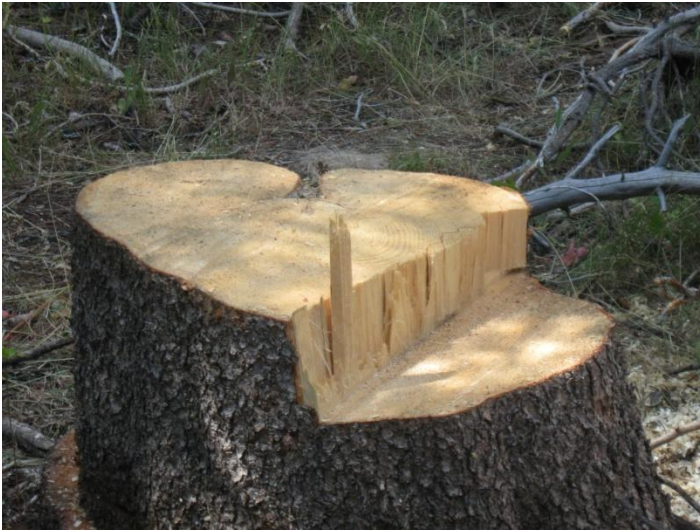
Tree falling techniques and concerns: The sawyer felled the first tree in the desired direction, using a conventional face cut and then back cut. There was a dutchmen in the face cut on the sawyer’s off side, and feeling that the dutchmen would not compromise the direction of lay, the sawyer completed the cut.

**Figure 2: Reconstructed stump of tree which was felled partially onto pump house.**

Reviewing the situation with the sawyer, discussion included multiple cutting procedures ( ¼ cutting the back cut so wedges will be in the tree early and often).

Always check your cuts.

Don't cut your holding wood.

Use wedges.
