WHISKY FIRE ACCIDENT INVESTIGATION REPORT

ACCIDENT: PERSONAL INJURY - NON-FATAL

LOCATION: PACIFIC SOUTHWEST REGION
KLAMATH NATIONAL FOREST
SCOTT RIVER RANGER DISTRICT

DATE: OCTOBER 27, 1992

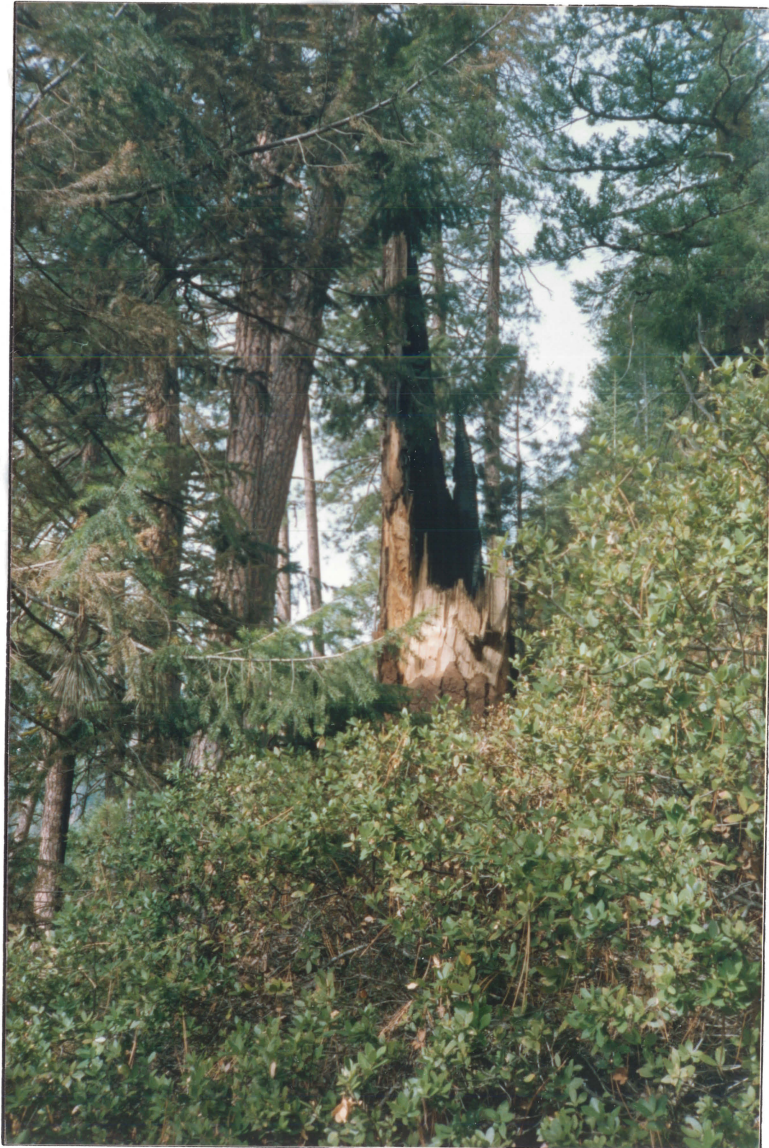
There were unsafe conditions existing on the fire. These were several burning snags within the fire perimeter. There was also the green Ponderosa Pine that had been struck by lightning, which started the Whisky Fire. This tree had a very large scar and void in the trunk which burned, causing the tree to fall. Visibility was very low because of darkness, smoke, and vegetative growth.

THIS PHOTO DEPICTS THE EASTERN BOLE FACE OF THE LARGE PONDEROSA PINE THAT BROKE. NOTE THE BURNED HOLLOWED CAVITY WITHIN THE TREE.

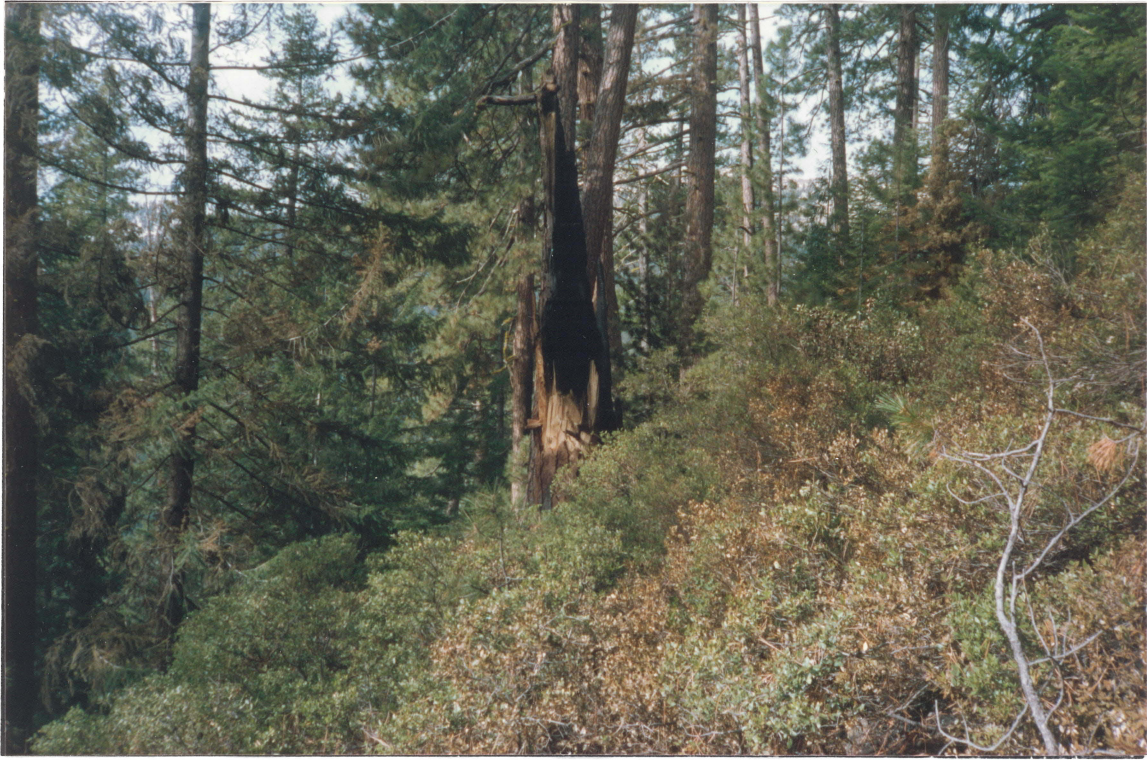
THIS PHOTO DEPICTS THE NORTHEASTERN FACE OF THE PONDEROSA PINE
BOLE.

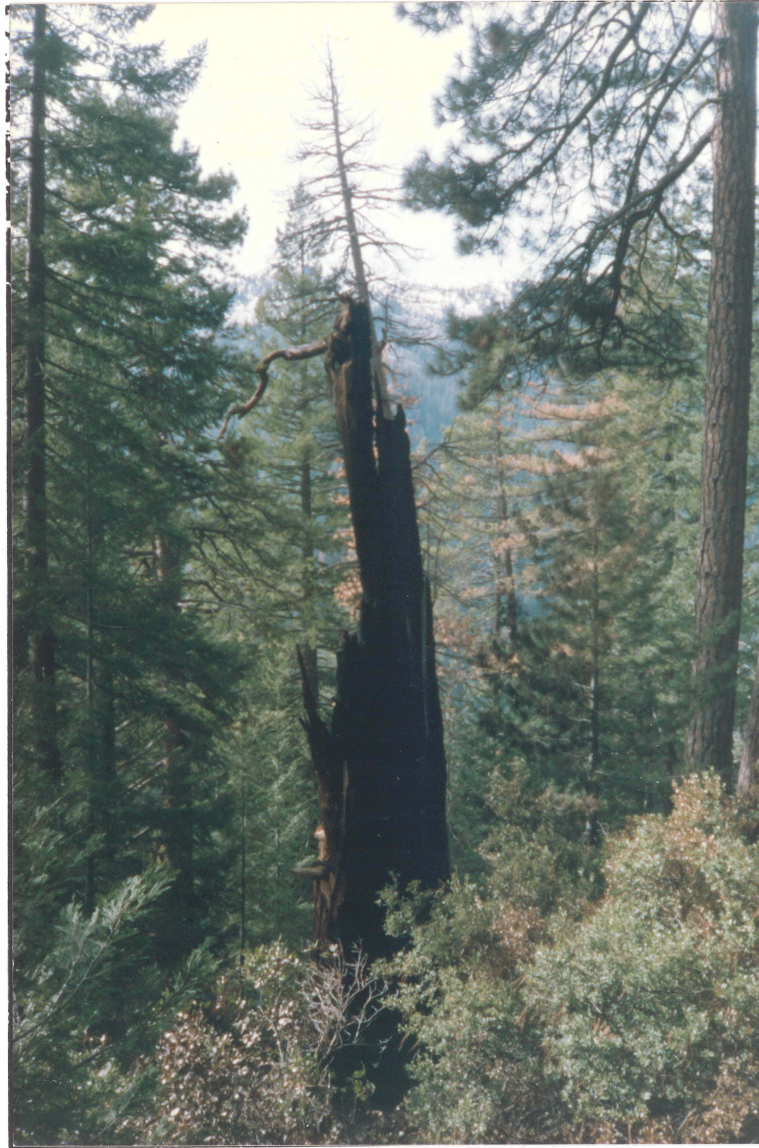
THIS PHOTO DEPICTS THE NORTHERN FACE OF THE LARGE PONDEROSA PINE
BOLE.

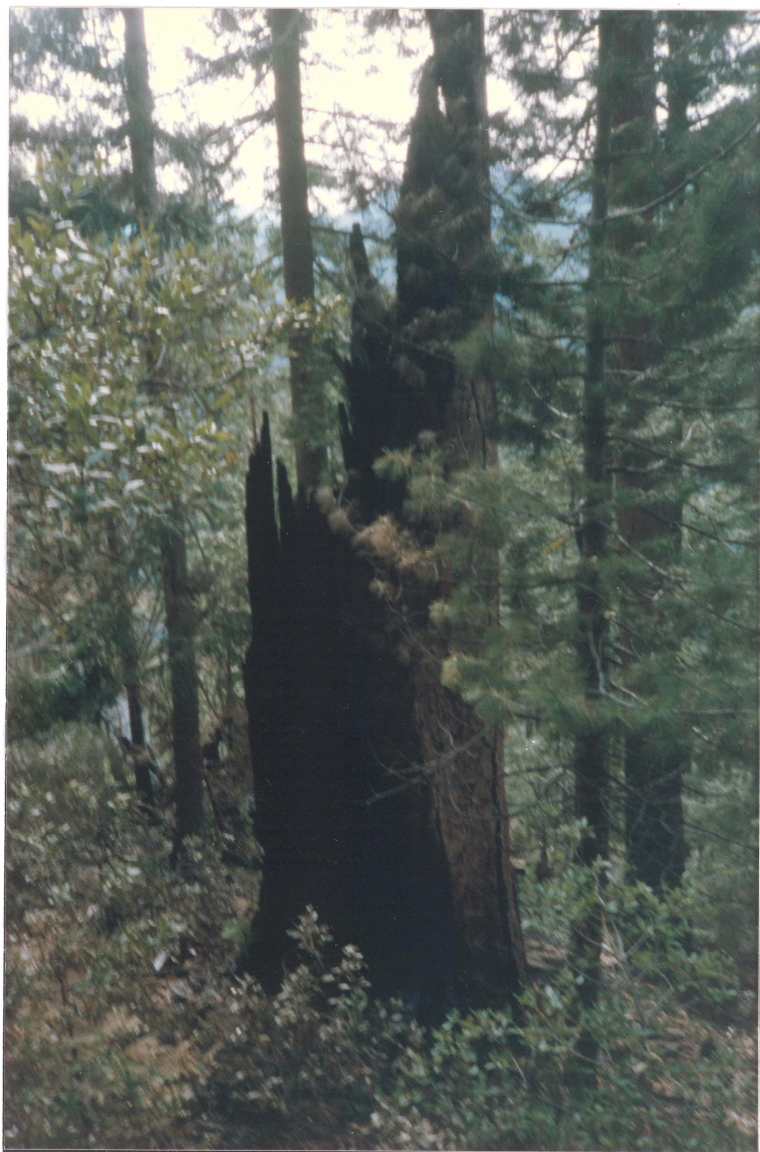
THIS PHOTO DEPICTS THE NORTHWESTERN FACE OF THE LARGE PONDEROSA PINE BOLE.

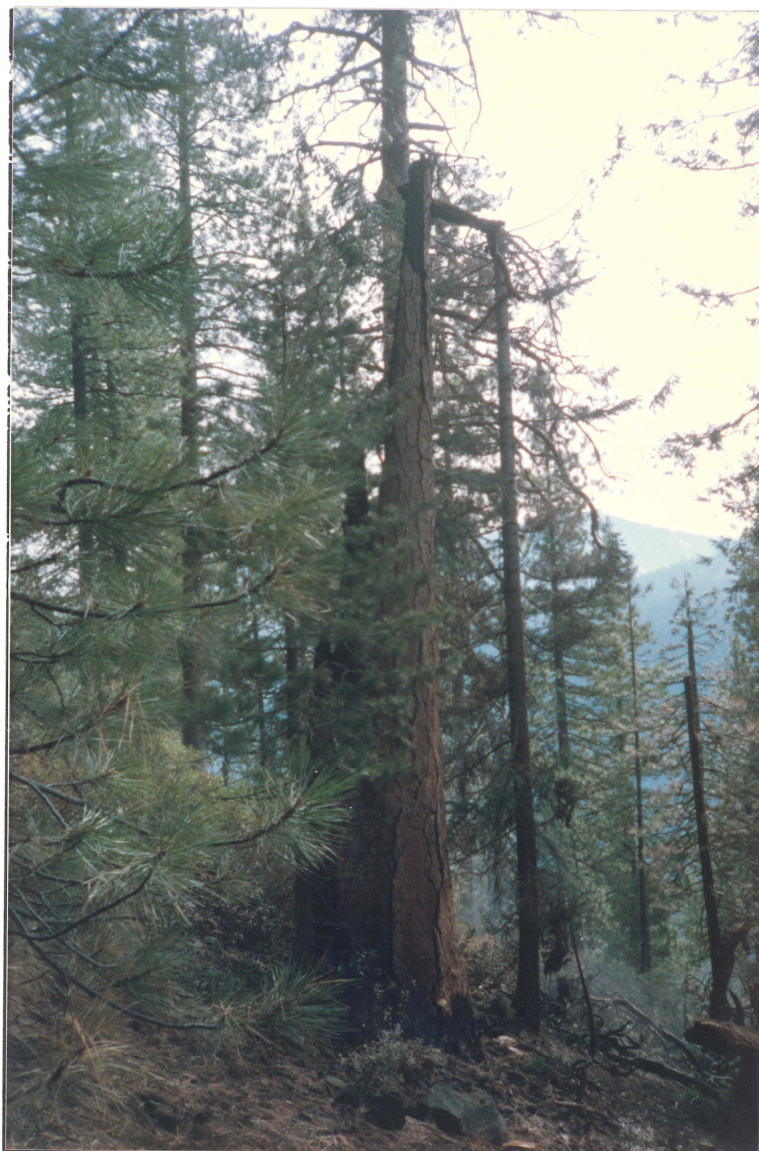
THIS PHOTO DEPICTS THE WESTERN FACE OF THE LARGE PONDEROSA PINE BOLE THAT BROKE. NOTE THERE ARE NO VISIBLE SIGNS OF THE HOLLOW CAVITY ON THIS SIDE.

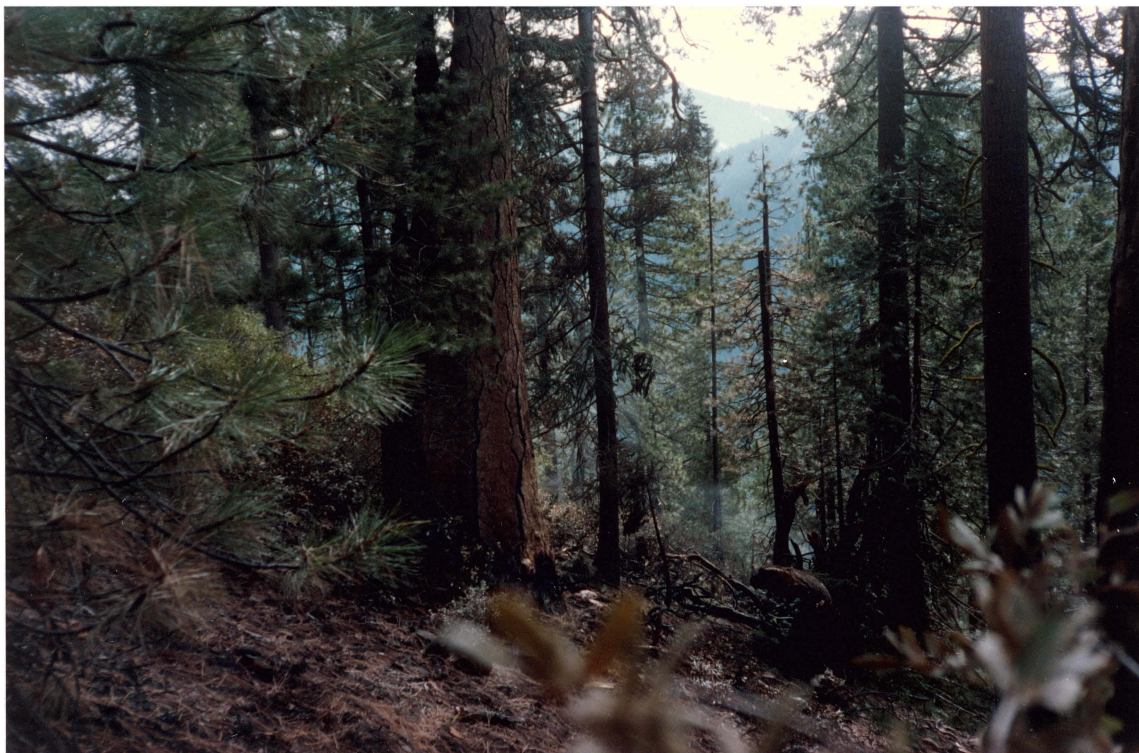
THIS PHOTO DEPICTS THE SOUTHEASTERLY FALL PATH OF THE LARGE PONDEROSA PINE. NOTE THE SMALLER PONDEROSA PINE WITH IT'S TOP MISSING WITHIN THE TREE'S FALL PATH. THE MISSING TOP WAS SNAPPED OFF DURING THE TREE'S FALL AND ALSO STRUCK ADAM RAIMER.

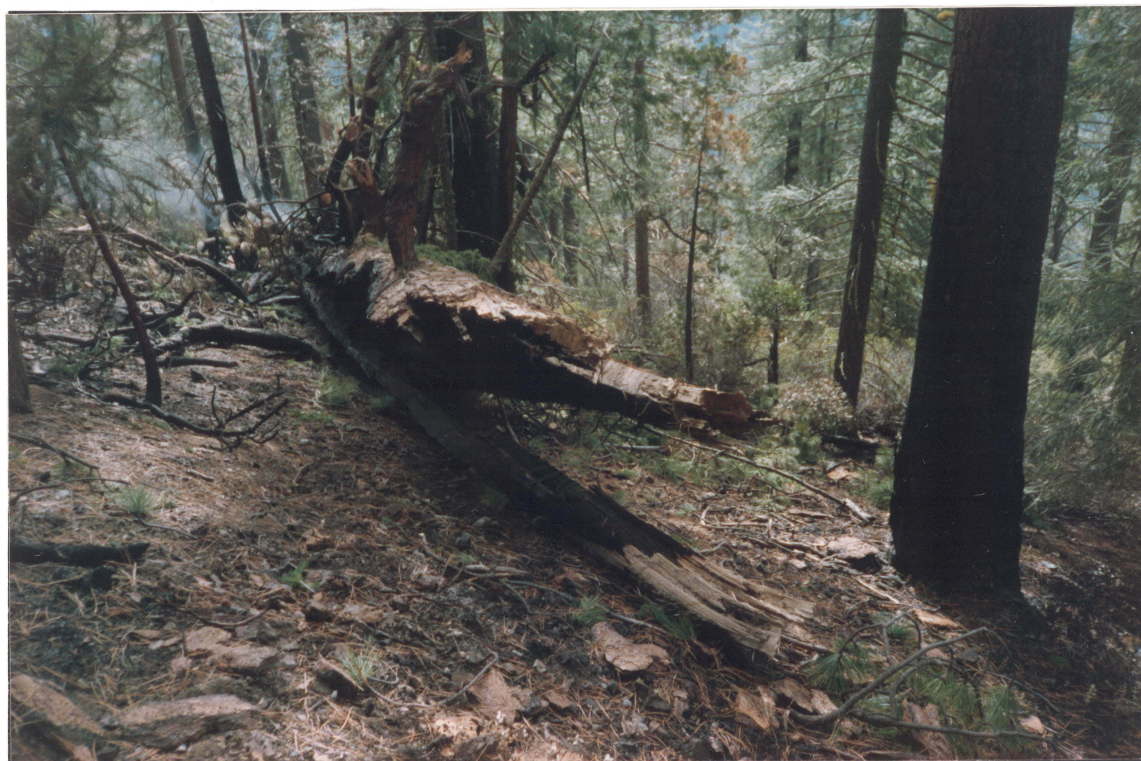
THIS PHOTO DEPICTS THAT PORTION OF THE PONDEROSA PINE THAT BROKE OFF OF THE TREE'S MAIN BOLE. NOTE THAT THIS PORTION FELL AND CAME TO REST APPROX. 18 1/2 FT. TO THE SOUTH OF THE TREE'S BASE. ALSO NOTE THE SMALL AMOUNT OF HOLDING WOOD REMAINING.

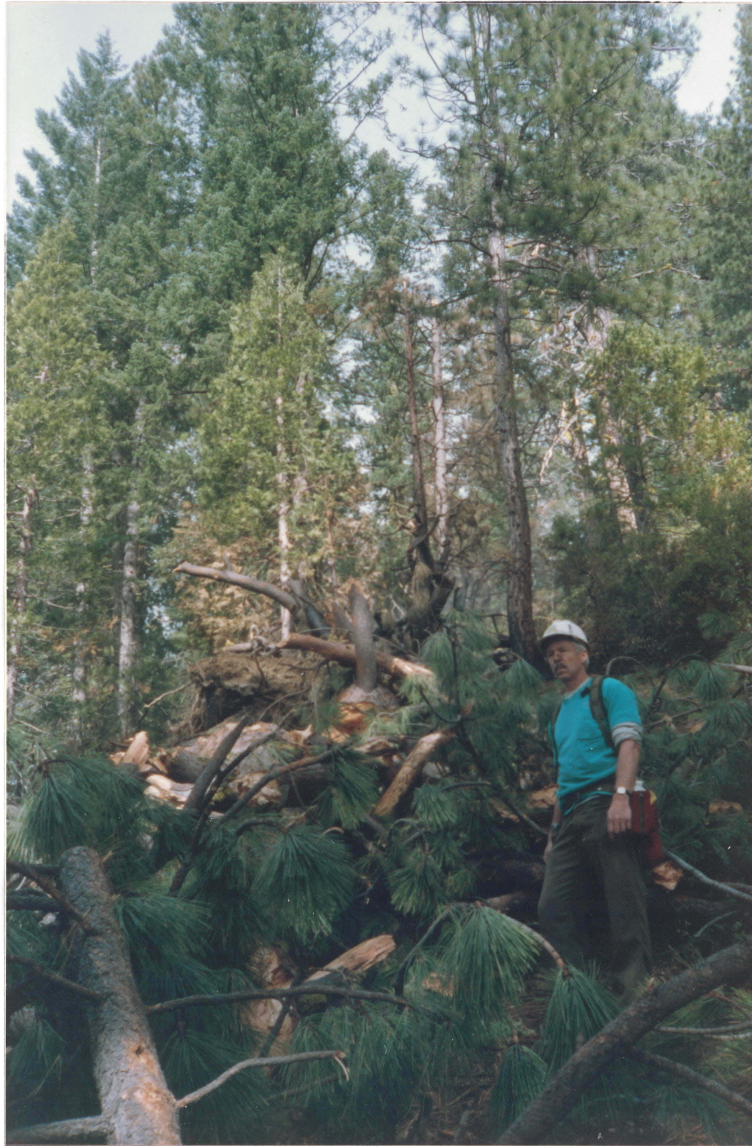
ACCIDENT SITE

THIS PHOTO SIMULATES THE LOCATION WHERE ADAM RAIMER WAS STANDING
WHEN HE WAS KNOCKED TO THE GROUND.

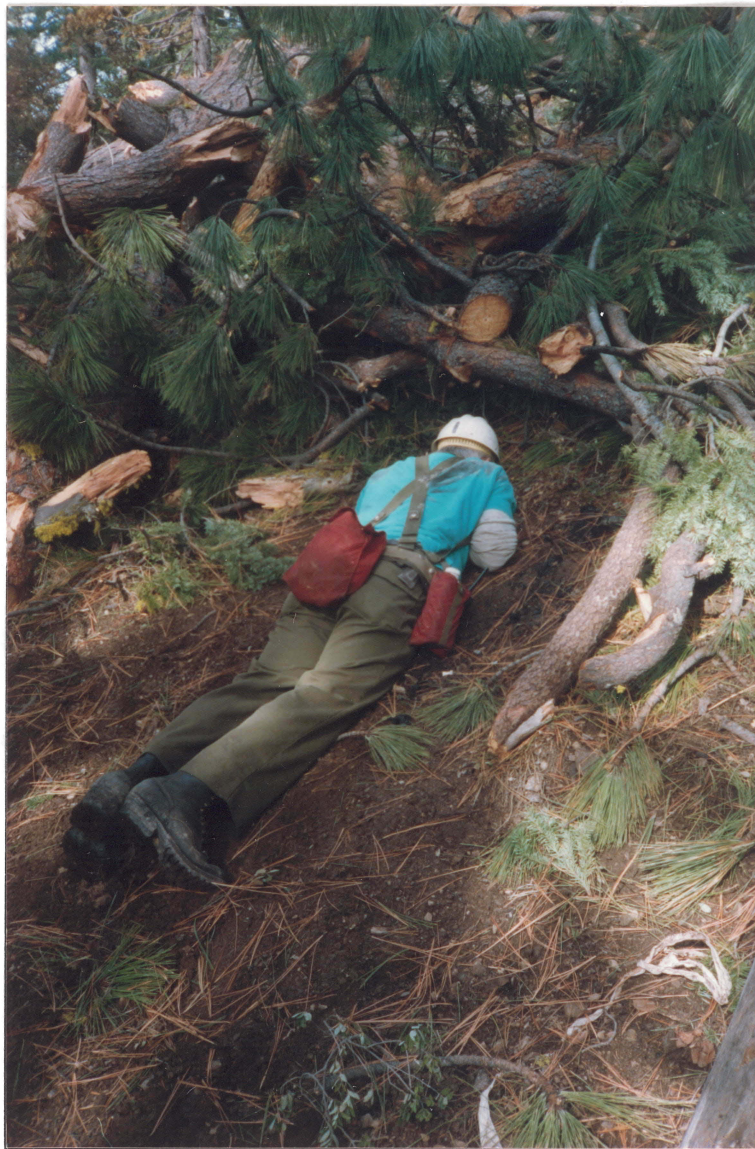
ACCIDENT SITE

THIS PHOTO DEPICTS THE SIMULATED POSITION OF ADAM RAIMER WHEN HE WAS KNOCKED TO THE GROUND AND AFTER THE TREE'S TOP WAS CUT AND REMOVED. NOTE THE CROSS SECTION OF THE TREE'S TOP IMMEDIATELY ABOVE THE FIREMAN'S HELMET. THAT CROSS SECTION IS A PORTION OF THE SMALLER PONDEROSA PINE'S TOP THAT WAS SNAPPED OFF.

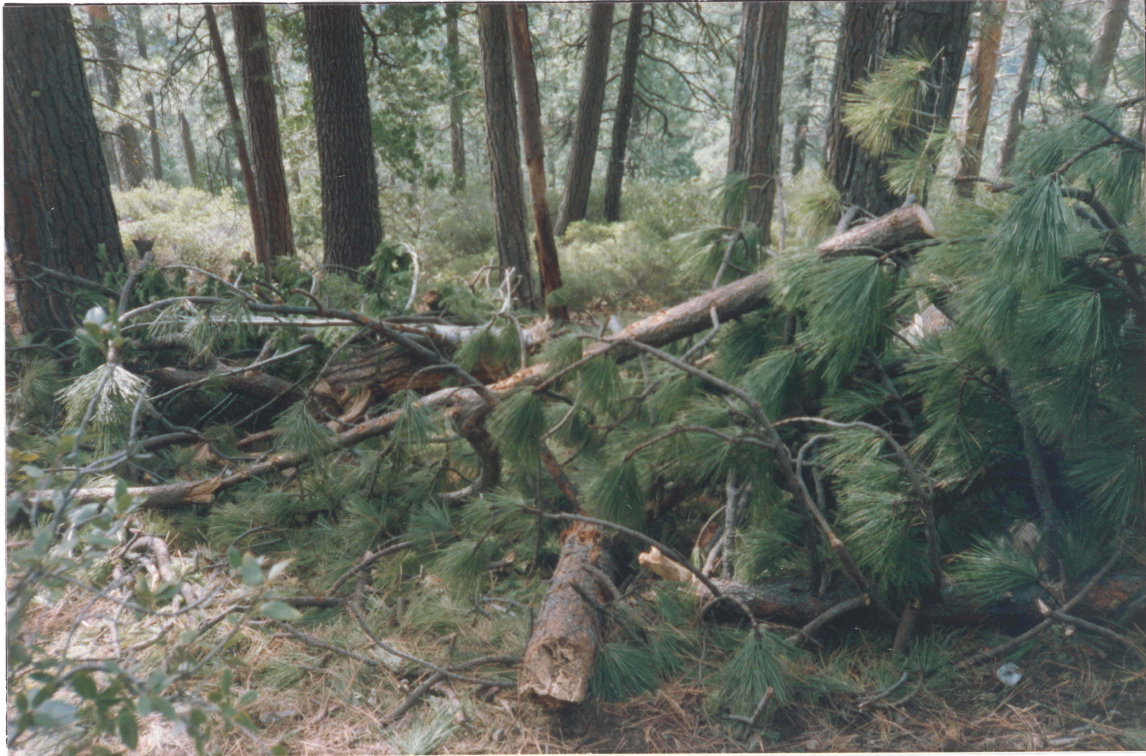
THIS PHOTO DEPICTS THE TREE TOP THAT WAS CUT AND LIFTED OFF OF
ADAM RAIMER. THE TOP IS IN THE CENTER OF THE PHOTO AND IS LAYING
AT A 30° ANGLE.
