WITHERS FIRE ENGINE INCIDENT

Facilitated Learning Analysis

Paisley, Oregon

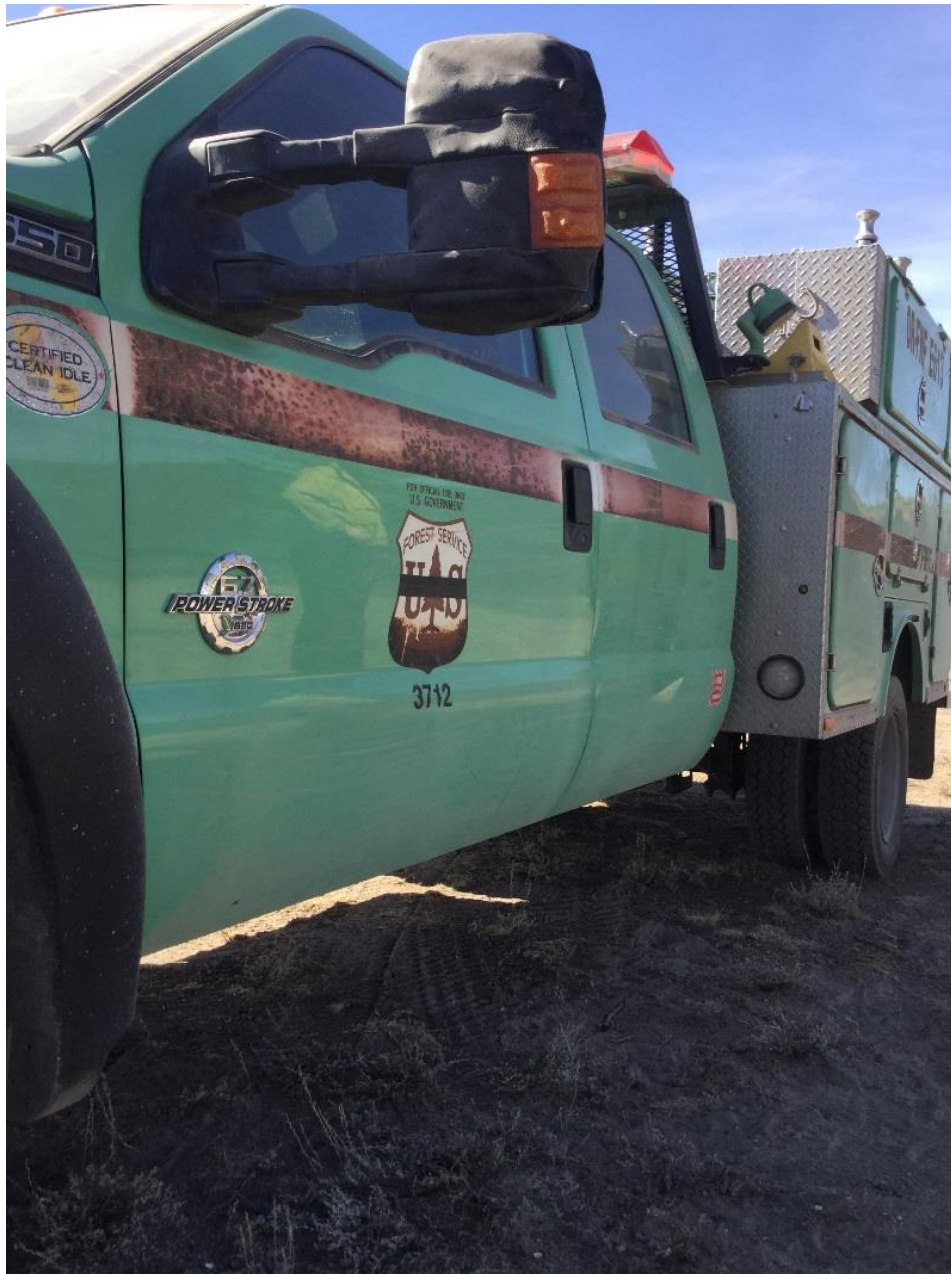
FIGURE 1: ENGINE DAMAGE

The engine had melting of the driver's side front fender, side mirror, and light bar. The reflective striping on the side of the engine was also scorched. (Please see the Appendix for photos.)
