Four Corners Fire

April 5 & 6, 2000

Entrapment Investigation Report

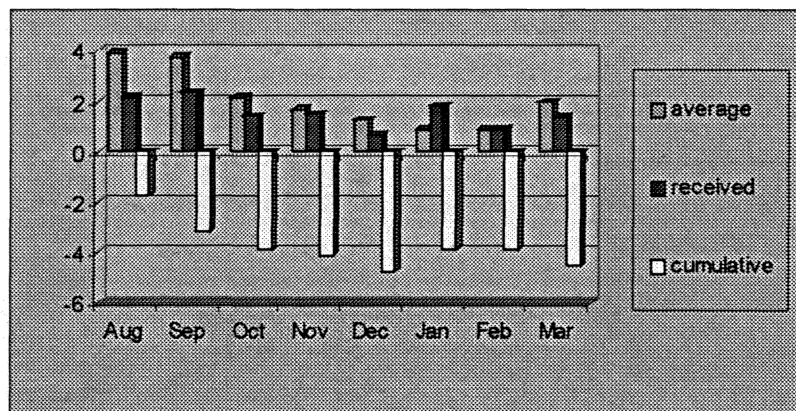
The following chart shows the precipitation deficit situation at La Crosse; approximately 20 miles southwest of the Four Corners fire.

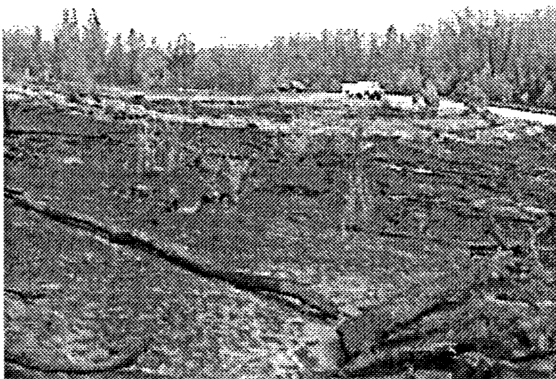
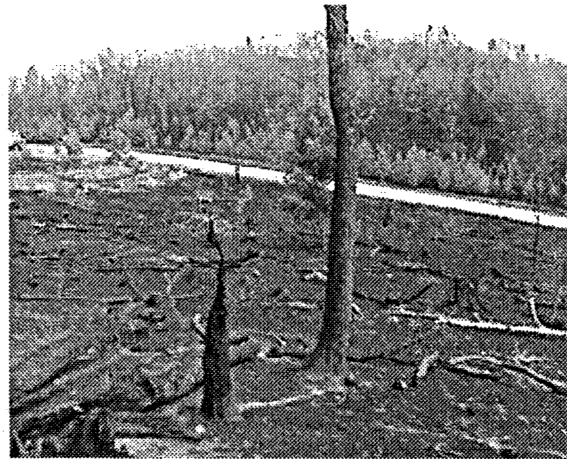
The general topography is characterized as gently rolling. Topographic influences on the fire behavior are insignificant overall. Of note, is the fact that the entrapment site is situated at the apex of a saddle, along a slight ridge. The slope approaching the entrapment area is a modest 7-9%. However, the crest of the ridge rises approximately 150 feet above the saddle both to the northwest and the east. (See Topographic Maps, pages A1-10/11)

THE PICTURES ABOVE ARE OF THE ENTRAPMENT SITE. THE PICTURES ARE TAKEN FROM A SPOT APPROXIMATELY 150' SOUTHWEST OF THE ENTRAPMENT SITE. THE ENGINE IN THE MIDDLE GROUND IS PARKED AT THE CREST OF THE SADDLE.

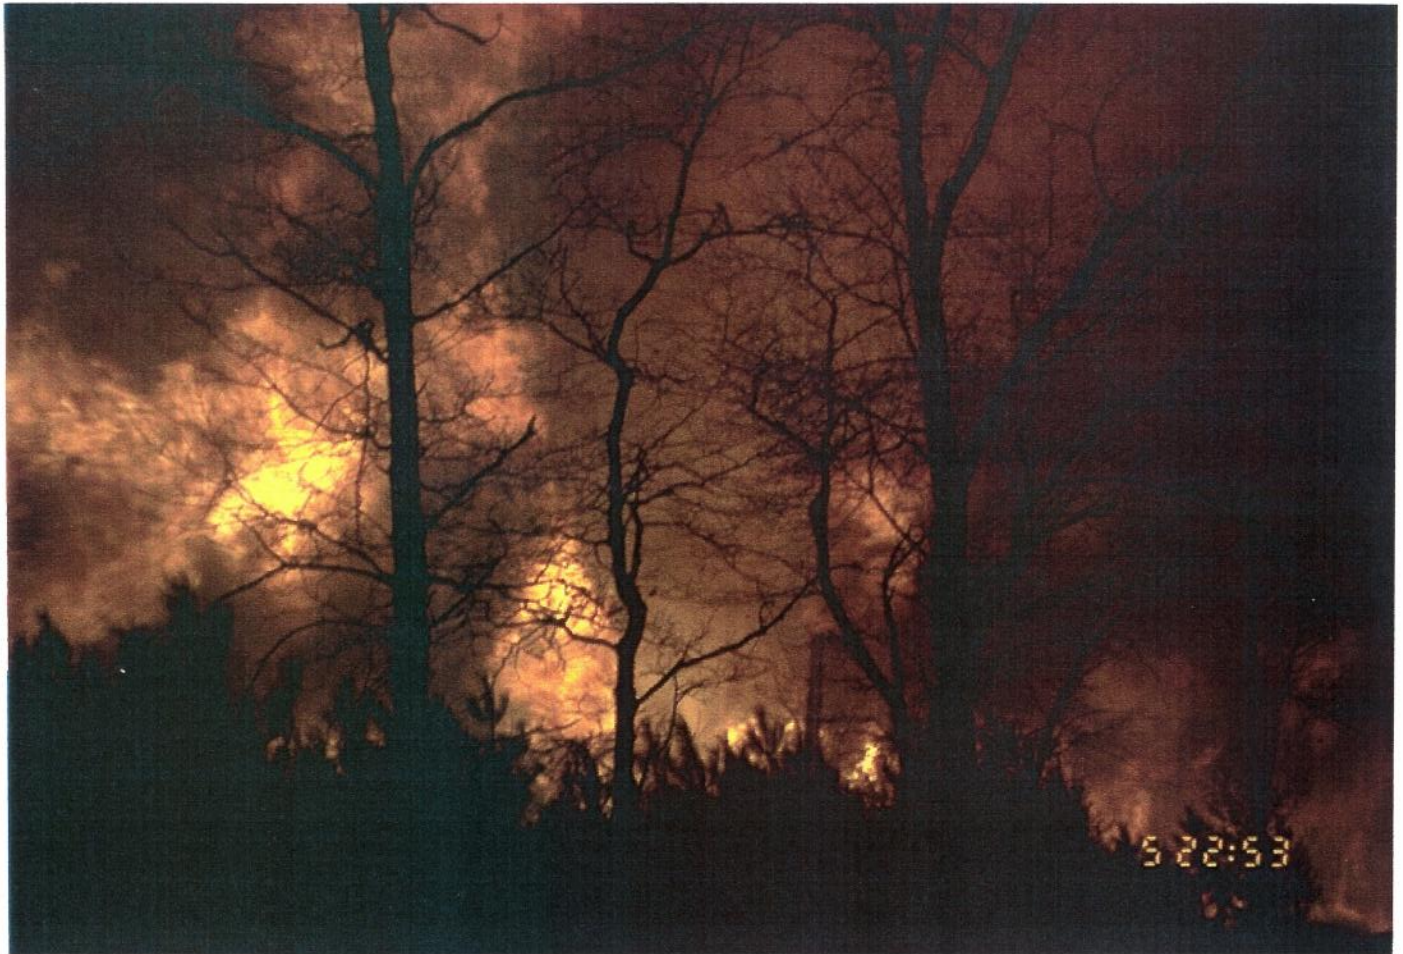
Photo take of the small stand of red pine directly across Sommers Road from the entrapment site as it began to torch out.
