# Monument Fire Entrapment Investigation Report

## Wildland Firefighter Entrapment

Occurred May 15, 2000

Pecos National Historical Park  
P.O. Box 418  
Pecos, NM 87552

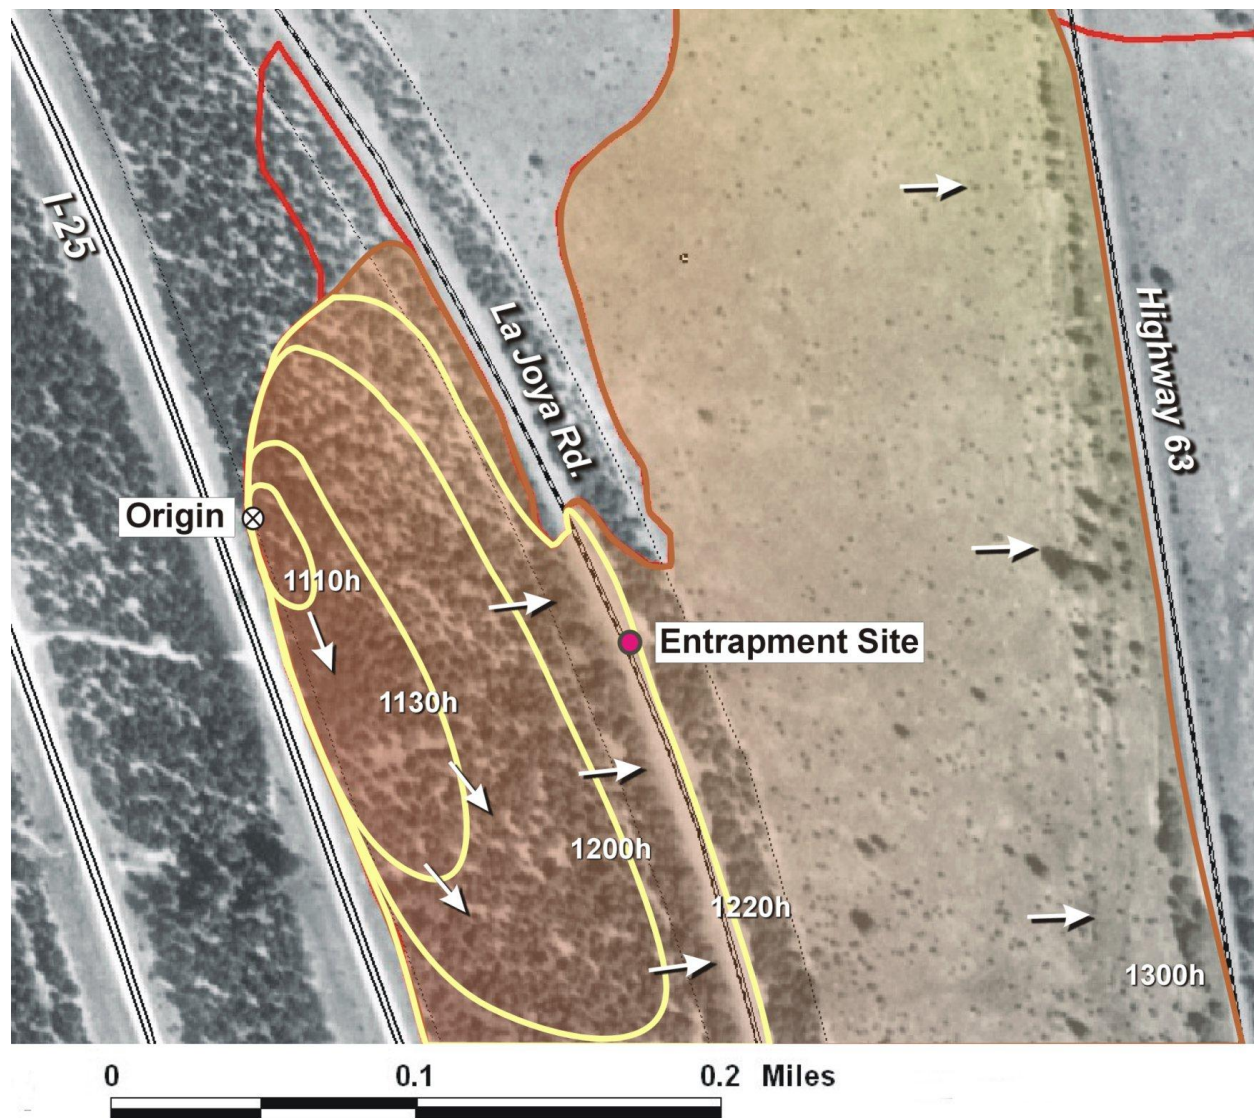
**Figure 2.** Approximate perimeter progression for the times referenced in the chronology. Arrows indicate the direction of fire spread for those times.

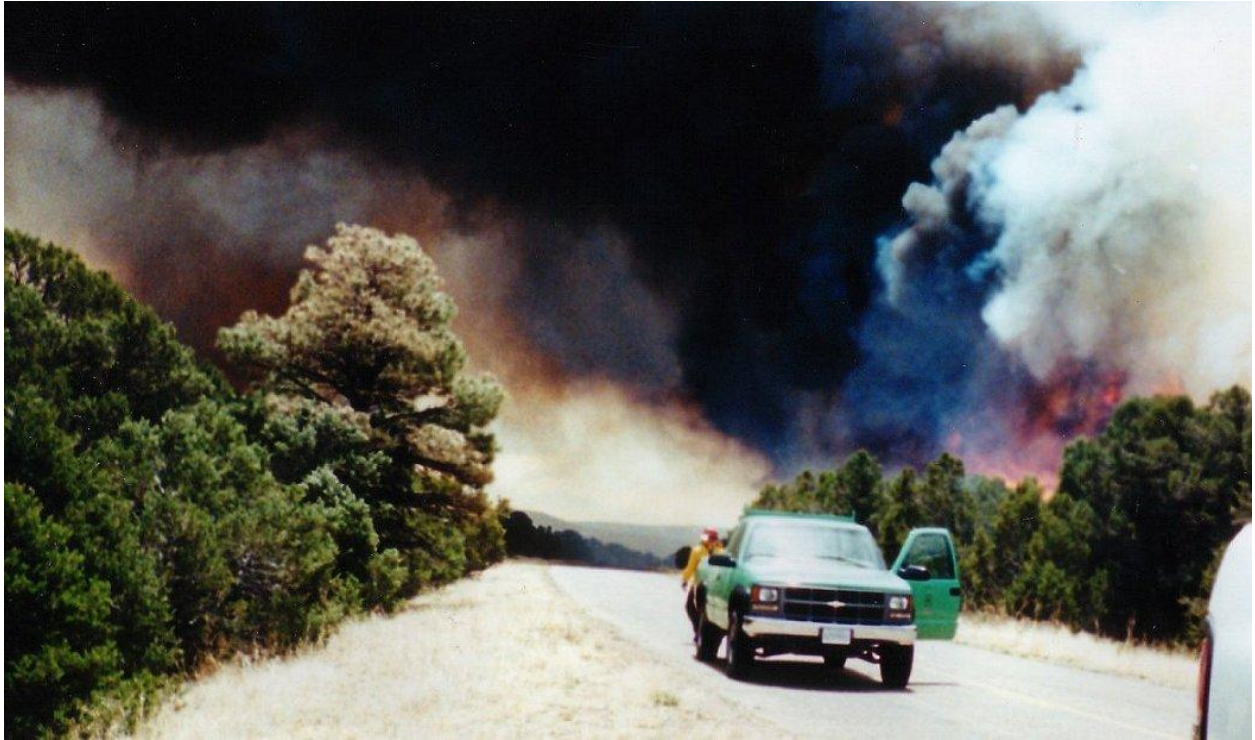
**Figure 3.** Fire bumping La Joya Road, viewed from north of the entrapment site.

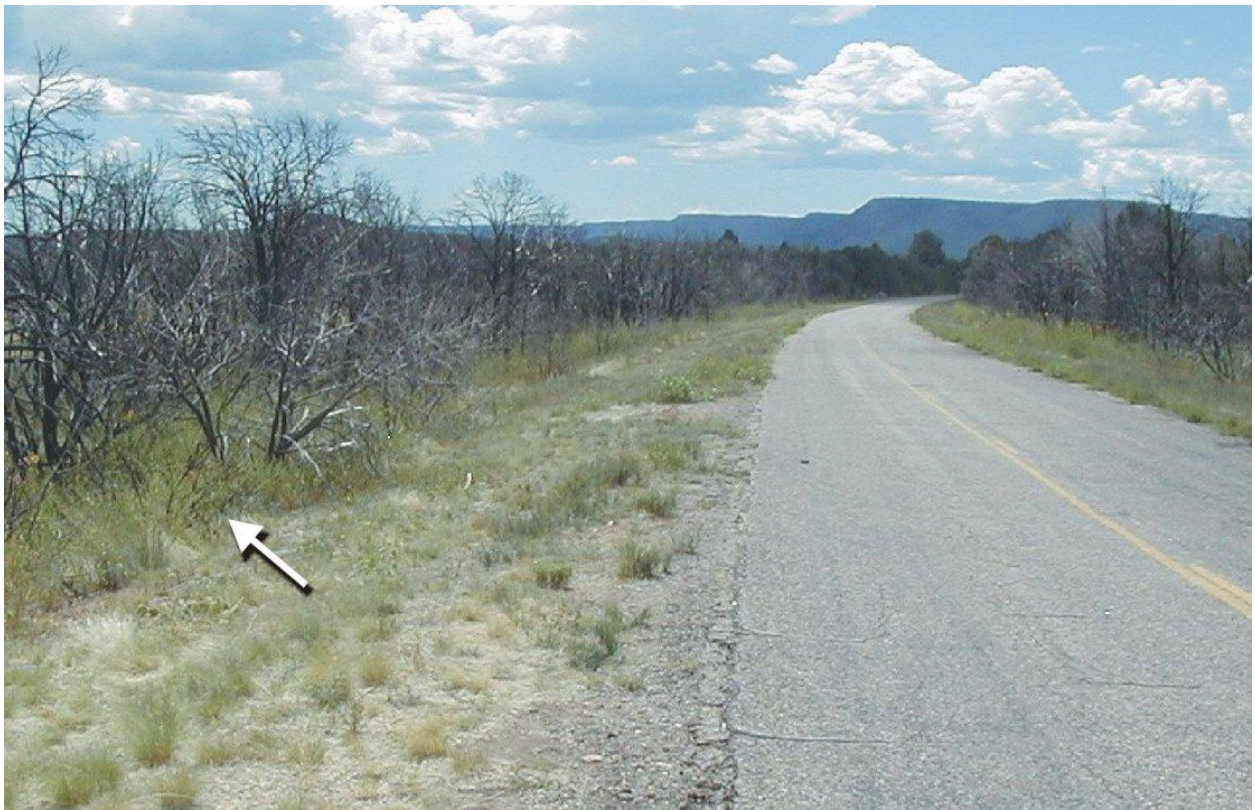
**Figure 4.** Entrapment site (arrow) on the east side of La Joya Road.
