Rapid Lesson Sharing

Event Type: UTV Tip Over

Date: August 3, 2023

The Story and the Lessons from a UTV Tip-Over Incident

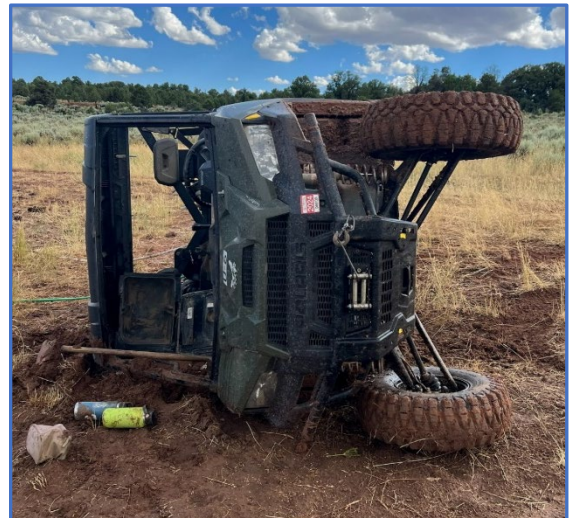
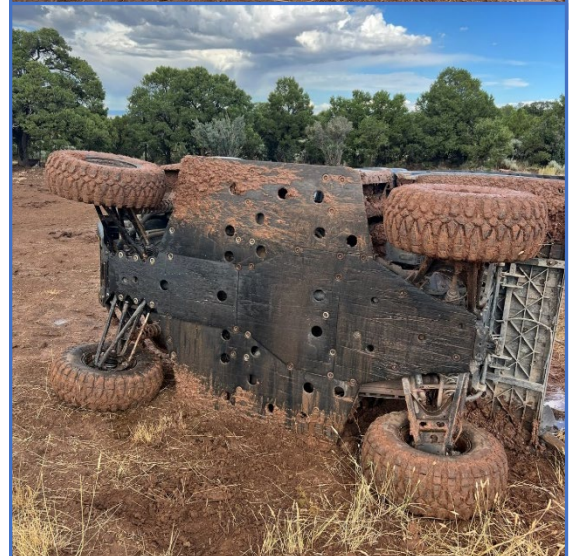
After a thorough inspection of the UTV by a Polaris dealer, it was determined that there was damage to the cargo box, cargo box supports, tailgate, and taillight. There was no damage to the UTV's ROPS.

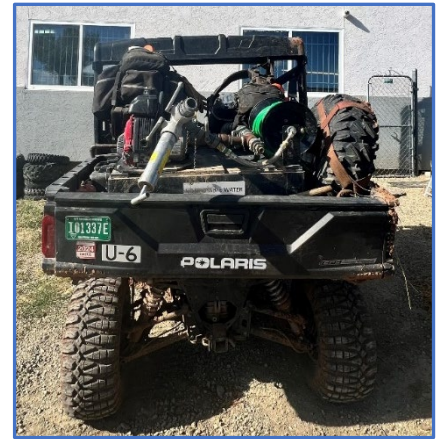
- The water tank was partially drained from a previous fire. We did not take the time to refill it, even though we were going to a new fire start. This may have caused the water to shift more in the tank, increasing the risk of rollover.
- Having the line gear mounted next to the roof on the ROPS. Having the weight up high may have changed the UTV center of gravity.
 - ✓ Always load the cargo box with the load as far forward and as low as possible. Reduce speeds while carrying heavy cargo.
- The poor road conditions resulted in very limited traction.
 - ✓ Decrease speeds and use extra caution while operating on slippery surfaces.

Typical gear configuration while responding to smoke reports.
