Rapid Lesson Sharing

Event Type: Engine Rollover

Date: October 2, 2022

Location: Anderson Butte Fire
Oregon

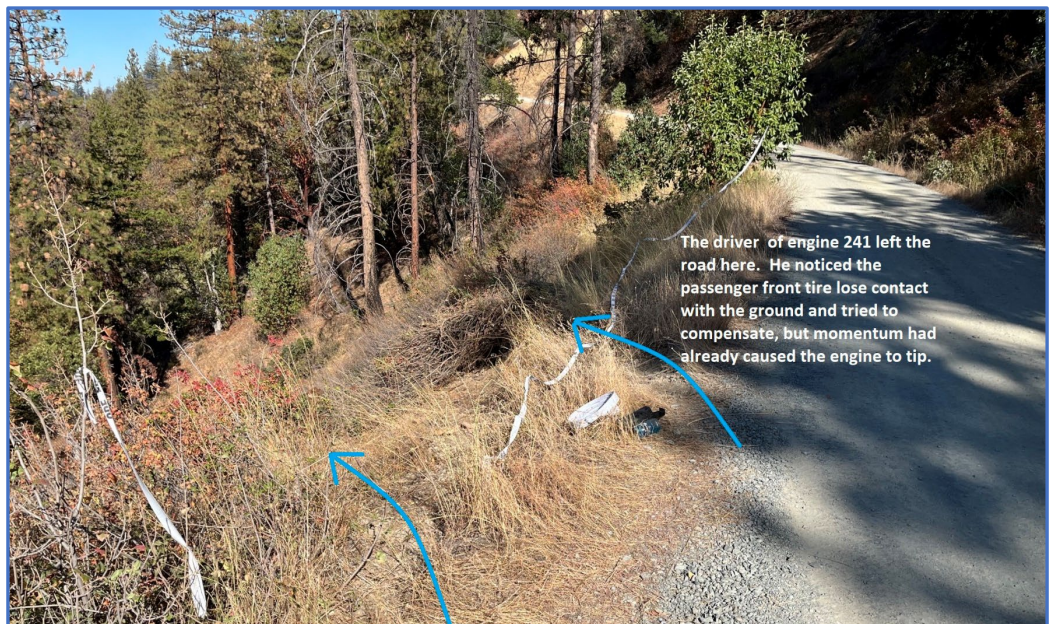
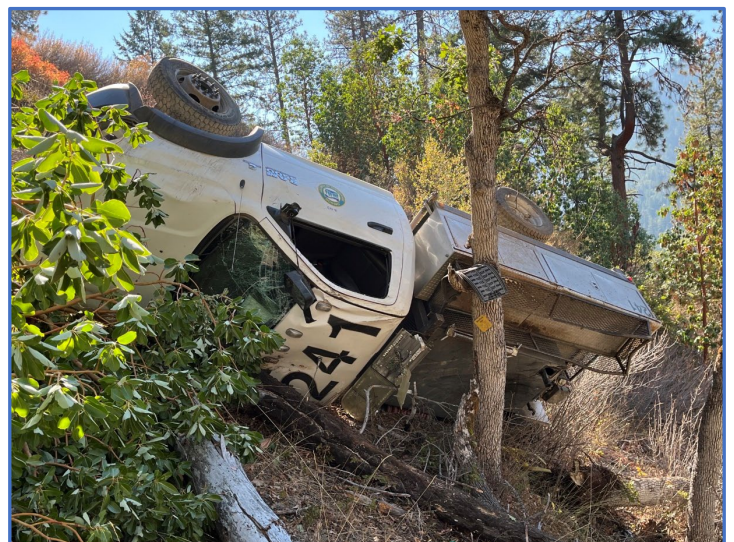
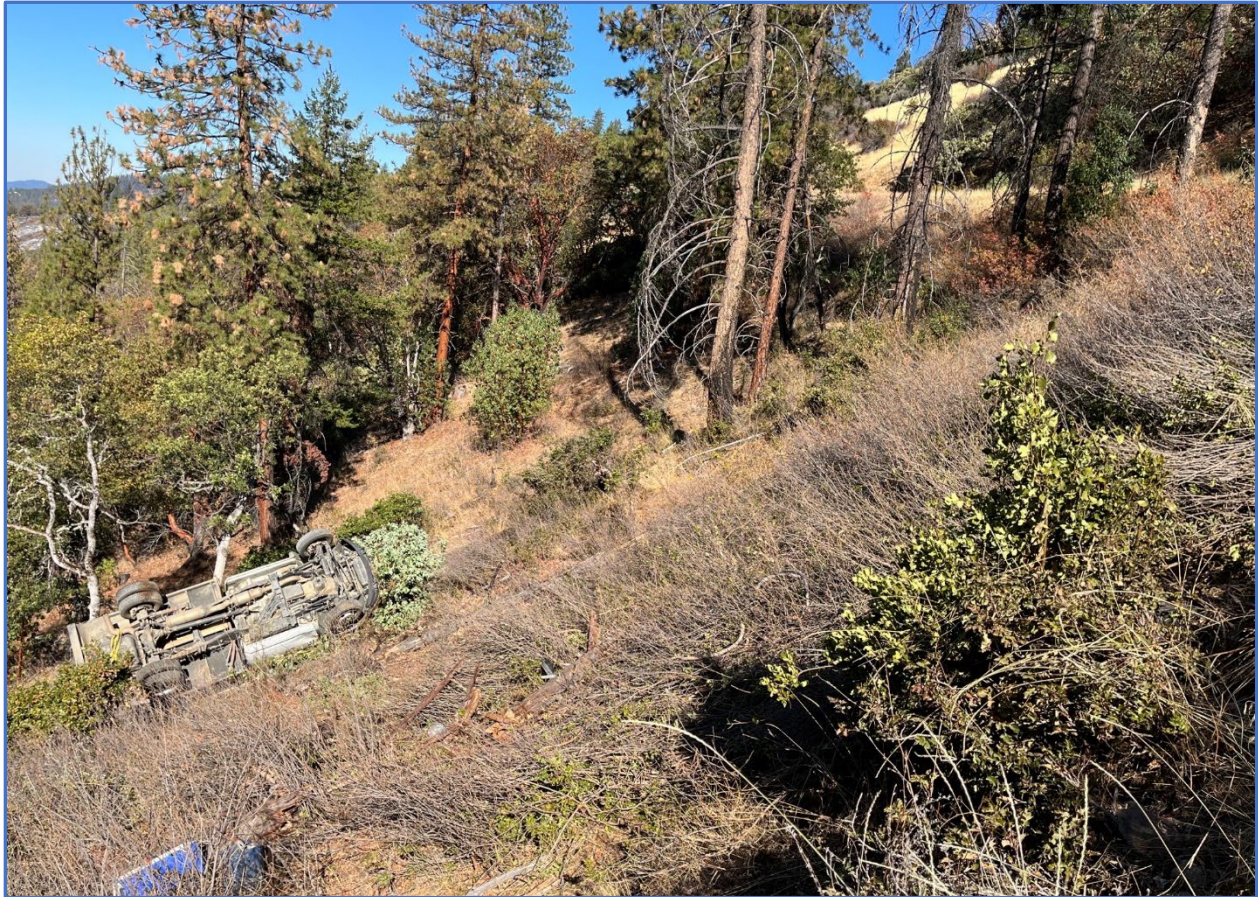
The driver of Engine 241, the last vehicle of the convoy, stated that *"the dust kicked up, just hung in the air."* He said the visibility had become greatly reduced to the point where seeing the road was difficult. He was relying on the emergency lightbar of the engines ahead of him to find his way.

As he rounded a shaded corner, the sun hit the engine windshield and severely impacted his vision. He did not notice the curve in the road.

Soon after, the Engine 241 driver—who was the vehicle’s sole occupant—noticed that the passenger side front tire was no longer contacting the ground. He attempted to steer back toward the road, but momentum caused the engine to tip. The engine then rolled more than two times before being stopped by a small grove of oak trees, finally coming to rest on the driver’s side, approximately 100 feet below the road.

The engine, which was totaled beyond repair, was retrieved by a wrecker the following day.

*The fact that the driver only received minor injuries
was attributed to his proper seatbelt use
and the engineered steel headache rack
that prevented the cab from fully collapsing.*

- ❖ Continuously evaluate conditions, as dust and sun angle make for less visibility, travel at slower speeds, and allow for more space in between yourself and the vehicle in front of you.
- ❖ If you can't clearly see the road: STOP.
