Rapid Lesson Sharing

Event Type: Tree Strike

Date: September 19, 2022

Location: Cedar Creek Fire, East Zone
Division Juliet

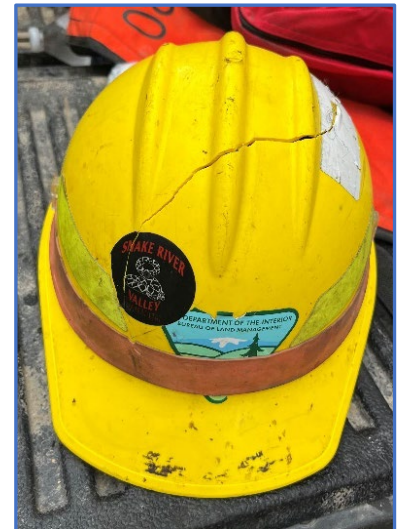
As the weight of the tree began to commit to its natural lean, it finally broke what remained of the hinge wood. That’s when the younger brother began to bear the true weight of the tree and realized his attempt to stop it from falling was futile. He therefore moved off to one side and watched in horror as the tree fell directly at his brother—striking him squarely in the center of his helmet. Although the tree was only 2 inches in diameter at the tip that struck him, it nonetheless hit him hard, causing his knees to buckle under the impact of the blow and knocking his helmet from his head.

**The firefighter’s helmet that was hit
in this tree strike incident. (For more
information, see page 5.)**

Incident personnel who responded and observed the large crack in the helmet after this accident occurred assumed that the age of the helmet may have been a factor that contributed to this large-size crack as the helmet appeared worn and somewhat brittle.

However, responders at every level had differing understanding of what the correct serviceability date guidance really was. The exact age of the helmet in this incident was never able to be determined as it was not available for inspection during the review. In addition, the picture provided was a top-down shot that did not include the date of manufacture that is printed underneath on the helmet's brim.

Current guidance for helmet serviceability is determined by three criteria:

1. Date of Manufacture: 10 years maximum.
2. Visual Inspection: Stress cracks, chemical exposure, Ultraviolet (UV) degradation, etc.
3. Physical Inspection: The 1-inch compression flexibility test.

A helmet needs to pass each of these three criteria to remain in service.
