RAPID LESSON SHARING

Montana DNRC

8/27/2023

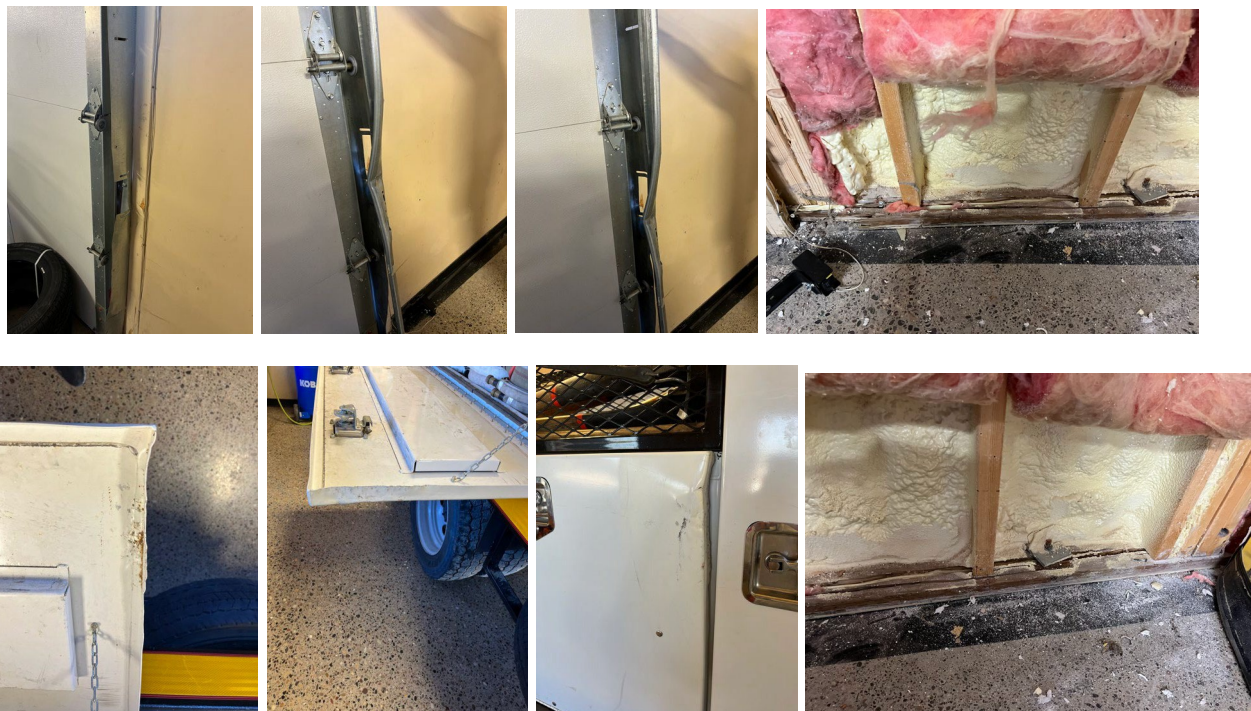
On August 27th, 2023, fire personnel were performing routine cleaning on the exterior of the E-7225. As the driver was pulling out of engine bay, the passenger side cargo bin door of Engine 7225 was left open and came into contact with the building and garage door frame. This caused damage to both the cargo door bin, garage door frame, and a load bearing wall. The cargo door is still functional. The garage door framing will have to be replaced. The wall itself is still functional but does require some maintenance in the form of repairs to the base plate. The building owner has been notified and is arranging repairs.

Prior protocols had been developed and were in place to help mitigate these issues, but protocols were not followed. The driver never completed his/her walk around and a spotter was not being utilized to help guide the driver when pulling out of the engine bay.

Even though it's slow, accidents can happen, even doing the mundain activities. We need to continue to preach and practice our SOP's that were developed from similar past issues. We are going to amend some of the current SOP's by adding a large mirror on the wall, giving drivers a better view of their surroundings. We are also going to move the keys to a strategic location where drivers complete a walk around by walking to where the keys are hanging.
