# Rapid Lesson Sharing

**Event Type:** Vehicle Rollover

**Location:** Moose Fire  
Salmon-Challis National Forest  
Idaho

## Lessons from a Vehicle Rollover Incident

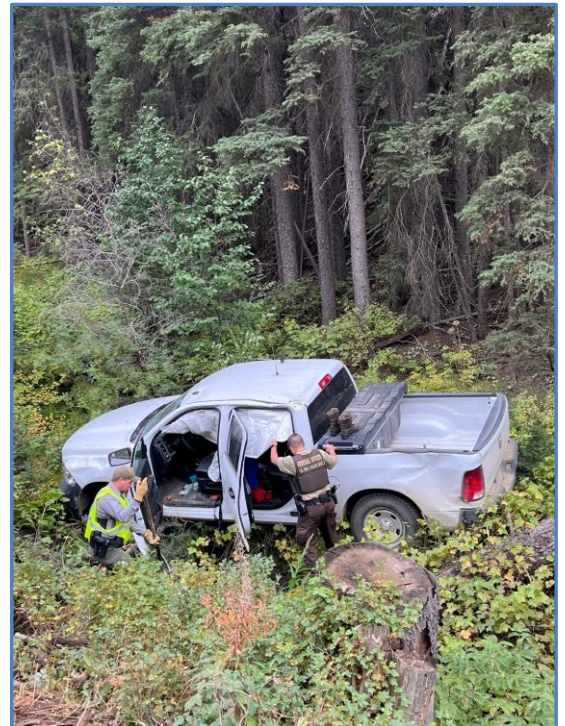
As he was reaching for his phone, the right front wheel caught the shoulder, which was softer than the driver expected. The tire was pulled into the soft dirt and down the embankment.

The truck's right front wheel caught the recently graded forest road's shoulder. The vehicle rolled over a stump and landed upright in a small creek.

- ❖ Beware of soft shoulders. Assume that gravel roads will have soft shoulders.
- ❖ Check in with adjacent fires when traveling through that fire's area.
- ❖ This incident reaffirms the need to use the Medical Incident Report. It is designed to help clearly convey necessary information in a standard format to expedite the medical response and get the appropriate medical care to the patient as quickly as possible.
- ❖ Provide accurate details when reporting the nature of accidents. This accident was not initially reported as a rollover, but as a simple vehicle accident. More accurate reporting would have reduced confusion.

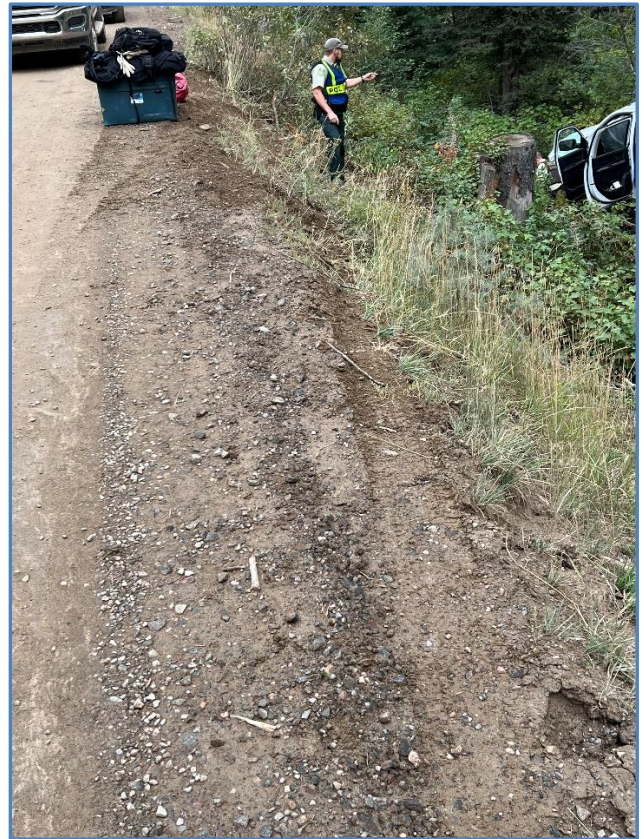
**Tire tracks are visible where the truck's wheels were pulled off the shoulder into the “soft” dirt—and the vehicle rolled down the embankment.**
