## LESSONS LEARNED

### UTV Torch

**Incident Type:** Prescribed Fire

**Location:** Illinois

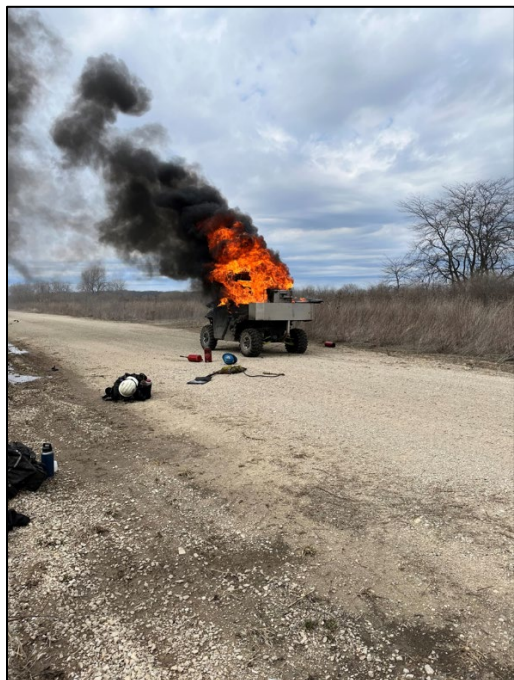
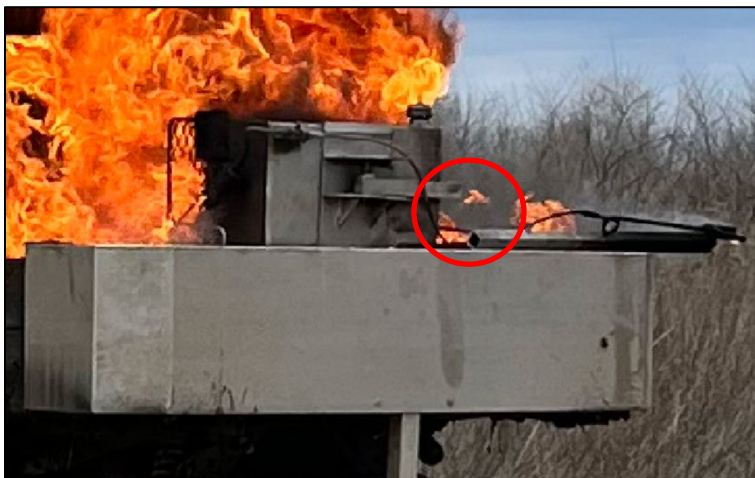
On April 3, 2023, at approximately 1400 hours, a U.S. Forest Service UTV torch malfunctioned while conducting prescribed burning operations. The UTV torch igniter arm snapped completely off at a weld joint and fell into the bed of the moving UTV, rapidly igniting the bed of the UTV on fire. (See red circle in photo below that indicates where the torch igniter arm was sheared off.)

Upon noticing the problem, the operators stopped the UTV, shut off the torch fuel line, removed the sheared UTV igniter arm from the UTV bed, and jettisoned gear from the back. Within minutes, the entire UTV was engulfed in flames. There were no injuries to the occupants of the UTV.

**Damage Sustained:** The UTV and the UTV torch were a total loss.

1. A local weld shop had fabricated and installed an aftermarket 12-inch aluminum extension to the UTV torch igniter arm. The original solid 24-inch aluminum igniter arm was cut (bisected) and a 12-inch extension was welded in between the bisected parts, resulting in two new weld joints and a new igniter arm length of 36 inches.

2. During the shift, the UTV operators noted the igniter arm had struck brush during ignition operations. Strikes or impacts to the igniter arm may have contributed to a clean break to the aftermarket weld joint.

3. The plastic bed of the UTV may have become primed for ignition with leaking torch fuels prior to the clean break on the weld joint of the aftermarket igniter arm. This may have resulted in an accelerated rate of spread.

4. Fire extinguishers were missing on the UTV and the UTV torch mounting bracket, potentially delaying quick knock down of the rapidly spreading fire in the bed of the UTV.

1. Alterations to an original manufacturer's design should only be completed by the manufacturer or a manufacturer's certified representative.
2. Never operate firing devices mounted to motorized equipment without the required fire extinguisher accessible on the equipment.

3. Frequently check motorized equipment equipped with firing devices during operations. Be alert for signs of malfunctions, fuel leaks, etc.
4. Incorporate specific UTV firing operation considerations into the operational or project briefing.
