Event Type: Fire Ignites Under UTV Floorboard

Date: May 21, 2017

Location: Moose Creek Prescribed Fire, Alaska This Has Happened Before!

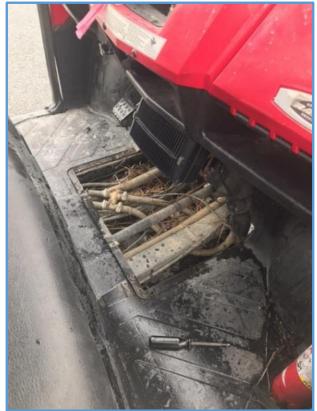
This fire melted a four-inch hole in the skid plate and floorboard and caused extensive damage to wiring and the gear selector cable. (See top photo on right.)

<u>TOP PHOTO</u> – Shows the damage to the wiring and gear selector cable caused by the fire that occurred under the UTV's floorboard.

<u>BOTTOM PHOTO</u> – Shows some fine fuel accumulation under a companion UTV's floorboard.

- Periodically clean out under floorboards of UTVs.
- Standard operating procedures include hosing down the under carriage of UTVs after use.
- The compartment under the floorboards is not obvious and is not easily cleaned by daily washing.
- ✓ To thoroughly clean this compartment, the panel on the floorboard needs to be opened and cleaned out. (Need to remove the eight T-27 torx screws.)
- A contributing factor to this ignition of the fine fuels was the fact that they were operating in a dry site. Typically, spring burning in Alaska involves driving through puddles. The combination of accumulated fuels and these dry conditions made the fine fuels available to burn.
- Typically, UTVs function without damage driving through low-intensity flames.
- All UTVs on this unit will have an inspected and maintained fire extinguisher mounted on them.
