Rapid Lesson Sharing

Event Type: Plastic Aerial Ignition Sphere Potential Hazard

Location: Quarry Fire
Stanislaus National Forest
California

An Important Heads-Up on Using ‘Dragon Eggs’

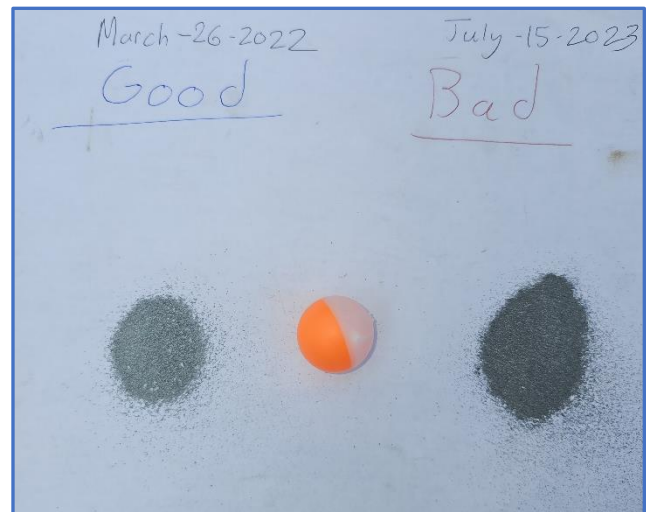
The difference in the color of the eggs' contents is easily noticeable. The amount of the potassium is also different (which may not be that evident in the photos). In the 2023 eggs, there seems to be a lot more potassium permanganate than in the eggs manufactured in 2022.

It was later determined that an additive that the manufacturer puts into the eggs with the potassium to slow the reaction time, was inadvertently omitted causing the contents of the eggs to look and react differently.

Potassium found in a March 2022 manufactured Dragon Egg—that is from a batch that works properly—compared to a Dragon Egg manufactured in July 2023 from a batch that is volatile.

An [Interagency Aviation Tech Bulletin](#) was created and circulated related to this issue recommending that boxes of Dragon Eggs stamped July 14-17, 2023 be removed from service.
