**Ridge Top Fire Entrapment  
Accident Investigation Report**  
Fort Hall Indian Reservation  
Bureau of Land Management, Idaho Falls District

**7/28/2012**

## **Executive Summary**

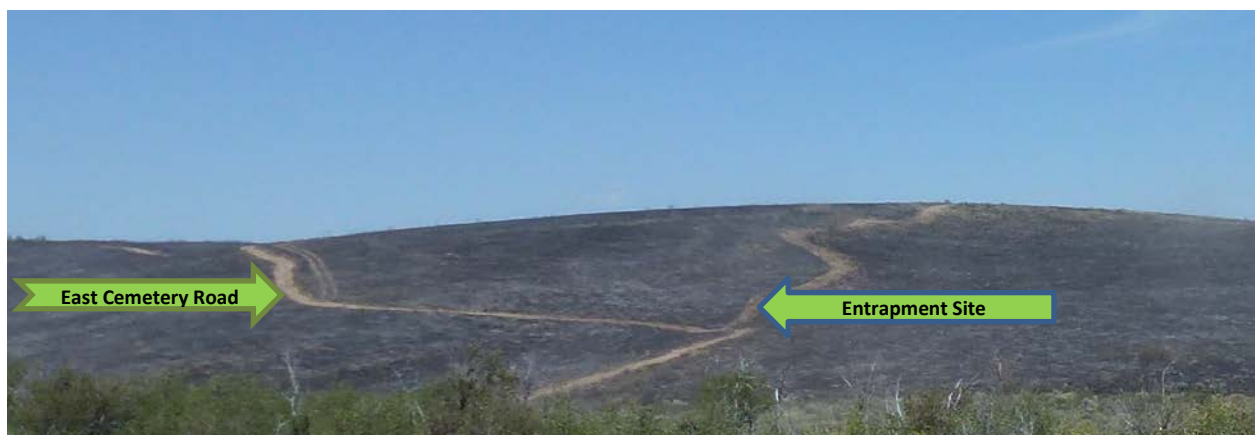
**Photo 1: Overview of the entrapment site looking north**

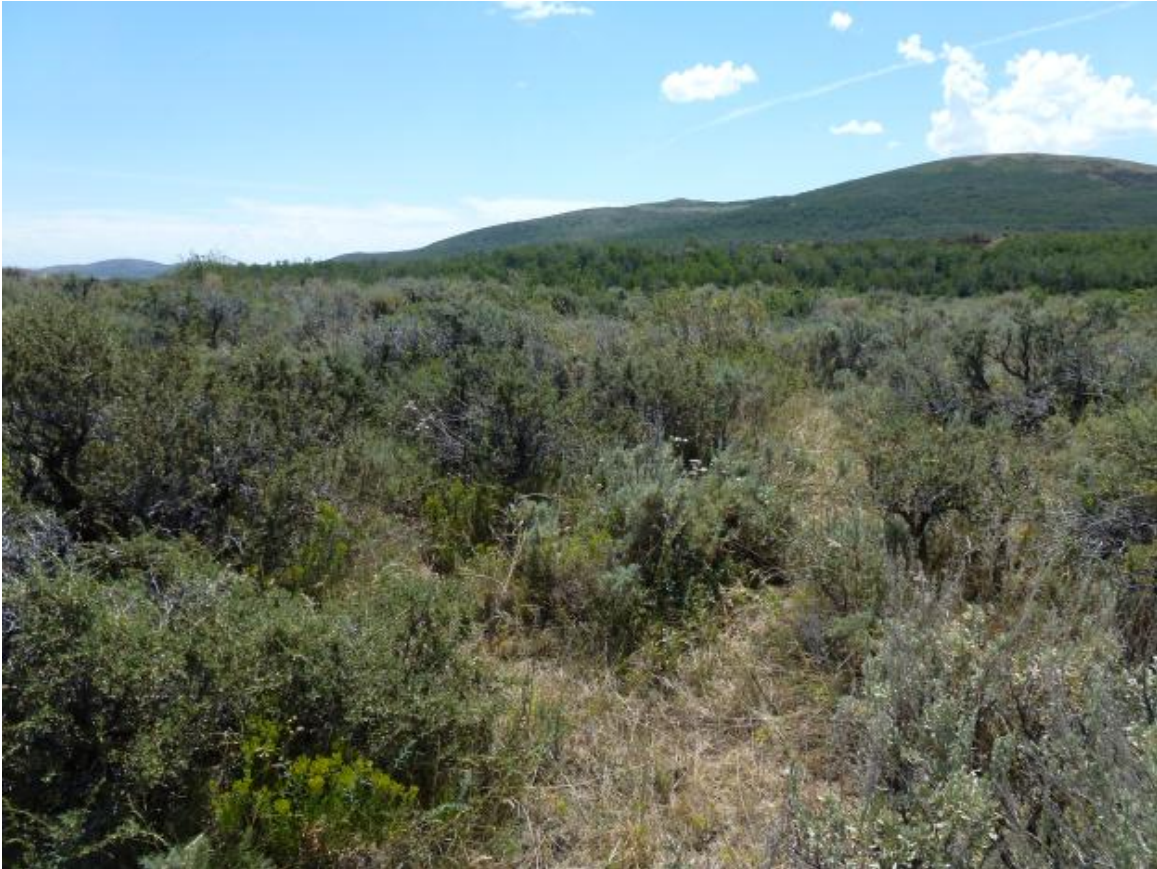
**Photo 2: Representative fuels near entrapment site**

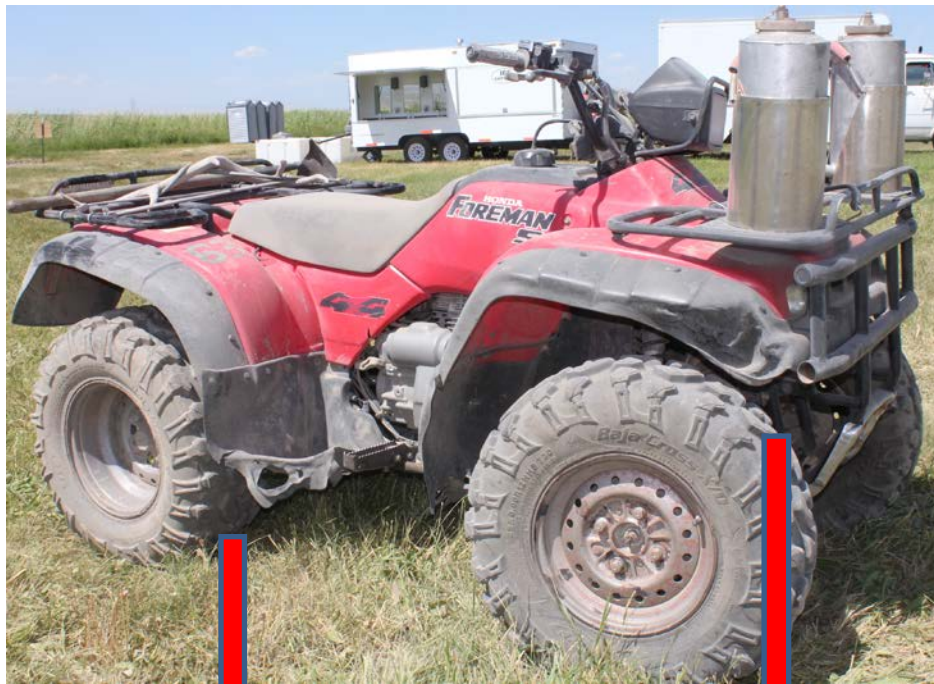
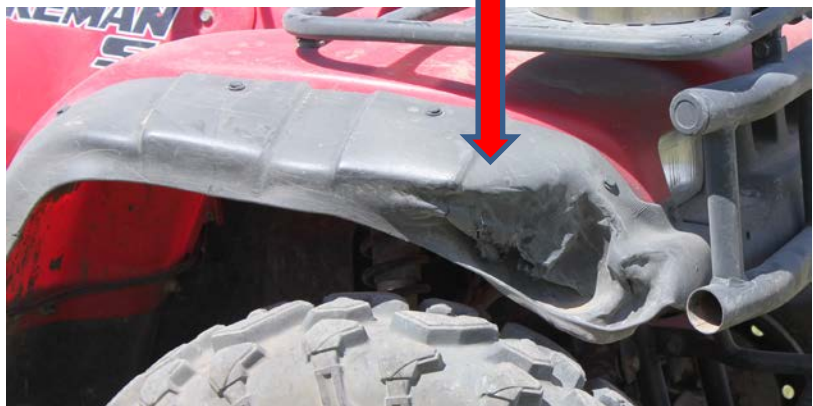
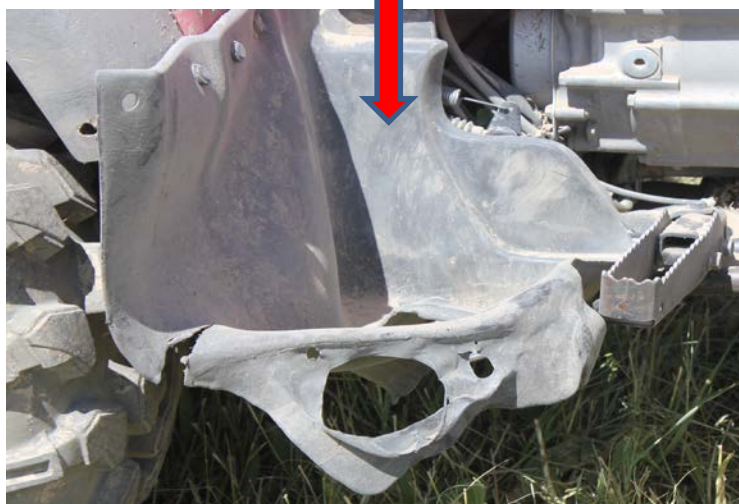
**Finding #10:** As DZSW1 proceeded down the dozer line towards East Cemetery Road, the ATV became inoperable for unknown reasons. DZSW1 subsequently sustained first and second degree burns from multiple radiant heat blasts.

**Discussion:** DZSW1 recognized the potential of fire entrapment and made the decision to continue down the dozer line and execute a sharp right-hand turn back onto East Cemetery Road back into clean black towards the safety zone. Before reaching the intersection, the ATV ceased operating due to unknown reasons and stopped against the dozer berm towards the unburned area of fuel (see photo 1). DZSW1 recognized the immediate peril, took a deep breath, and buried head between legs while still on the ATV. The first wave of radiant heat hit DZSW1, and likely caused the first and second degree burns. Following the first wave, DZSW1 pulled the ATV away from the berm and crouched low to the ground in an attempt to use the ATV as a heat shield. DZSW1 did not deploy fire shelter due to concerns that moving away from ATV would cause additional exposure to heat. The radiant heat disfigured plastic components on the ATV (see photo 3).

**Photo 3: ATV showing damage from radiant heat**
