**Event Type:** Broken Wheel Studs  
on a Type 6 Engine

**Date:** February 3, 2024

**Location:** Land Between the Lakes  
National Recreation Area,  
Kentucky

## Broken Wheel Studs on a Type 6 Engine

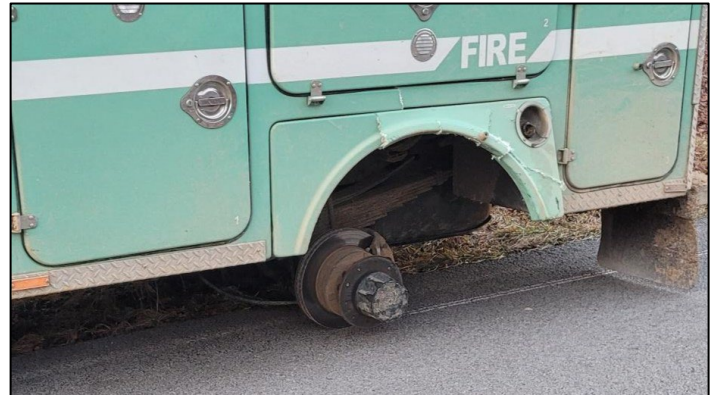
*Image shows the driver's side wheel studs that were sheared off.*

While everyone was on scene, the AFMO and FEO inspected the wheel hub on the engine and clearly saw that all the wheel studs had been sheared off. The FEO moved the vehicle as far off the highway as possible to clear the road. Several hours later, the vehicle was towed to the local dealership for inspection and repairs that had resulted from the broken wheel studs.

The flanged wheel lug nuts on about 435,580 of the above vehicles may have been over-torqued during service to an incorrect torque specification in the Service & Owner's manuals. A yielded wheel stud may eventually break, which could lead to a wheel separating from the vehicle during operation. A wheel separating from the vehicle could cause a vehicle crash without prior warning and/or the wheel/tire could pose a risk to other vehicles or pedestrians.

- 2. If recalls or repairs cannot be completed immediately, firefighters should coordinate with their Fleet Manager and supervisor to ensure the vehicle is safe before it is placed back into service.** Dealerships are often located in remote areas that may not have parts on hand to immediately make repairs or recalls. Additionally, dealerships may not know the workload and stresses that are associated with how these vehicles are used. Under “normal” conditions they may consider the vehicle to be “operational.” Therefore, coordinating with Fleet Managers and others may be needed to ensure the information from the dealership is accurate and if the vehicle is truly safe to operate.
