USDA Forest Service  
Pacific Northwest Region

August 2, 1989

FIRE SHELTER DEPLOYMENT REVIEW

*Glacier Complex  
Malheur N.F., R6*

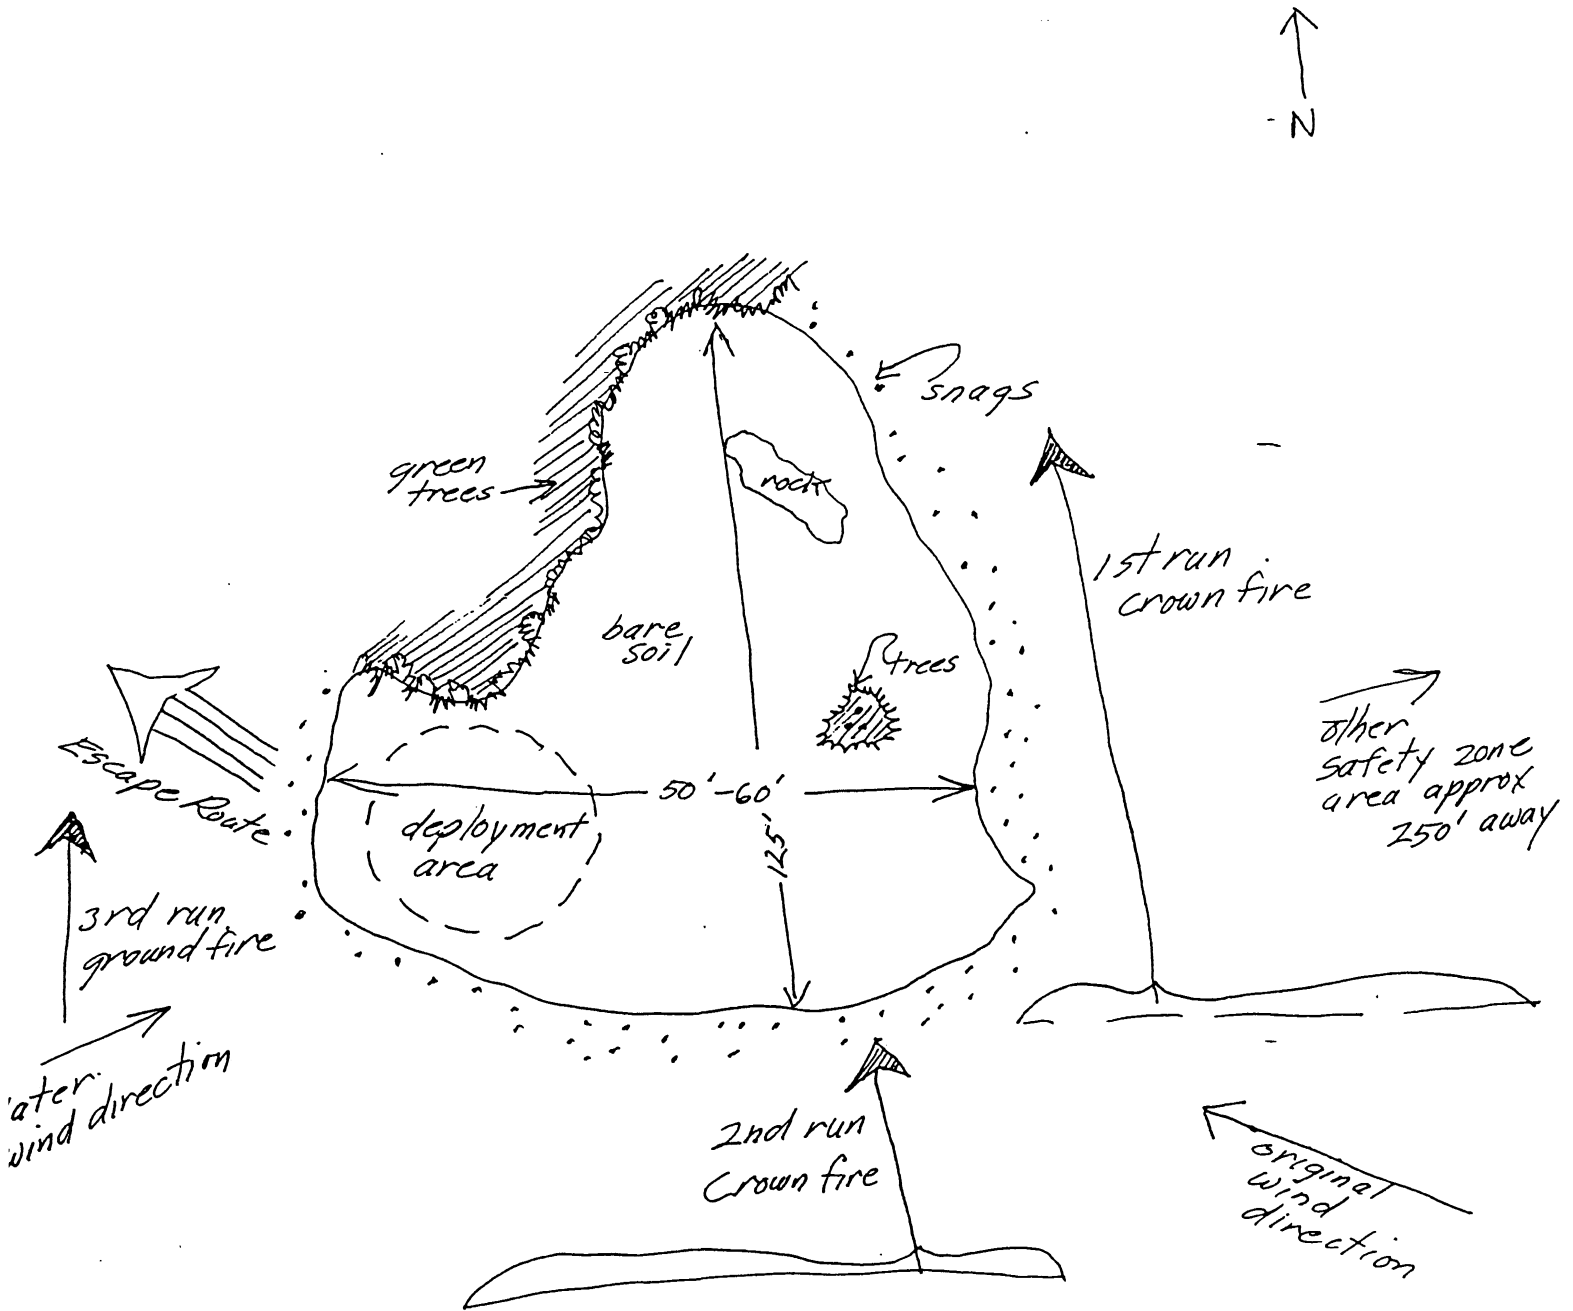
# Deployment Area Diagram

There was a rapid increase in intensity of the spot fire, and because of the ladder fuel, the fire was in the crowns within seconds. As the fire ran to the south and east side of the safety zone where Cheyenne 15 and the Division Supervisor were located, the Division Supervisor moved the crew around in the safety zone to keep away from heat and ash. The fire moved around the area. Spots appeared to the west of the location. At this time, the crew members were instructed where to deploy their shelters. The crew deployed shelters while the crew boss and Division Supervisor made sure of the safety of the crew. Shortly after this and just before the crew boss and Division Supervisor crawled under their shelters, air attack contacted the Division Supervisor and instructed that there was an escape route west of their location and led them out by radio. He then moved them to a larger safety zone away from the fire. There were no injuries.

The lack of additional information about other, larger potential safety zones (in some cases 100-200 feet away) beyond the immediate line construction area, and limited information about terrain and fuel to the west of the deployment area, were factors in the decision to deploy.
