Rapid Lesson Sharing

Event Type: Hazard Tree Felling/Line Gear Stowing

Date: November 18, 2023

Location: Horseshoe-Wild Bill Rx
Near Lava River Cave Recreation Site
Coconino National Forest, Arizona

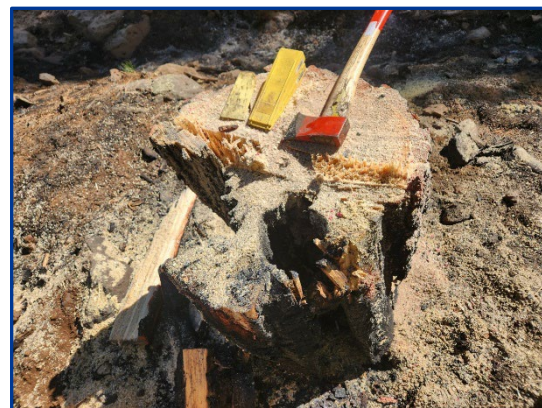
Image 1 – Stump of the fire-weakened ponderosa that was felled beside Forest Road 245.

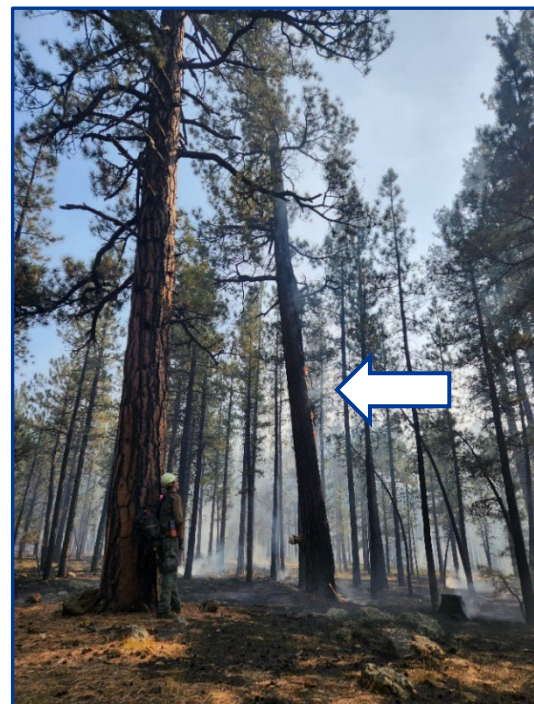
One situation involved two 10 to 12-inch DBH trees hung up that required multiple cuts to walk the trees around the hang up point to fall clear. Another situation was a live 18-inch DBH ponderosa with fire in the bottom 30 feet inside an old decaying lightning strike scar (see Image 2).

Image 2 – Active burning in this ponderosa tree's bottom 30-feet inside an old decaying lightning strike scar.

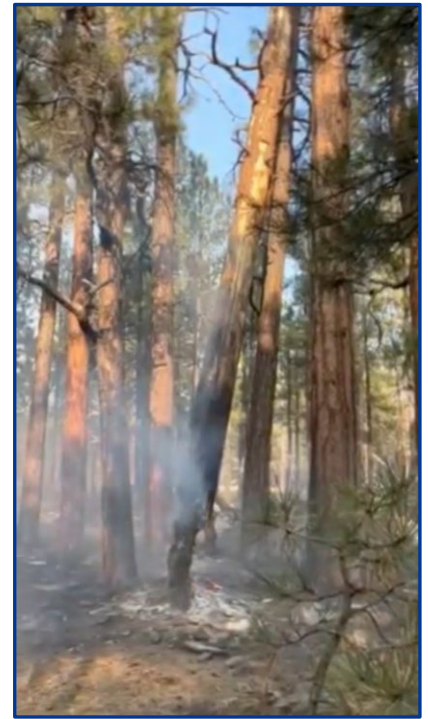
The third situation was a 20-inch DBH snag with a burned-out base surrounded by other trees of the same size. This snag's base area was bone piled to burn out the snag and the tree. Then, when being taken down, the snag hung up (*Image 3*).

Image 3 – The burned out and hung-up tree.

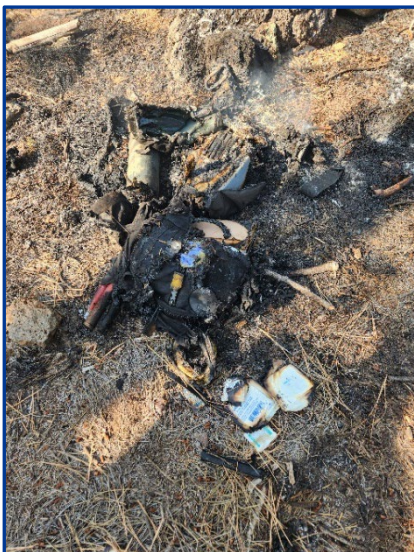
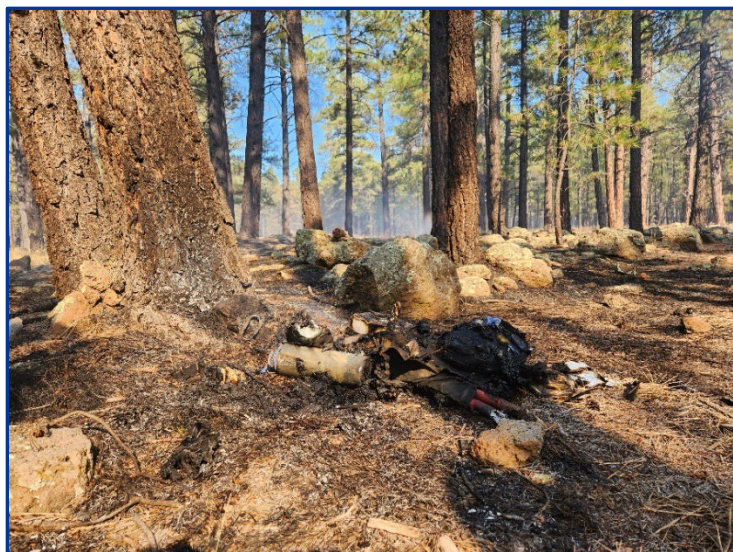
We discovered that one of our drip torches had an incorrect collar that leaked because it could not properly seal. (This issue has been documented in previous events: [Clear Creek Rx](#), [Brundage Rx](#)) We believe this drip torch fuel absorbed onto the crewmembers' line gear. As shown in *Images 4 and 5*, the burned line gear had been placed at the edge of burned and unburned pine needles.

Aided by wind, the fire crept through the pine needle cast under the line gear. The fuel that had been absorbed into the material caused the line gear packs to be more flammable. The line gear was discovered to be on fire when fusee firing devices ignited in the pack's side pouches. Crewmembers applied their drinking water to the packs to extinguish the flames.

Notable equipment damaged included: the fireline pack, fire shelter, bleed kit (CAT-T and hemorrhage control bandage), Headlamp, DPH battery clamshell, MRE and some personal effects.

Images 4 and 5 – The burned line gear.

- ❖ Cold trail and/or scrape away fine fuel from gear set on the ground in active fire areas.
- ❖ Inspect drip torches for leaks before being placed with other equipment. Specifically check for mismatched components. Replace equipment not functioning properly.
- ❖ Avoid placing line gear and other personal PPE with fuel. Develop separate carry racks and mounts on vehicles.
