INVESTIGATION REPORT

BURN INJURIES

DAWSON FIRE

DATE OF REPORT: June 30, 1981

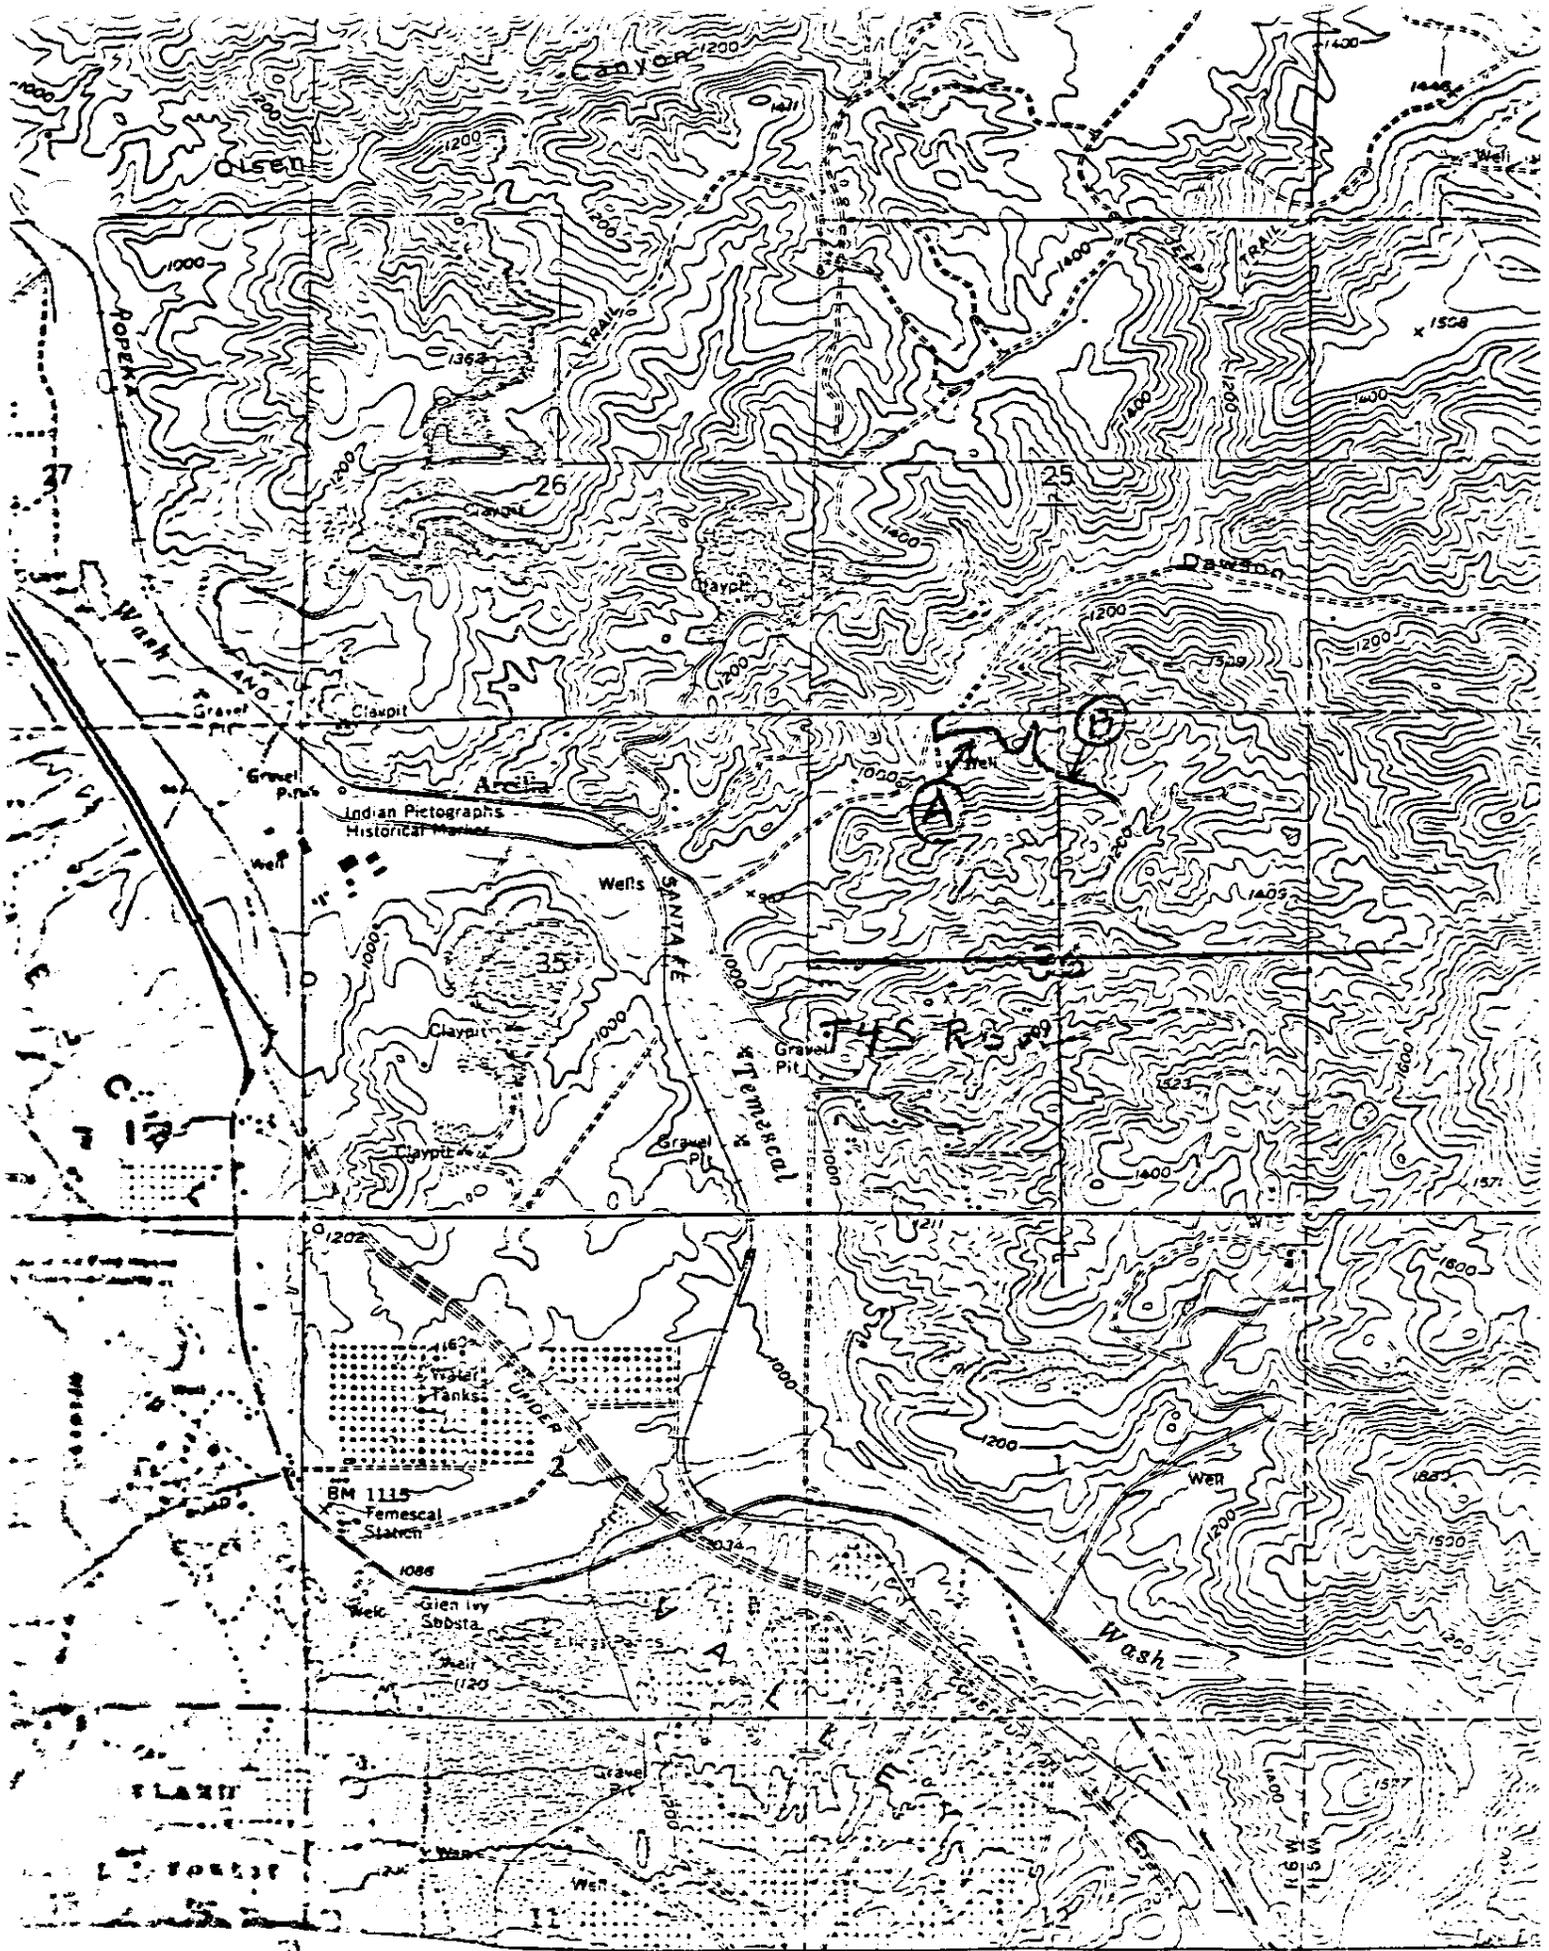
EXHIBIT A - Survey

At approximately 1720 hours, Captain Mike Williams in Engine 27 was working along Dawson Canyon Road and at a point near a dirt road which formed the right flank on the western most edge of the fire. (See Exhibit A, point A) Road on Exhibit A colored brown is the road on which incident occurred.

Brusewitz first noticed the dozer when it was on the dirt spur road which, at that time, formed the right flank and western most line of the fire. (See Exhibit A, point A) He made contact with Mr. Charles Lewin and another man, later identified as Lou Charles Randall, D.O.B. 1-29-59, Route 2, Box 91-B, Corona, California. Captain Brusewitz described the man (see statement) as an older clean-shaven man and a younger man with a full beard and long hair.

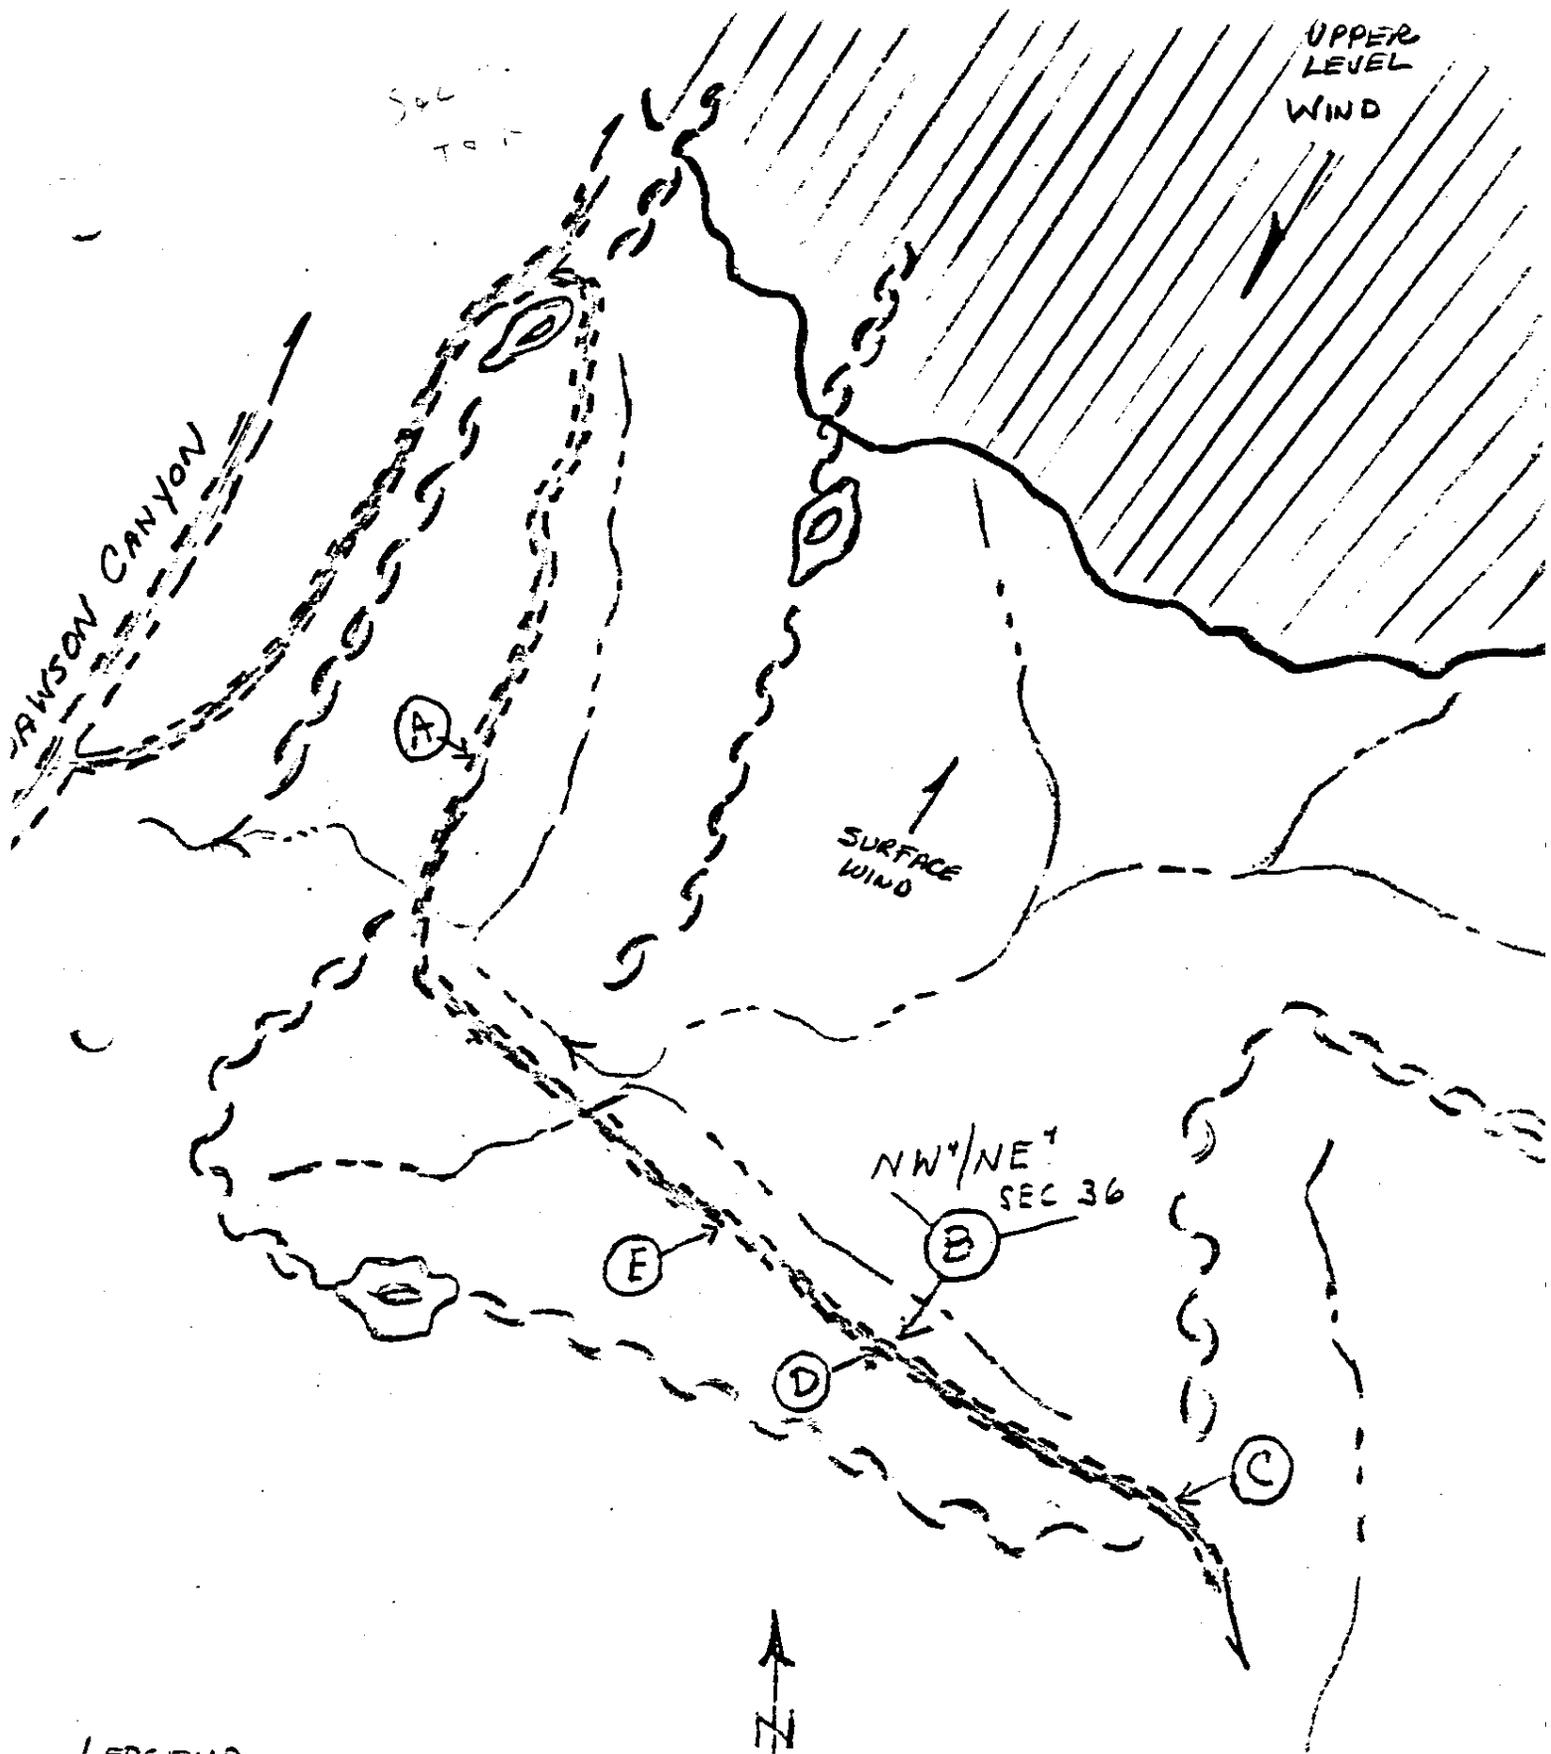
The area into which the dozer was moving was a small drainage or basin comprised of several steep ridges and canyons as shown on Exhibit B. The fire was backing down the face of the basin, moving northeast to southwest against the wind which was from southwest to northeast. Rate of fire spread was slow.

When Dashiell was a short way down the road into the drainage, he observed the smoke beginning to lay in the canyon bottoms. He stated the wind had stopped and was calm. He stated it did not feel right, so he stopped his engine. He could not see the dozer due to smoke. (See Exhibit B, point A)

Dashiell did not see the second victim, Charles Lewin, for some time and not until after Randall had been removed from the scene. He saw him staggering down the road. He got to Lewin and saw that he was badly burned. He saw the dozer parked about half-way up the grade on the road. (see Exhibit B, point B) Dashiell loaded Lewin onto Engine 11 and transported him to the cleared area where Randall had been taken. Incident Commander Bliss notified Perris ECC of the second burn victim at 1825 hours. This was after Lewin had been transported to the clearing.

From the statements of the various witnesses, it appears that just after the dozer, with Randall and Lewin, passed to the bottom of the drainage and began to climb up the grade toward the saddle shown on Exhibit B, the wind then began to blow from the northeast and the fire spotted across the road resulting in area ignition and the injuries to Randall and Lewin. The dozer stopped at the point marked on Exhibit B. (marked "B")

Sometime after the removal of the injured, and prior to daylight on 6-18-81, a party or parties unknown moved the dozer up the road and into the saddle at the point marked "C" on Exhibit B.

During the course of the investigation, the scene of the injuries was examined on 6-18-81 by SFR II Pressley Kent and Forester III David Gearhart. At point "D" on Exhibit B, the remains of a cloth baseball-type cap was found. Fire had almost completely destroyed the cloth. At point "E" on Exhibit B two burned pieces of what appeared to be cloth from a light weight shirt were found. These remains match the description provided by Captain Brusewitz of the shirt worn by Mr. Lewin.

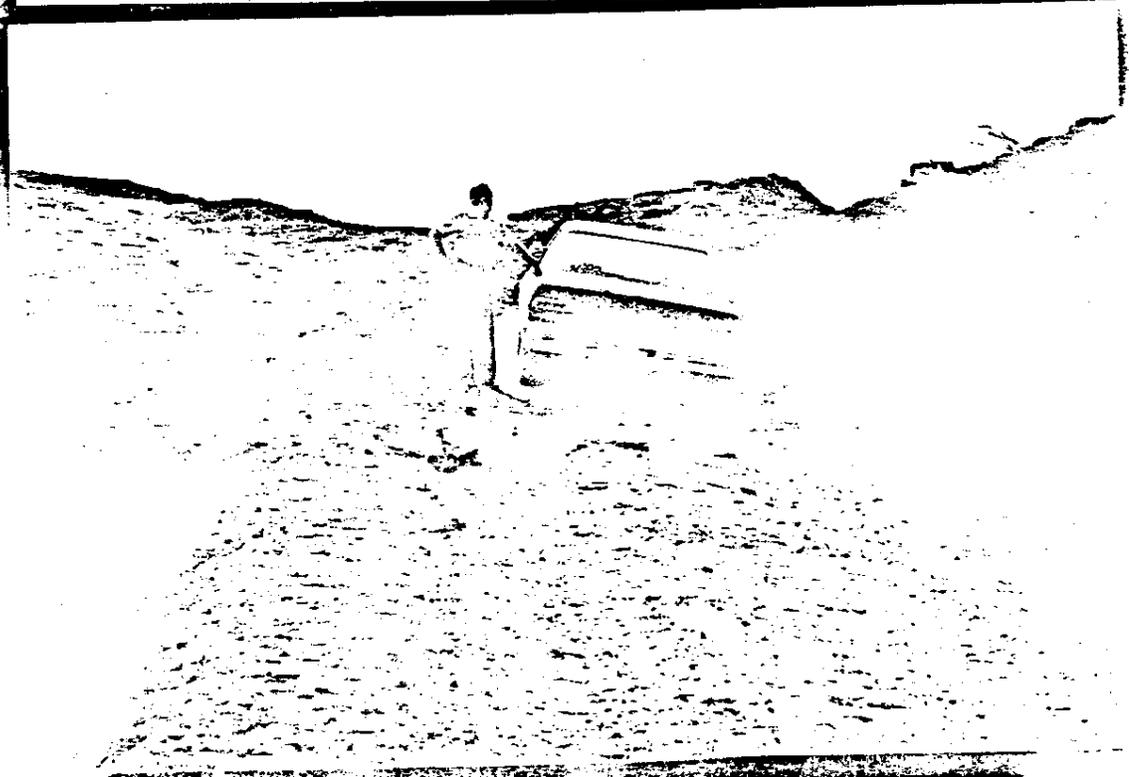
6. Looking south from where dozer was overrun by fire.

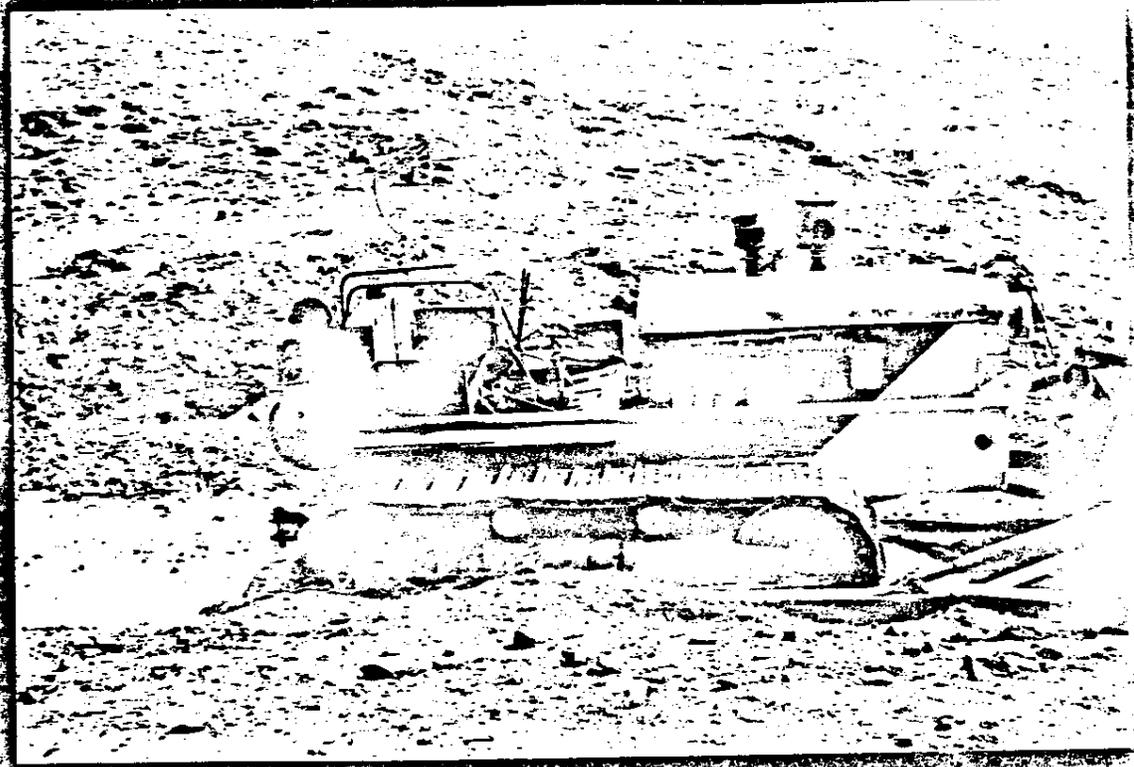
12. View of right side of dozer showing fire damage to seats and bodywork.
