KATES BASIN FATALITY REPORT

August 11, 2000

U.S. Department of Interior
Bureau of Indian Affairs
Wind River Agency
Fort Washakie, Wyoming

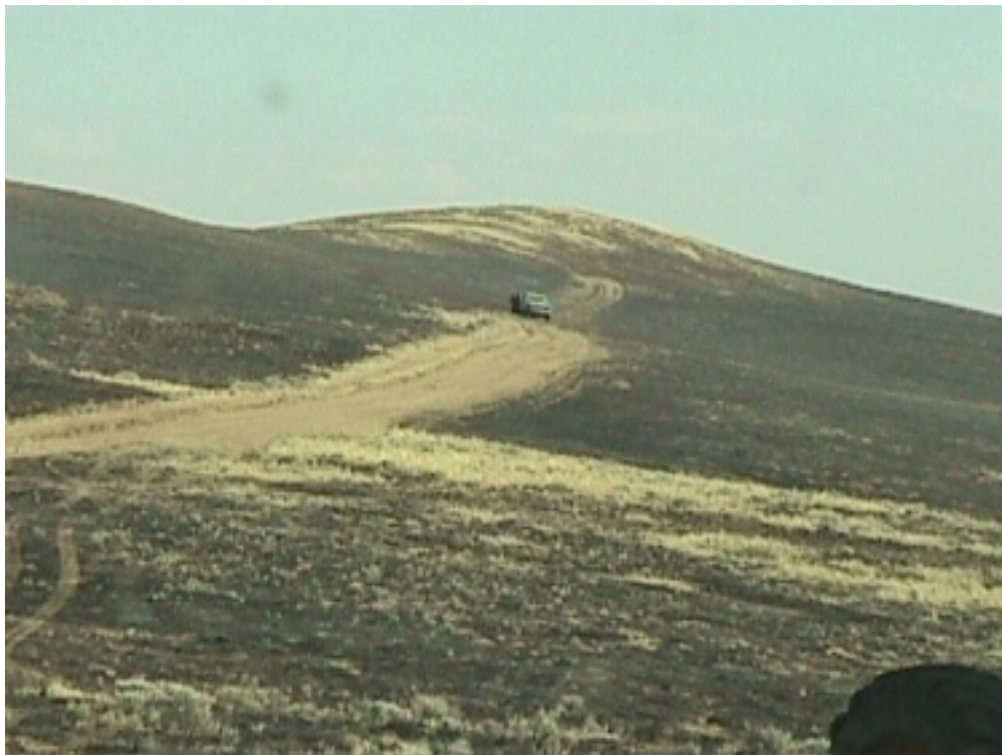
Engine #2 at intersection of dozer line and two-track.

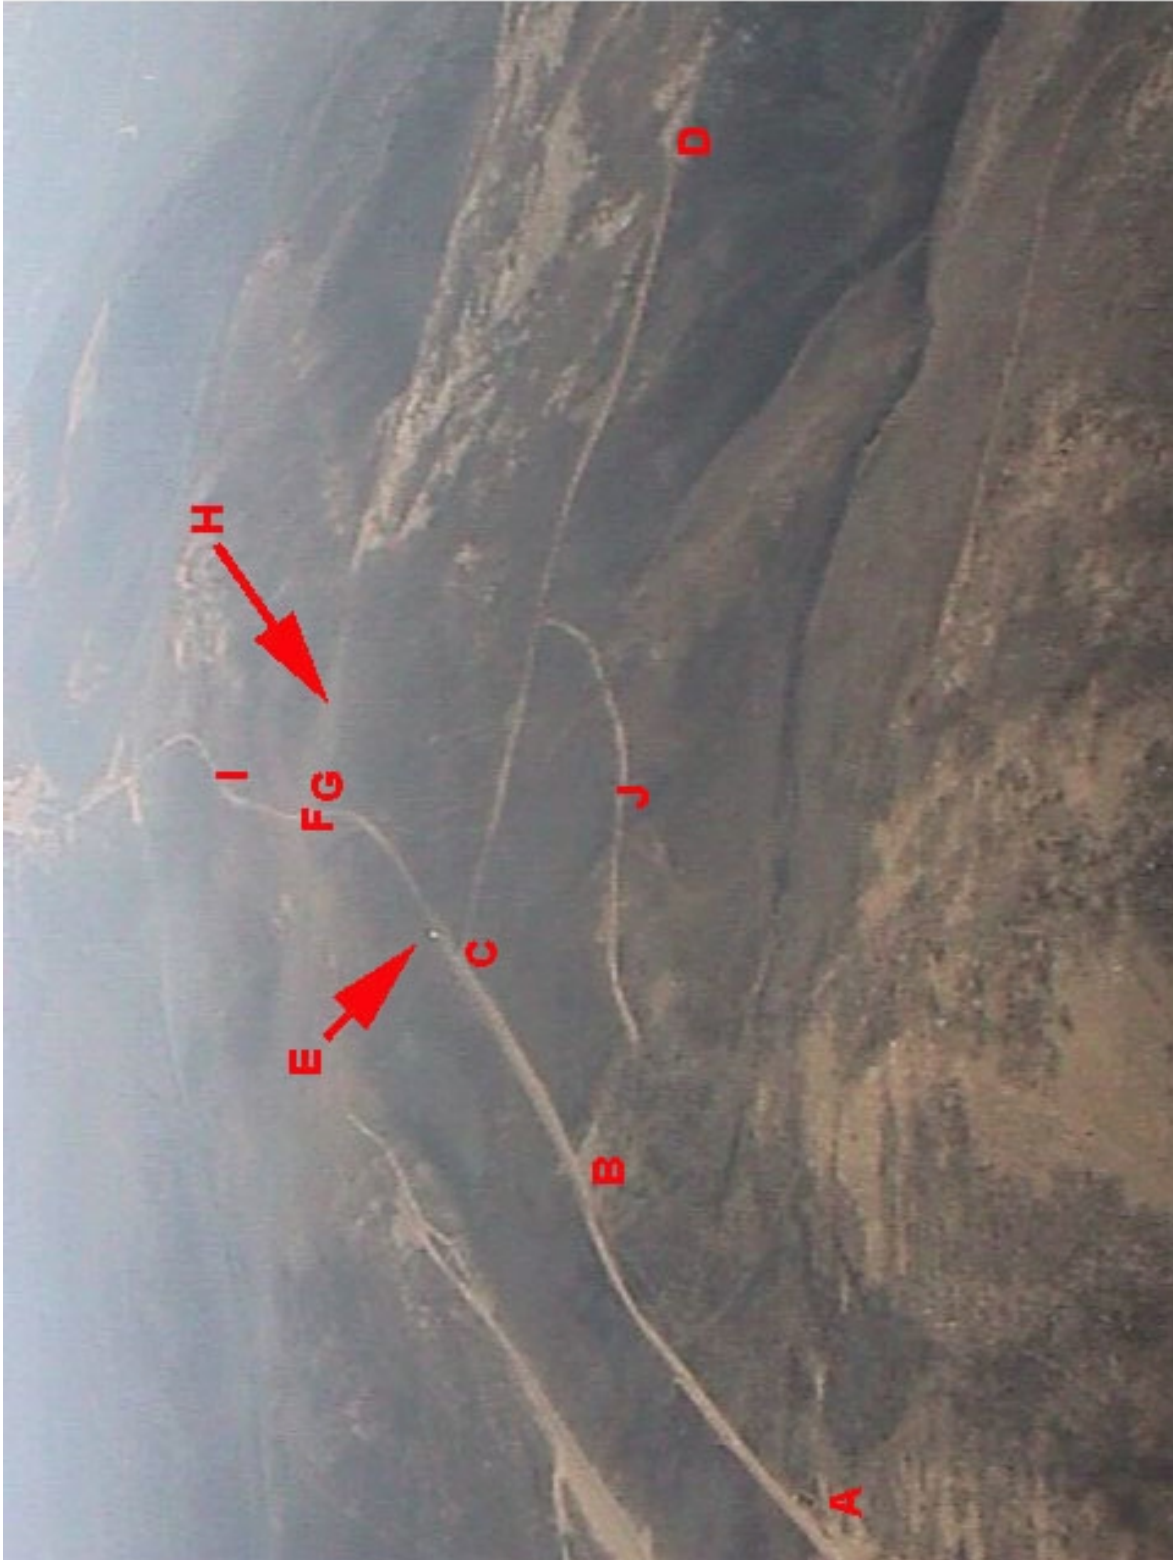
Aerial view of the entrapment site

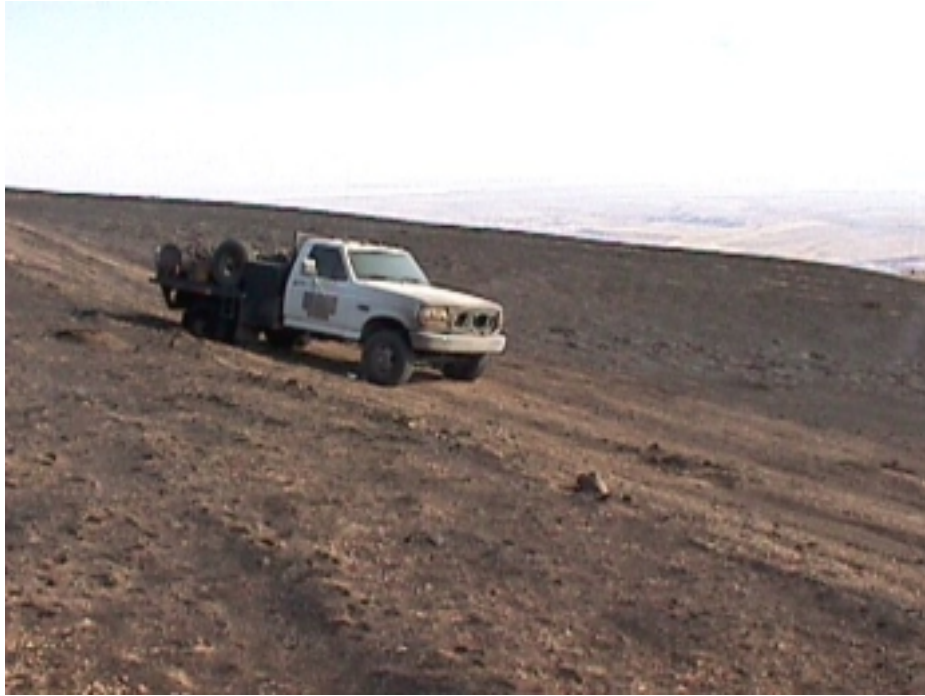
On August 12, 2000, the vehicle's condition was inspected by members of the Serious Accident Investigation Team (SAIT). The vehicle was heavily damaged by direct flame impingement to the front and driver's side of the vehicle. Equipment and personal gear packs on the top of the engine's water tank had caught fire and were heavily damaged or destroyed. The right rear dual wheels had caught fire and burned. All other wheels were charred, but did not lose pressure. The pump's control panel was heavily damaged but the Hobbs meter was still recording time, the voltage meter was registering twelve volts, and the "on" light and panel light were still functional. The vehicle's transmission was in reverse, the transfer case was in 2H and the emergency brake was in the off position. The engine was started and functioned normally. The engine's two-way mobile radio also functioned normally. The driver's door panel and molding melted and charred from intense heat to the outside of the driver's door.

Right side of Oklahoma Engine #2

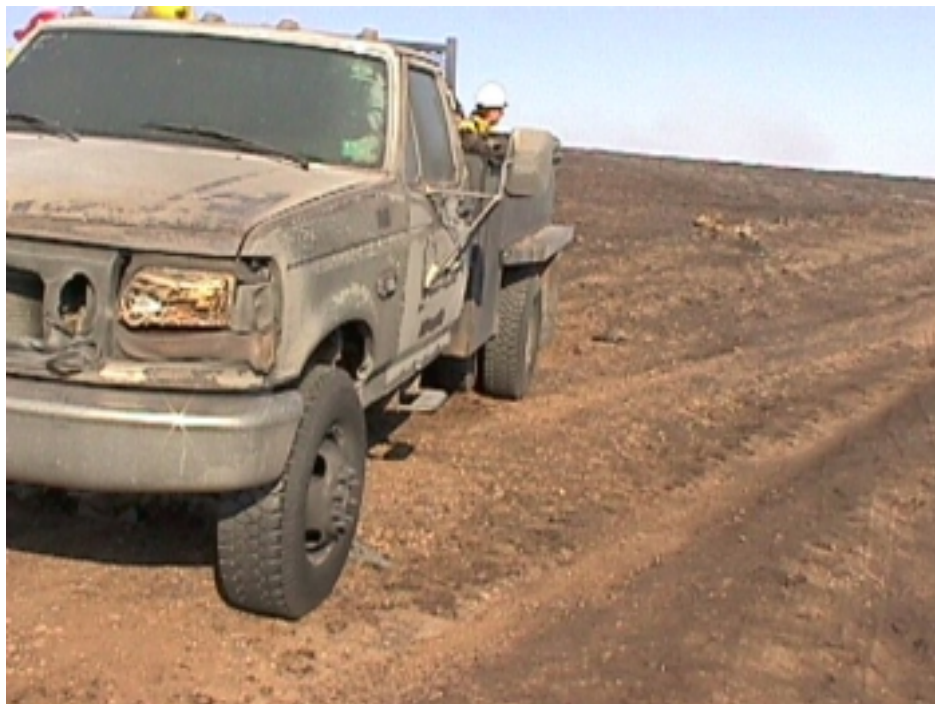
Left side of Oklahoma Engine #2
