**Event Type:** Crew Carrier Rollover

**Date:** June 25, 2023

**Location:** Glenwood, New Mexico (5 miles south)

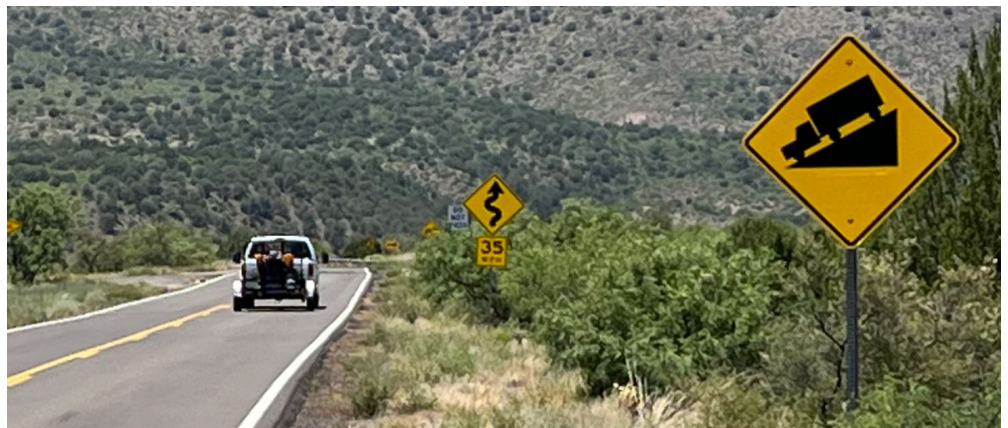
Assessment at the scene of the accident indicated that the crew

carrier right rear dually tire(s) exited the roadway, causing the rear of the vehicle to pull hard to the right. The

crew carrier “clipped” a directional arrow sign and the driver immediately steered the vehicle back onto the roadway, into the oncoming lane of traffic. The driver attempted to correct the direction of travel by steering back to the right. The momentum of the vehicle caused the vehicle to swerve to the right and roll over on to the driver’s side. The vehicle slid for approximately forty-five feet on the driver’s side, then rolled over on to the roof of the vehicle and came to rest partially blocking the opposite side of the highway, opposite the direction of travel. Distance from the location the vehicle’s right rear tire(s) came off pavement to the vehicle coming to rest was approximately two hundred and twenty feet. Witness reports and individuals interviewed stated that speed was not a factor in the accident.

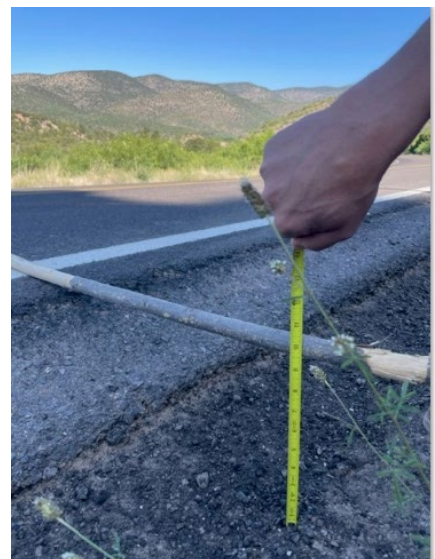
**Finding 3.** Road Conditions. The section of highway where the accident occurred had recently been repaved. The original pavement, combined with the new pavement, created a measurement of approximately nine inches from the top of the pavement to the dirt/gravel shoulder. The distance from the outside edge of the white line to the shoulder was approximately twenty inches. The lane of travel measured approximately nine and a half feet and the width of the crew carrier measured approximately eight and a half feet.

**Discussion:** The condition of the road surface was excellent. However, the narrow width of the lane of travel, combined with the width of the vehicle, left little margin for error to stay in the lane when traveling around the curve. Oncoming traffic, or the

possibility of oncoming traffic would naturally incline a driver to steer as far right in their own lane as possible. The height variation between the road surface and the shoulder was a factor in the incident, when the right rear dually tires exited the road surface onto the shoulder. The combination of the shoulder height, height of the old pavement, and height of the new pavement created a step affect which could easily pull the dually tire(s) on to the shoulder if the vehicle moved slightly off the new pavement.

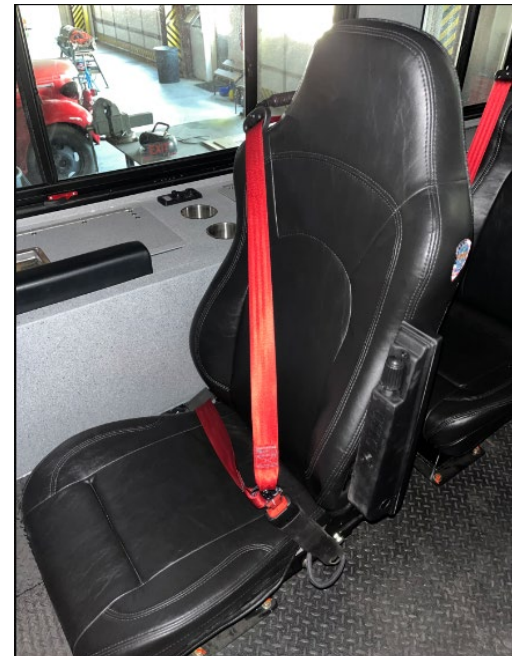
**Finding 5.** Restraint systems. All occupants of the vehicle were wearing seat belts. All seats were equipped with three-point seat belt systems. When the vehicle came to rest, responders saw occupants upside down within their seats.

**Discussion:** Two individuals, within the crew carrier compartment, had slid the shoulder belt portion of the seat belt system behind them. Though no additional injuries were noted by these two individuals, one of the individuals got tangled up in the seat belt when the buckle was released, and the individual attempted to exit the vehicle. This required cutting of the seat belt to allow the occupant to exit the vehicle. Another individual's seat belt, within the crew compartment, required cutting. Individuals were hanging upside down when the vehicle came to rest, so tension was continually on the belts. It is clear, wearing of seat belts was a key factor resulting in only minor injuries during this incident.
