# **CDF GREEN SHEETS**

## **Investigation Summaries of Serious CDF Injuries, Illnesses, Accidents and Near-miss Incidents**

**CONCOW FIRE  
CA-BTU-10476  
BUTTE RANGER UNIT  
COAST-CASCADE REGION  
SEPTEMBER 19, 2000  
SHELTER DEPLOYMENT**

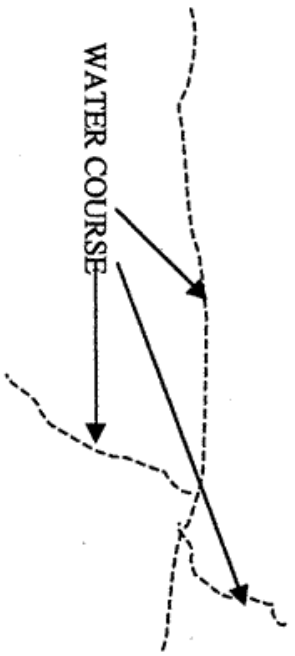
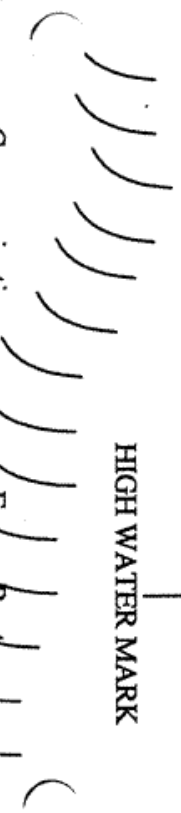
1. 470 FEET FROM DEPLOYMENT SITE TO ENG A & ENG B
2. 1,040 FEET FROM THE DEPLOYMENT SITE TO THE ROCK PILE

SHELTER  
DEPLOYMENT
