# **Concow Fire**

## **September 19-20, 2000**

## **Concow Fire September 19-20, 2000**

John R. Hawkins, Assistant Chief California Department of Forestry and Fire Protection  
Butte County Fire Rescue 6640 Steiffer Road, Magalia, CA 95954-9778  
Bus (530) 873-0330 FAX (530) 873-1473 Email <john\_Hawkins@fire.ca.gov>

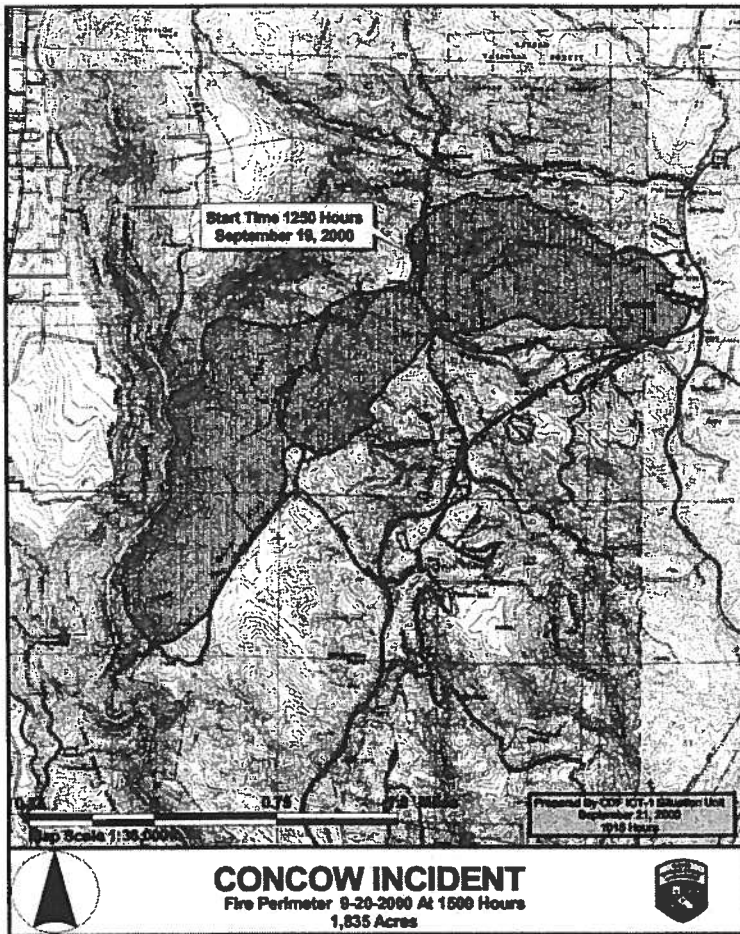
Figure 1. Map of the Concow Fire, August 19-20, 2002, showing both fire spread directions. The first spread direction was to the east from the origin. The second spread direction was from just southeast of the Concow School to the southwest (Concow Fire documentation report).

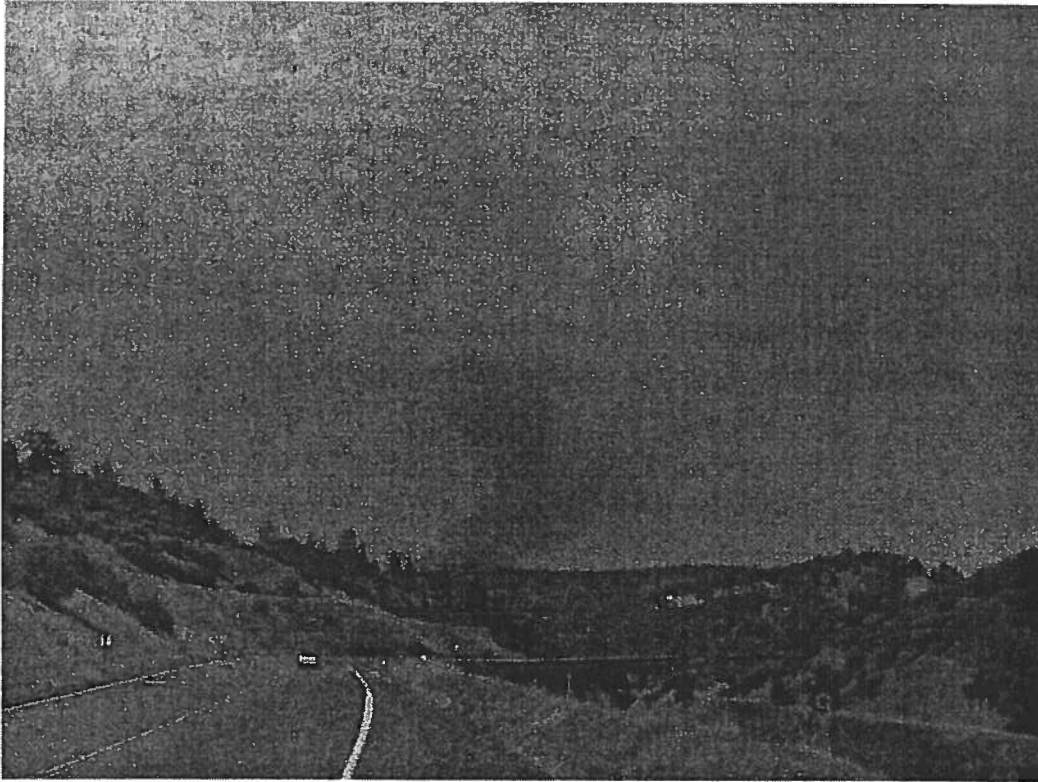
Figure 2. Picture of the Concow Fire taken September 19, 2000, 1418 hours. The picture was taken about four miles southwest of the fire. Note the fractured smoke column indicating an east wind aloft (Wilson 2000).

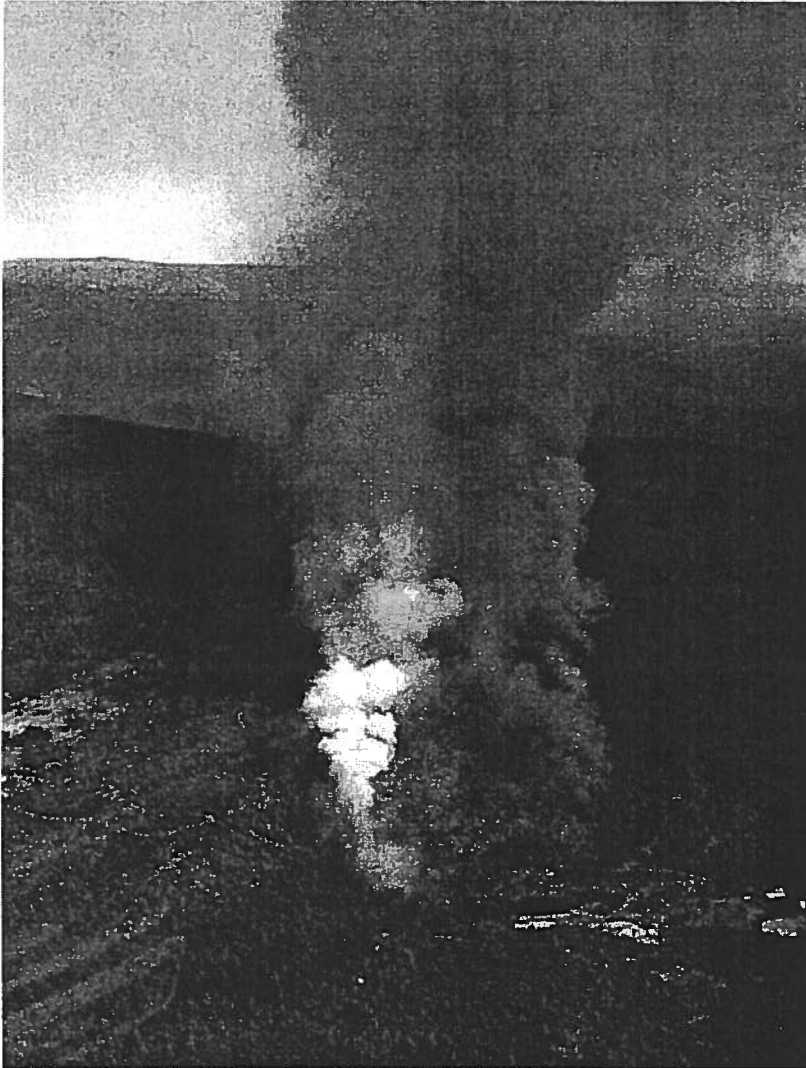
Figure 3. Picture of the Concow Fire, August 19, showing the initial fire spread to the east from the vicinity of the Concow School (Iverson 2000).

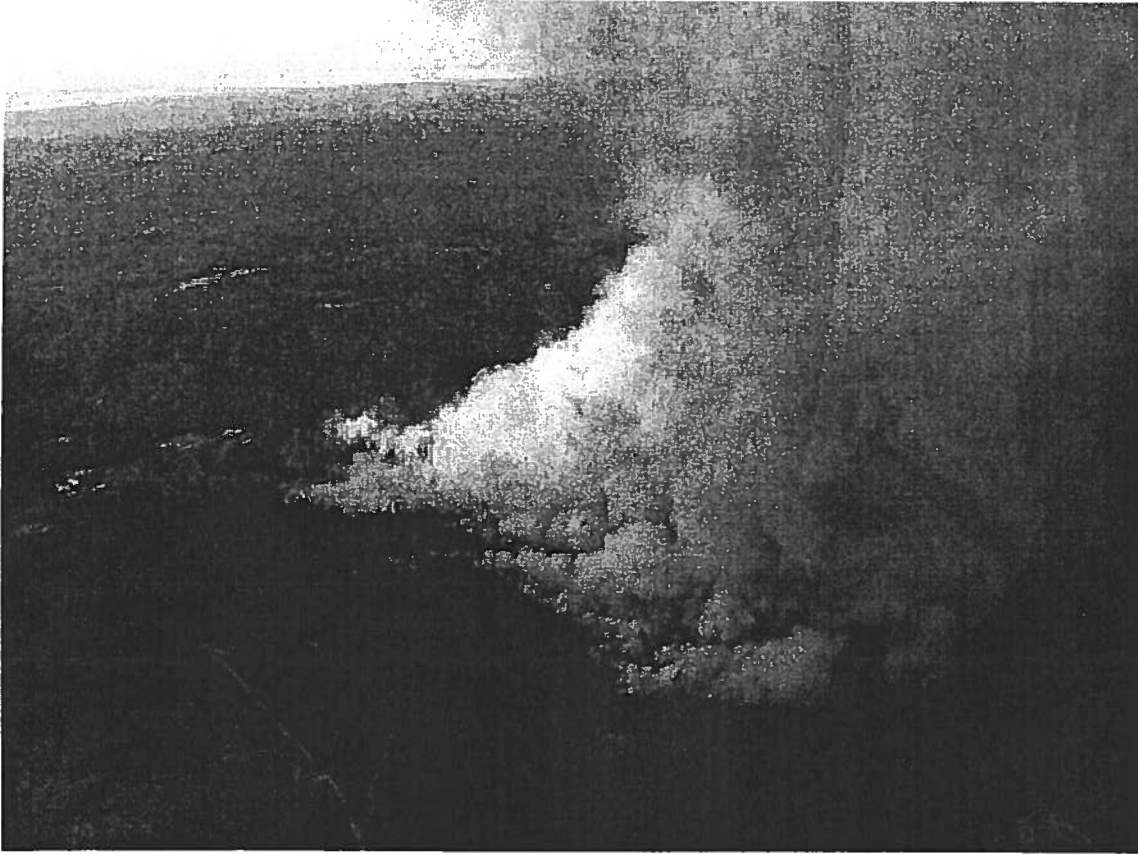
Figure 4. Picture of the Concow Fire, August 19, approximately 1500 hours as it ran over Miller Peak and towards Tim Tam Lane. The Concow School is visible just to the left of the rear of the fire (Iverson 2000).

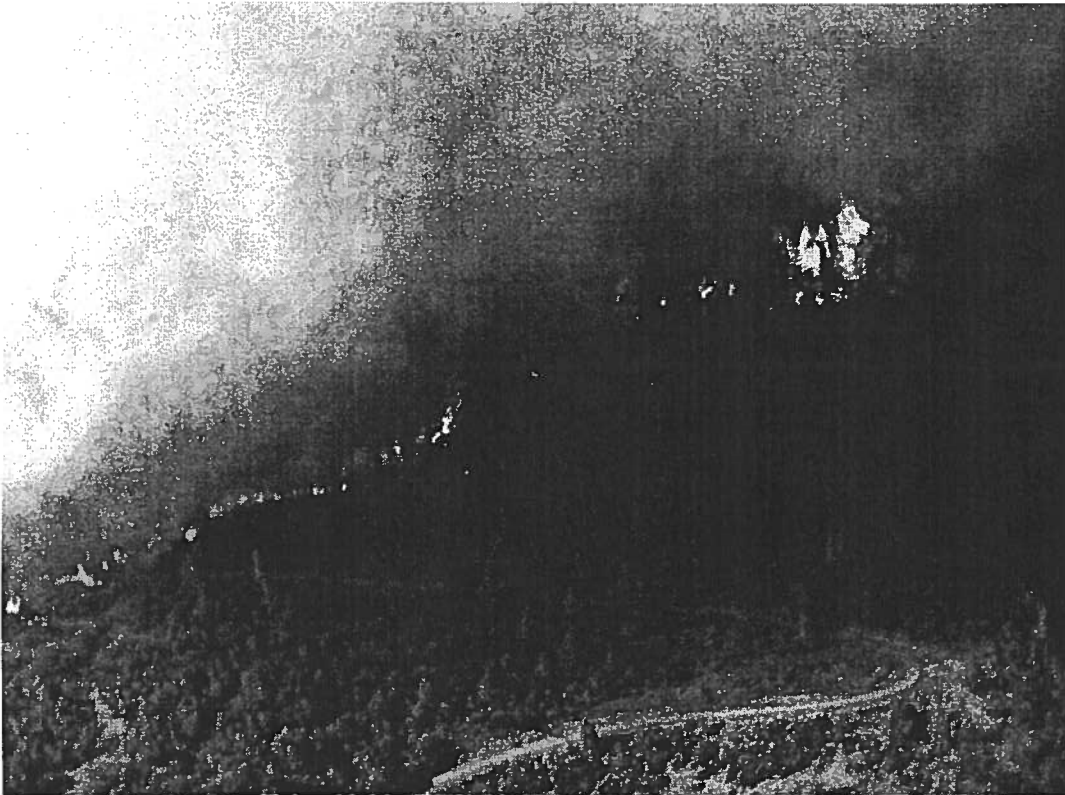
Figure 5. Picture of the Concow Fire, August 19, approximately 1500 hours, near Miller Peak showing extreme burning conditions at the head and right flank of the fire (Iverson 2000).

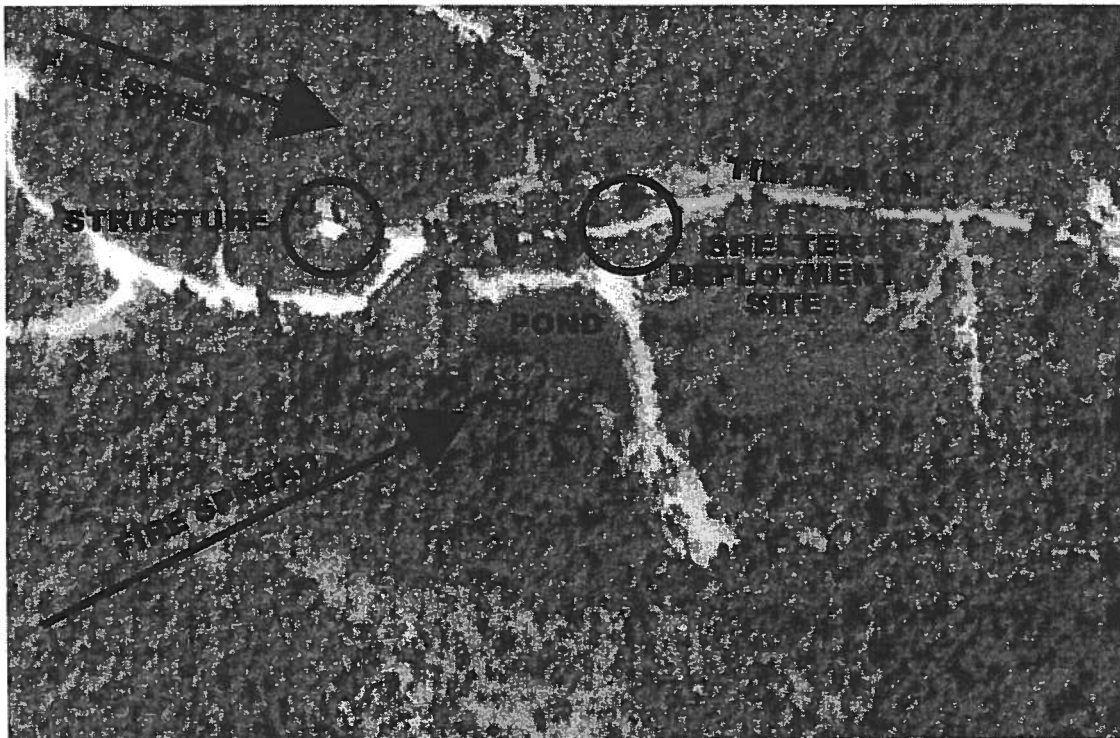
There was no coordination of the firing operation with the Division Supervisor. The officer of Engine A (Engine 64R) took the lead putting down fire, on the south side of the roadway, approximately every twenty (20) feet. The firefighters burned out the vegetation between these spots. The firefighters only had one torch and no other tools were taken along. The extra firefighter was told to watch the progression of the fire, but was not specifically ordered to act as a lookout. Approximately 70 yards into the firing operation, the engine officer noticed two small spot fires to the southwest of their position, and that there was fire on the ridge behind the spot fires. The officer also noticed a small spot fire on a knoll approximately 200 yards

to the southeast of their position. The firing operation was proceeding well, with fire being carried slowly downhill, in the ground litter. Fire did not extend into the Manzanita canopy. After completing the firing to their objective, approximately 470 feet, the crew turned to go back to the engines. At that time, the engine officer realized the main fire had come up behind them and was moving in their direction. The officer ordered the drip torches be put down and the firefighters to start back toward the engines. The fire started to sheet across the roadway from the south cutting off their escape route to the engines. They turned to go in the opposite direction and noticed the fire had extended up the minor drainage, from the pond to their east, and was also sheeting across the roadway. The officer gave the order to deploy fire shelters. One of the firefighters had difficulty getting the shelter out of the carrying case, and then removing it from the plastic cover. The officer pulled the head and torso of the firefighter into the officer's shelter. The head of the firefighter was in the lap of the officer. The officer was in a sitting position. The second firefighter, who was also in his fire shelter, put his shelter over the first firefighter's legs. After the fire crossed the roadway from the south side the officer ordered the first firefighter who had trouble deploying to finish the deployment of his shelter. The crew then experienced an increase of heat from the north side of the roadway. During this time air support was requested, but due to the smoke obscured conditions, the water and retardant drops did not reach the sheltered crew. Two CDF Firefighters were injured. The first firefighter was treated for heat exhaustion, and received intravenous fluid replacement. The second firefighter suffered two, ½ inch diameter, second degree burns to the left forearm. Both were released after treatment at Oroville Medical Center.

Figure 6. Graphically enhanced aerial photo of the Concow Fire, August 19, 1515 hours, where the fire shelter deployment occurred on Tim Tam Lane (MS Terraserver 2001).

1. Post lookouts whenever working away from an established deployment area or safety zone.
2. Coordination between crews, leaders, and division supervisors has to be established prior to firing operations.
3. Crewmembers not actively putting down fire in a firing operation need to have a fire-fighting tool in their possession.

4. Be aware of dynamic fire behavior in the area of operation, and if the main fire is not seen, contact someone who can see the fire, or post a lookout.
5. Be aware of the surrounding topography and the effect of topography on fire behavior.
6. Identify the risk/benefit of firing out the down slope side of a mid slope roadway, while moving in an uphill direction.

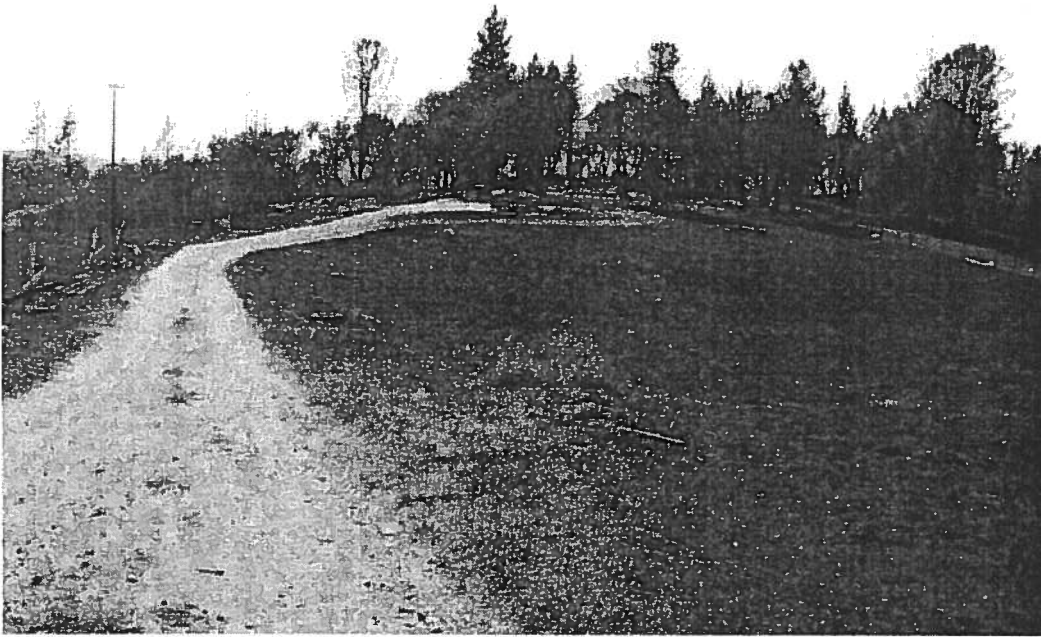
The structure was a single story wood frame, wood sided dwelling with an aluminum roof. A detached garage was connected to the house by a roof, creating a breezeway of about 5 feet. The garage was used for storage and provided a heavy fuel load and excellent fuel bed on the fire-side of the structure. The structure sat on top of a knoll, with gentle slopes on the fire-side with pasture and star thistle. The fire was driven down a hillside of heavy fuel (grey pine, manzanita, probably over 90 tons per acre) until it crossed Stagecoach Lane. At this point the fire was driven by the now heated winds across the field of star thistle and into the structure.

Figure 8. Picture of the driveway leading to the structure protected by Engine 71 where the attempted rescue occurred (John Hawkins 2000).

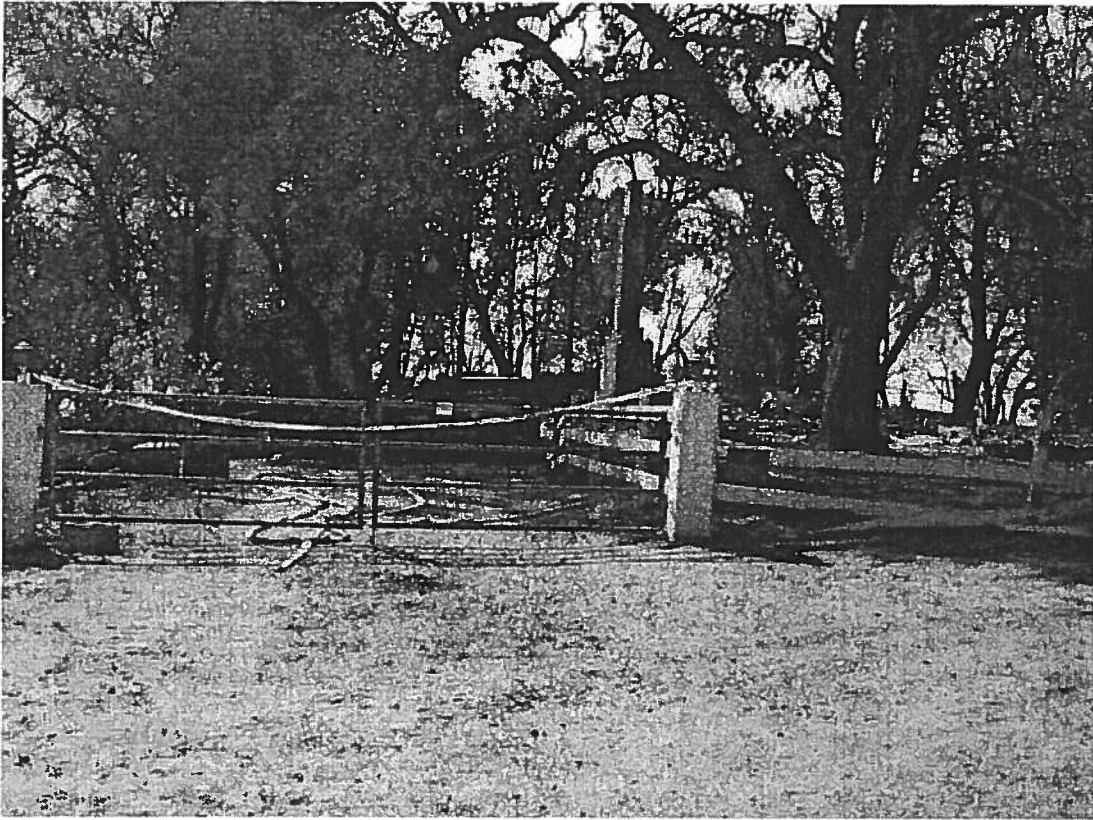
Figure 9. Picture of the structure protected by Engine 71 where the attempted rescue effort occurred. Note the abandoned hose lines near the gate (John Hawkins 2000).

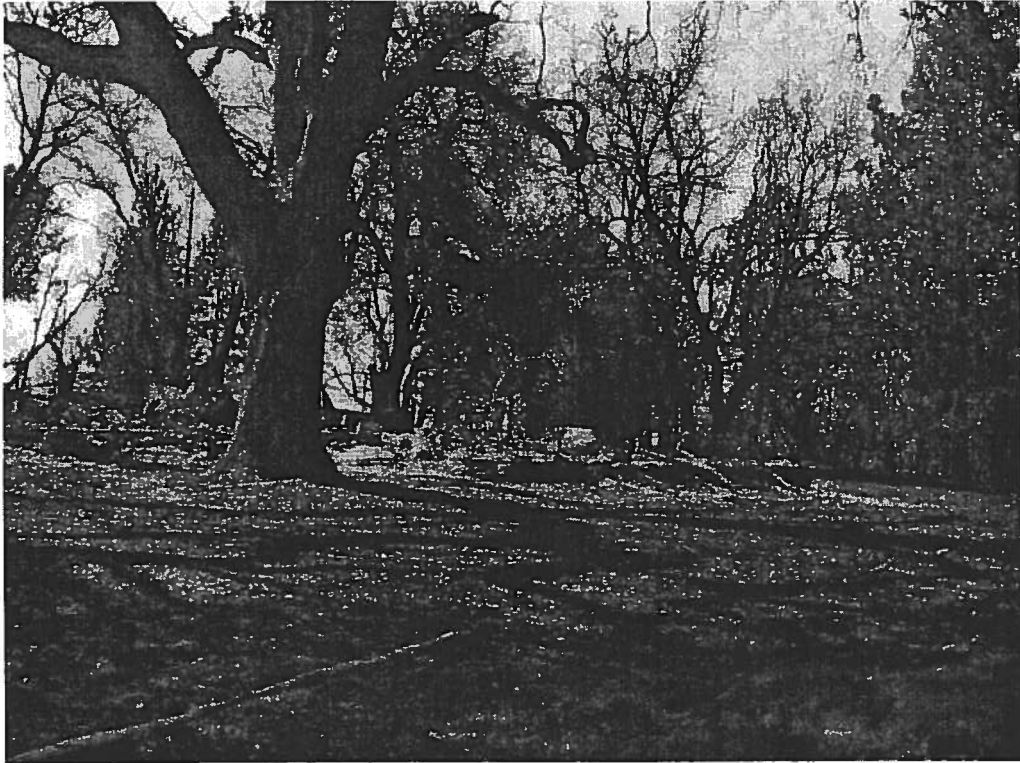
Figure 10. Picture of the structure protected by Engine 71 where the attempted rescue occurred. Note the discarded hose in the foreground. The Captain escaped from the right side of the structure (John Hawkins 2000).
