Rapid Lesson Sharing

Event Type: UTV Fire
Date: June 5, 2025
Location: Barksdale Air Force Base
Louisiana

Barksdale Air Force Base Pile Burning UTV Fire

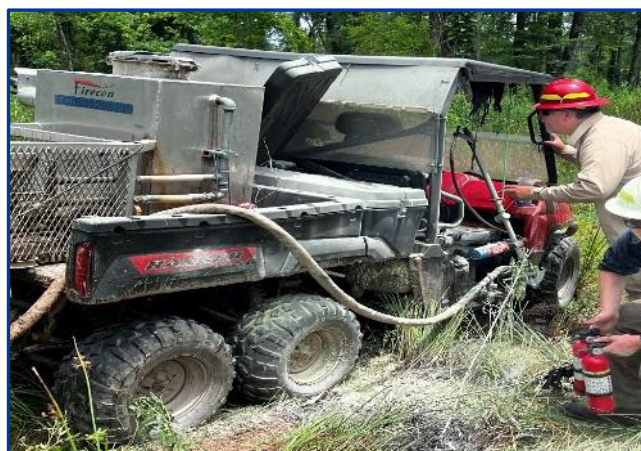
Photo taken by the RXB2 as he first approached the Terra Torch UTV fire.

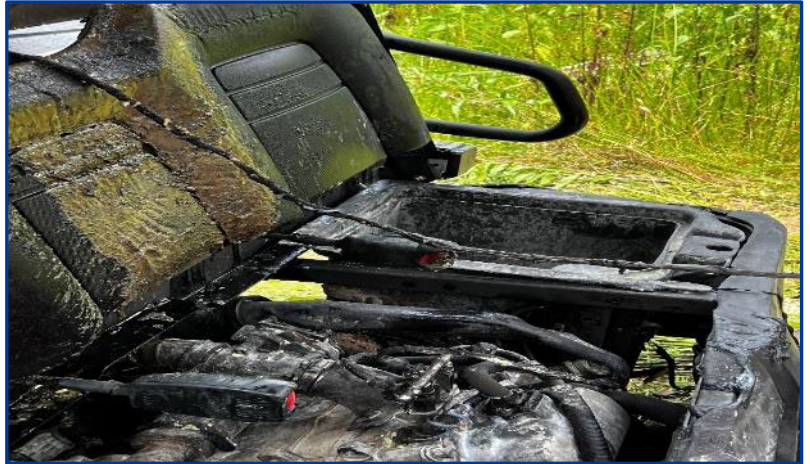
Fire damage underneath the UTV’s seat.

Through peer reviews and statements from the Terra Torch UTV's driver and passenger, it was determined that the fire originated from underneath the UTV's seat and flared outwards toward the open cabs, to the left of the driver and to the right of the passenger.

The fire did not appear to have originated from the Terra Torch lines or nozzles. Upon further examination from all parties, we noticed all the damage was done underneath the seat. Some wires burned completely as well as one open nozzle with charred rubber and a metal hose clamp.

We believe the fuel line had a leak in it and it leaked onto the exhaust—causing the fire. All fire extinguishers available were used that were on or nearby the UTVs, along with 50 gallons of UTV #3's water. The Terra Torch had one-half tank left of the fuel mix.

- ❖ Check all UTV fuel lines for dry rot or normal wear and tear.
- ❖ Double check all fire extinguishers prior to using the machine.
- ❖ Keep skid plates and engine compartments clean from burnable debris.

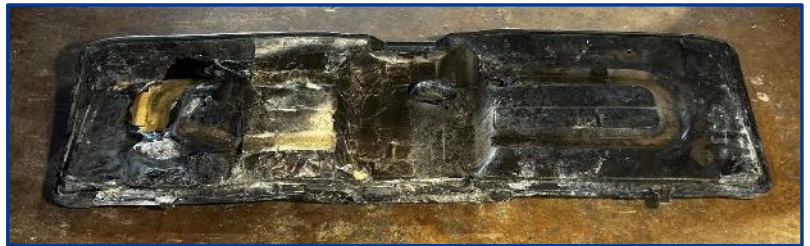
The UTV’s seat cover. The left side is the passenger seat; the right side is the driver’s seat.

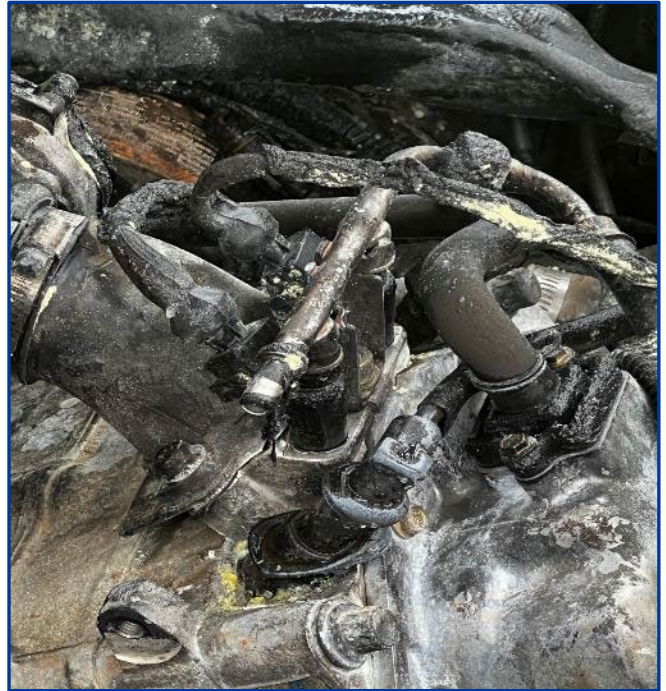
One June 6 the UTV was transported to the local Polaris dealership. Upon their inspection they indicated the main fire started on or near the fuel injectors surrounding the engine.

The UTV's engine area underneath the seat cover.
