Lessons Learned Review

Conner Fire Burn Injury

Conner Fire

BLM Nevada Carson City District

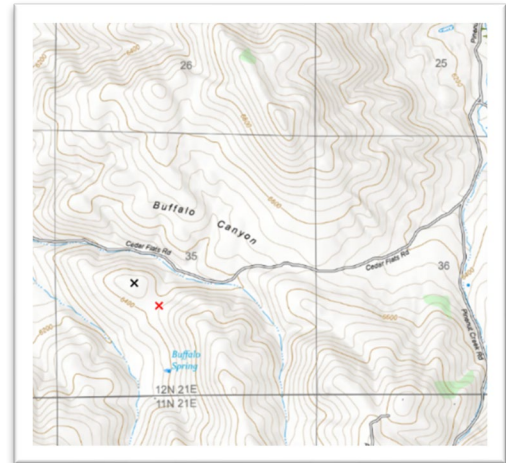
Approximate location of Conner Fire incident (x) and approximate location of a previous firefighter entrapment (x) according to the [Preacher Fire Facilitated Learning Analysis](#).

- The burned area has a history of frequent fires, and the accident site even had a prior firefighter entrapment. Under such circumstances, it is important that incoming resources are properly briefed on current conditions, any exceptional or unusual concerns, and local fire history or management concerns.

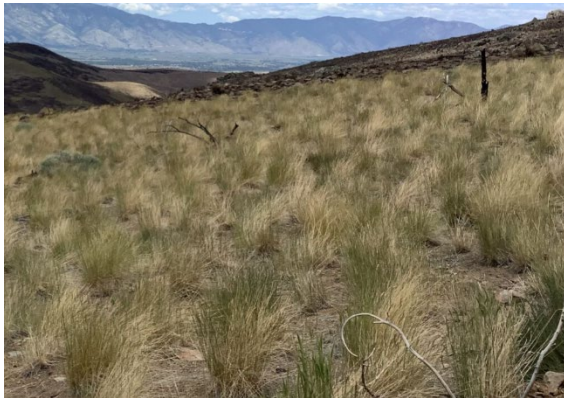
Fuels at the site of the accident included continuous cover of crested wheatgrass, roughly two feet high and not completely cured. A few scattered piles of skeletal debris from previously burned shrubs, about 3-4 feet wide were near the road.

Unburned crested wheatgrass adjacent to the accident site. Grass was continuous and not fully cured.

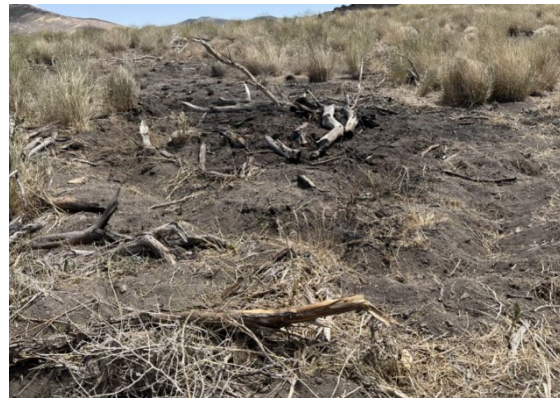
Skeletal debris from previously burned shrubs, near the accident site. The BLM engine had stopped at the saddle to extinguish a spot fire in similar fuels..

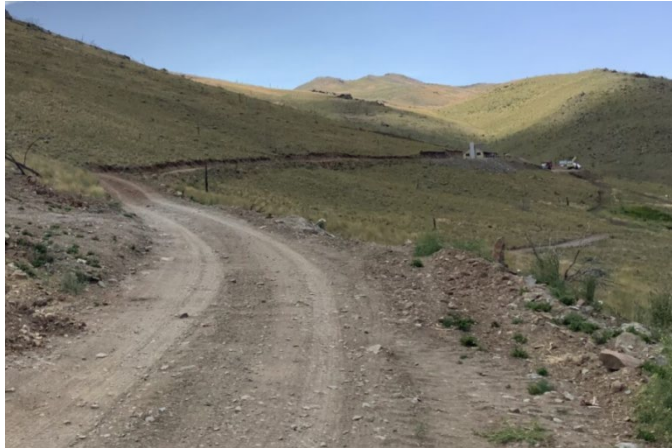
View of the structure at Buffalo Springs from the saddle.

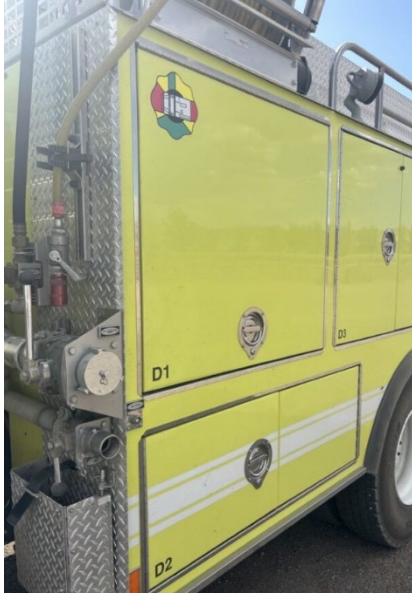
The captain was driving the engine while the assistant captain dismounted to deploy the 1.5 inch knockdown hose on the driver's side of the engine.

The assistant captain pulled out the 25-foot hose and opened the valve to charge it. While the hose was filling, he began putting on his fire pack. Before he

Engine hose deployed before accident occurred

- Personal protective equipment (PPE) is designed to protect the user and minimize the risk of severe injuries. While on the fireline, wearing full PPE will help protect you if you find yourself in an unexpected situation.
