Rapid Lesson Sharing

Event Type: Airboat capsized and sank; no injuries

Date: June 17th, 2025

Location: Chugach National Forest,
Cordova Ranger District

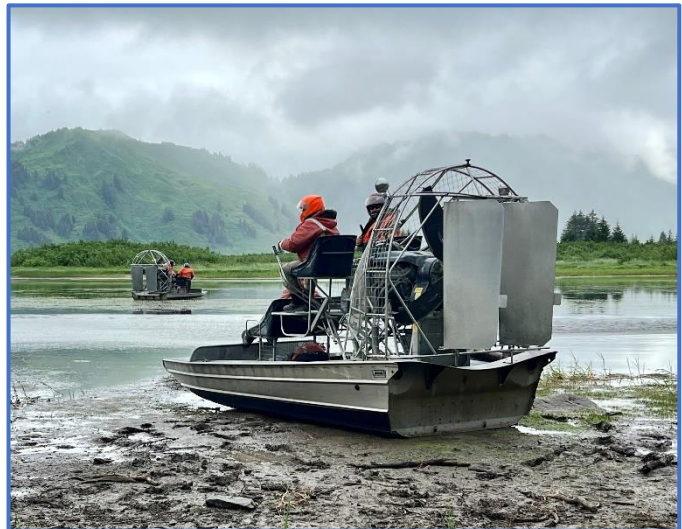
Cordova Ranger District staff operating an airboat like the one that capsized in Controller Bay.

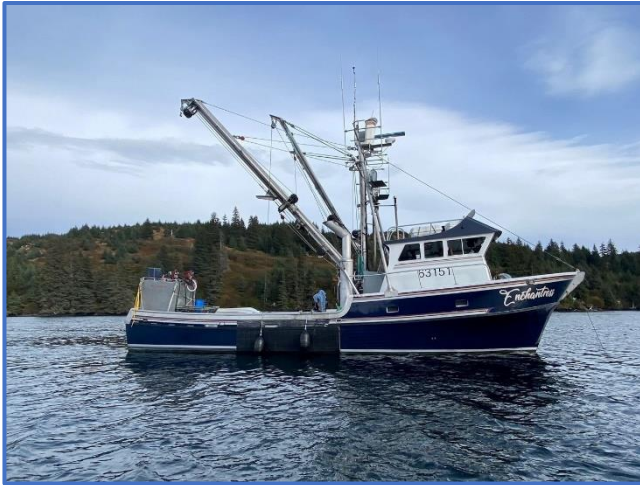
The F/V Enchantress, a 56' seine boat acted as base camp and support vessel for the FS fish crew.
