Event Type: Chainsaw Cut

Date: July 19, 2025

Location: South Rim Fire, Colorado

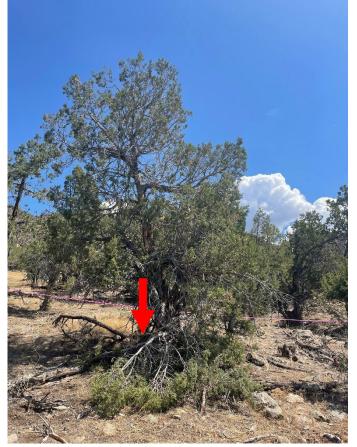
A crew was removing trees adjacent to a completed dozer line that was intended to be used for a burnout within the coming days. While limbing a 10-inch diameter juniper, a sawyer pinched the bottom of the chainsaw bar in a 3-inch limb when the cut was approximately 90 percent completed. The limb was visually covered by dead limbs of the same juniper.

The sawyer, who was not directly working with a swamper, reached forward to move the limb to free the bar from the tree while maintaining his right hand on the trigger handle. As he reached forward, he inadvertently activated the throttle. The sawyer's left hand contacted the top of the chain while it was running at cutting speed, causing severe injury to the sawyer's hand.

Figure 1: Juniper tree that was being limbed. Sawyer was standing to the left of the tree, indicated by the arrow.

The sawyer noted that it would have been better to work with a swamper and lock the chain break before clearing the debris from the bar.

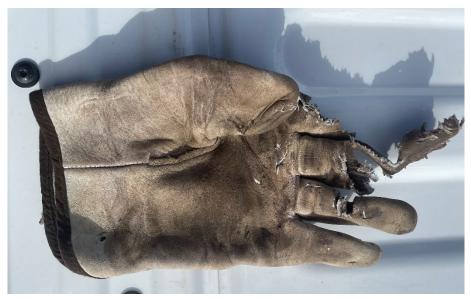
Figure 2: Sawyer's left glove showing damage from chainsaw.
