Trout Fire Dozer Entrapment

Facilitated Learning Analysis

Gila National Forest

June 17, 2025

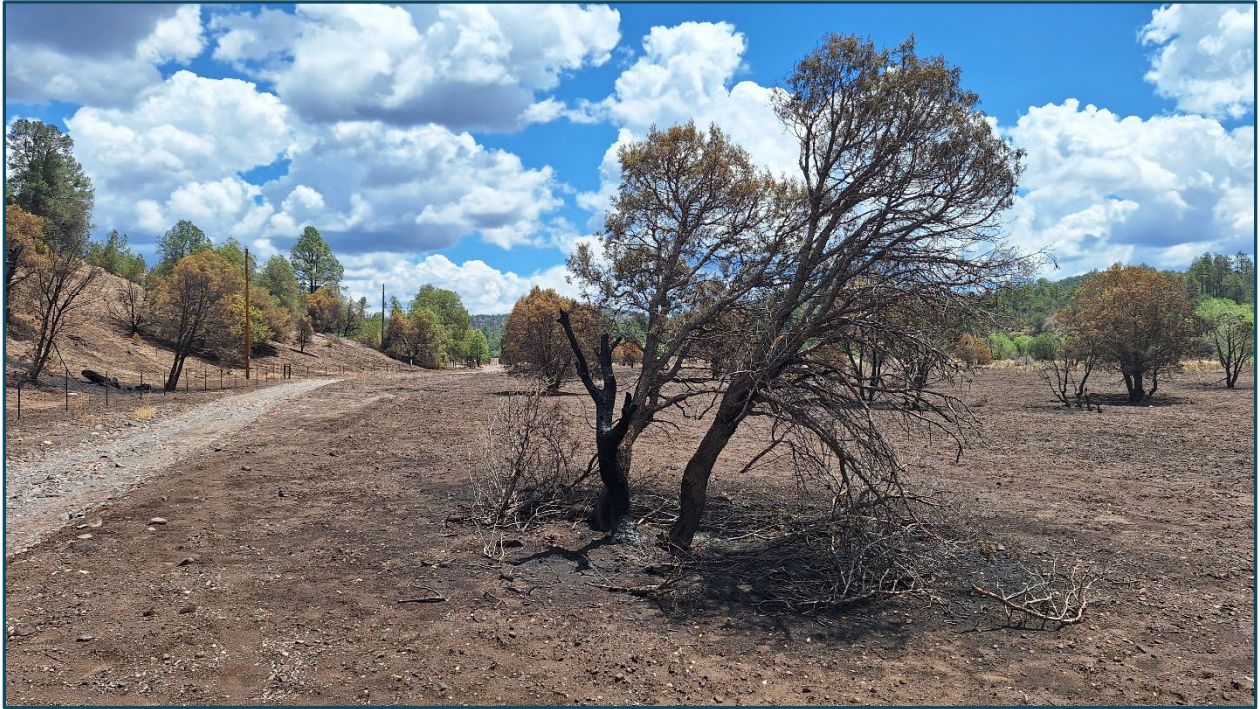
A half-torched juniper at the dozer entrapment site on the Trout Fire.

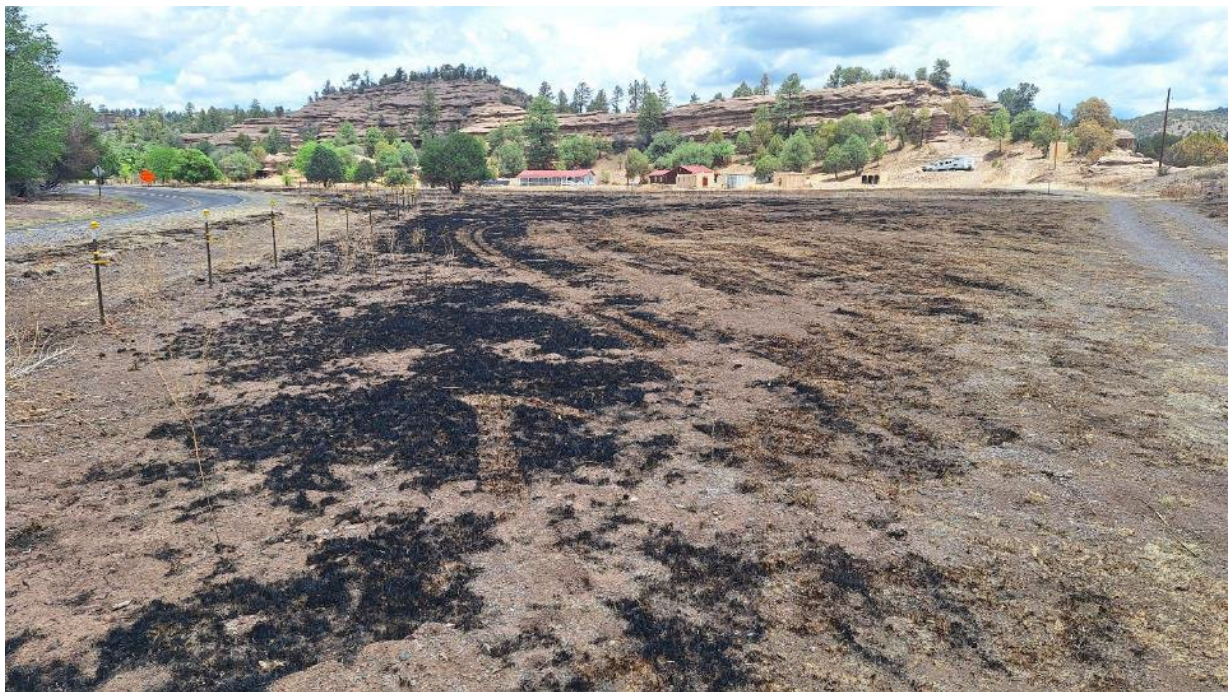
Figure 3 – Where the dozer transport and chase truck were initially parked. The sandstone rock outcropping is visible in the background. The entrapment site is in the top right corner, behind the rocks.

After parking the dozer transport and chase pickup truck (Figure 3), Tim jumped into the dozer to back it off the trailer. *“It should have been a clue [about what was to come],”* he would explain later, *“that I didn’t even get the dozer off the trailer before spots were starting and burning towards us.”* Tim immediately put the blade down and started to attack the spot, successfully cutting it off. In hindsight, he says, *“I probably shouldn’t have even unloaded... but you don’t want to be the guy just standing there.”*

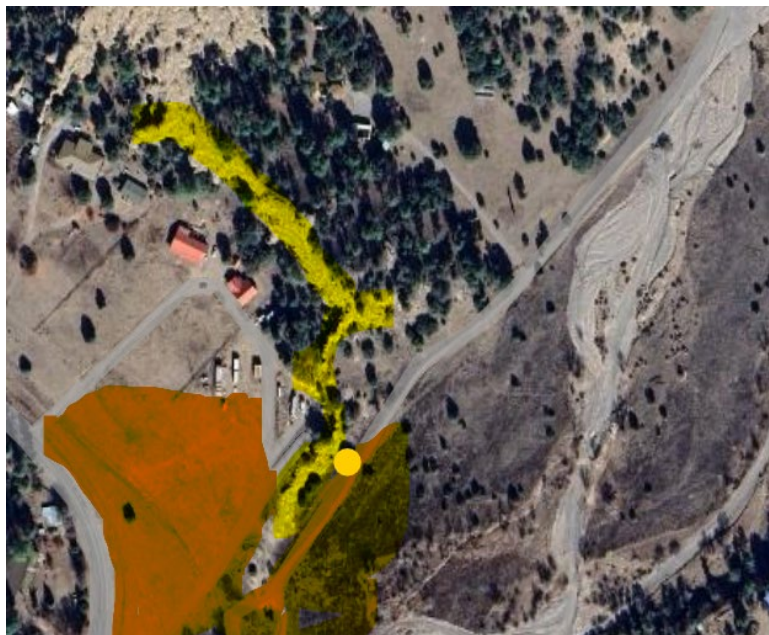
Figure 4 – Google Earth image of the entrapment location. The yellow highlight is the sandstone rock outcropping; orange highlight is the approximate fire location. The yellow dot is the approximate entrapment site.

Visually tracking the fire's advance, Tim judged it was about 200 yards away in the tall grass and scattered junipers. Looking back only moments later, it was 100 yards¹ away. Then it was on him (Figure 4).

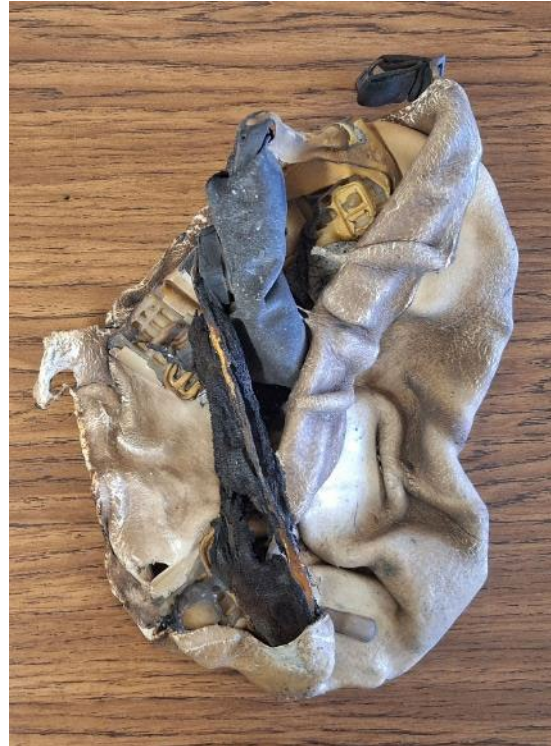
Tim was hit by a blast of intense heat from at least one torching juniper tree and jumped off the dozer, his helmet tumbling off as he hit the ground (Figure 5). His hands and his face were burned. The pain was intense.

Figure 5 – Tim's melted helmet found at the entrapment site.

The helmet found at the scene was extremely deformed and partially burned. Softening of helmet polycarbonate begins when it is heated through to 325°F. Deformation and melting can occur in polycarbonate material when it is heated through its entire thickness to 550°F. The presence of charring on the edges of the deformed helmet indicate it was briefly exposed to temperatures that exceeded 1,000°F. The helmet was found next to a burned juniper tree. That may account for the high heat exposure.

- ❖ **Use all the PPE available to you.** The flame-resistant clothing Tim was wearing almost certainly prevented further injury: *"I'm a firm believer in Nomex,"* he assures. Tim pointed to additional pieces of PPE that would have potentially lessened his injuries: flame-resistant gloves (flight gloves) that provide both protection and manual dexterity, and a face and neck shroud. In these situations, you likely won't have time to put on PPE that isn't already on.

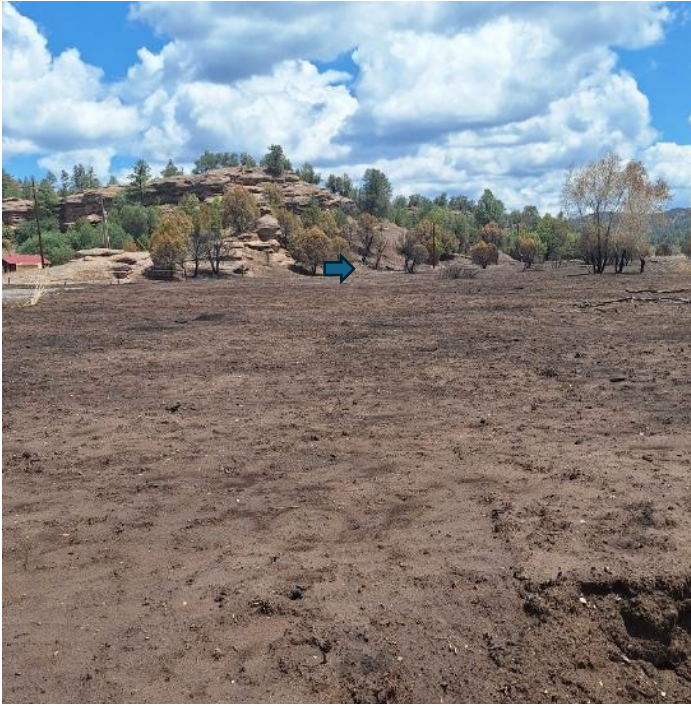
In his escape from the advancing fire, Tim had inadvertently left his machine in reverse. It walked itself about 600 feet backwards (Figure 6), across the dry wash of the Mimbres River, through dense riparian shrubs (Figure 7), and up a driveway until it stopped against a tree (Figure 8). Its tracks were still turning, digging into the sandy soil. A firefighter in the area found the dozer shortly after the entrapment and shut it off. There it sat as a curiosity, an undamaged dozer parked against a tree. How could this undamaged dozer in the green be associated with the reported entrapment?

Figure 6 – Part of the path Tim's dozer took after the entrapment. Arrow points to approximate entrapment location.

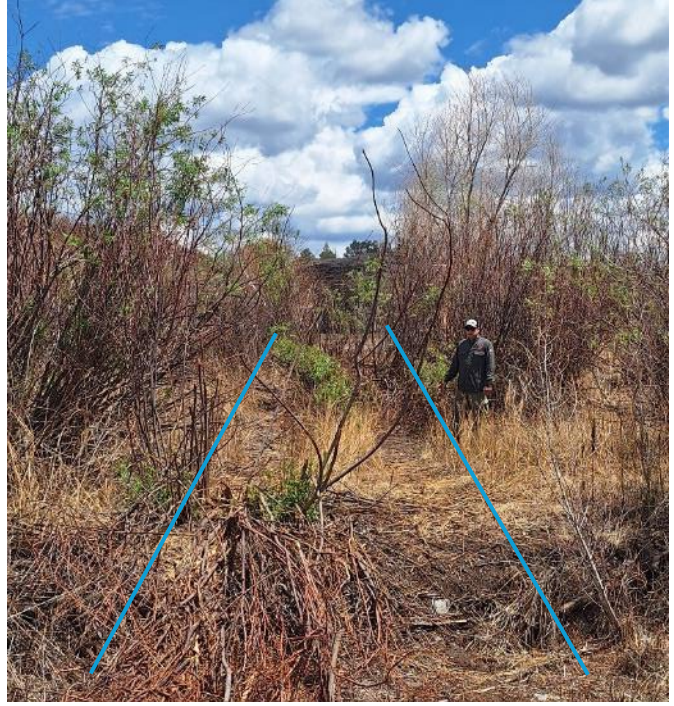
Figure 7 – The dense riparian brush pushed down by the driverless dozer. (FLA Team member for scale.) The blue lines indicate the dozer's path.

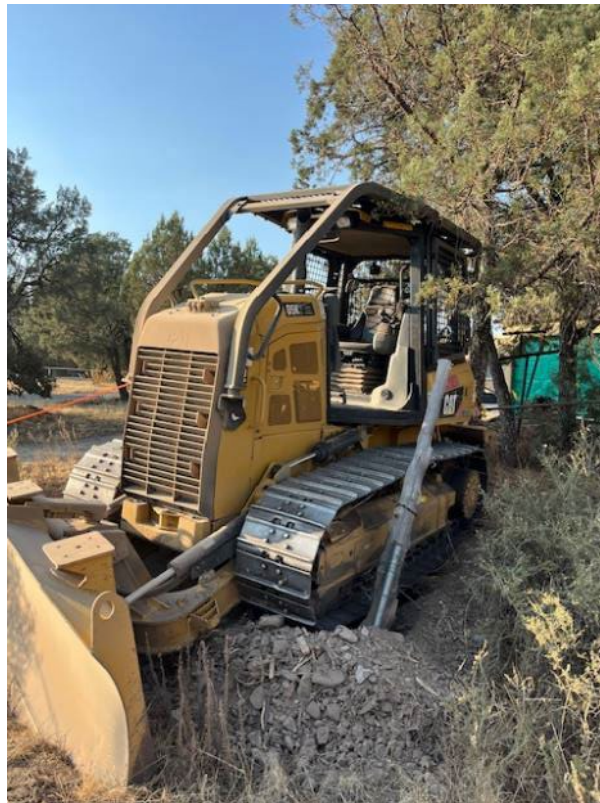
Figure 8 – Final location of Tim's dozer.
