# GREEN SHEET

## Canyon Incident

### Vehicle Rollover with Injuries

**CA-VNC-068268**

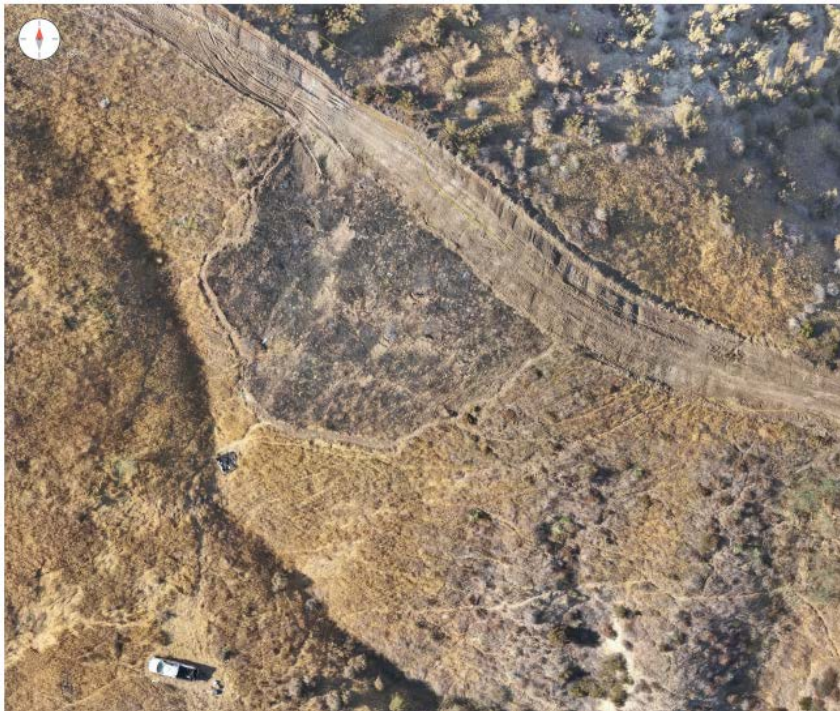
While attempting to position the vehicle, P1 left the dozer line and rolled approximately five times down into a canyon. The vehicle ultimately came to rest on its four wheels on a mid-slope knob. D1 was ejected from P1 as it rolled down the canyon.

*Figure 1: Aerial view of the accident site*

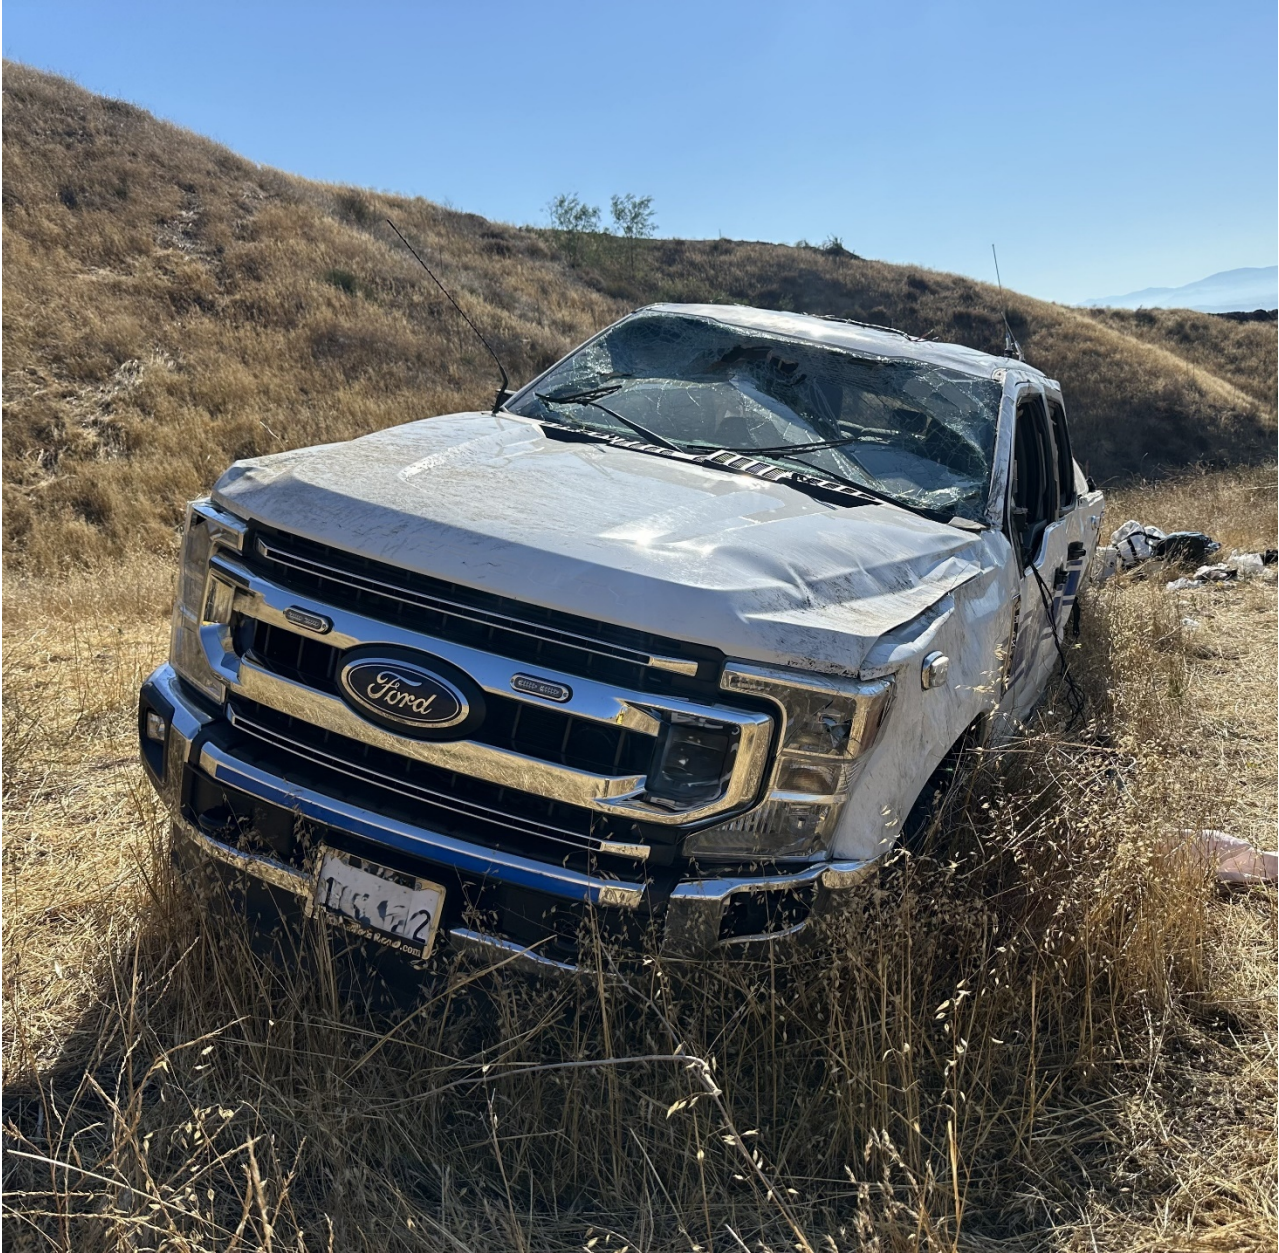
- D1 suffered major injuries.
- P1 sustained major damage.

*Figure 2: Pickup (P1)*

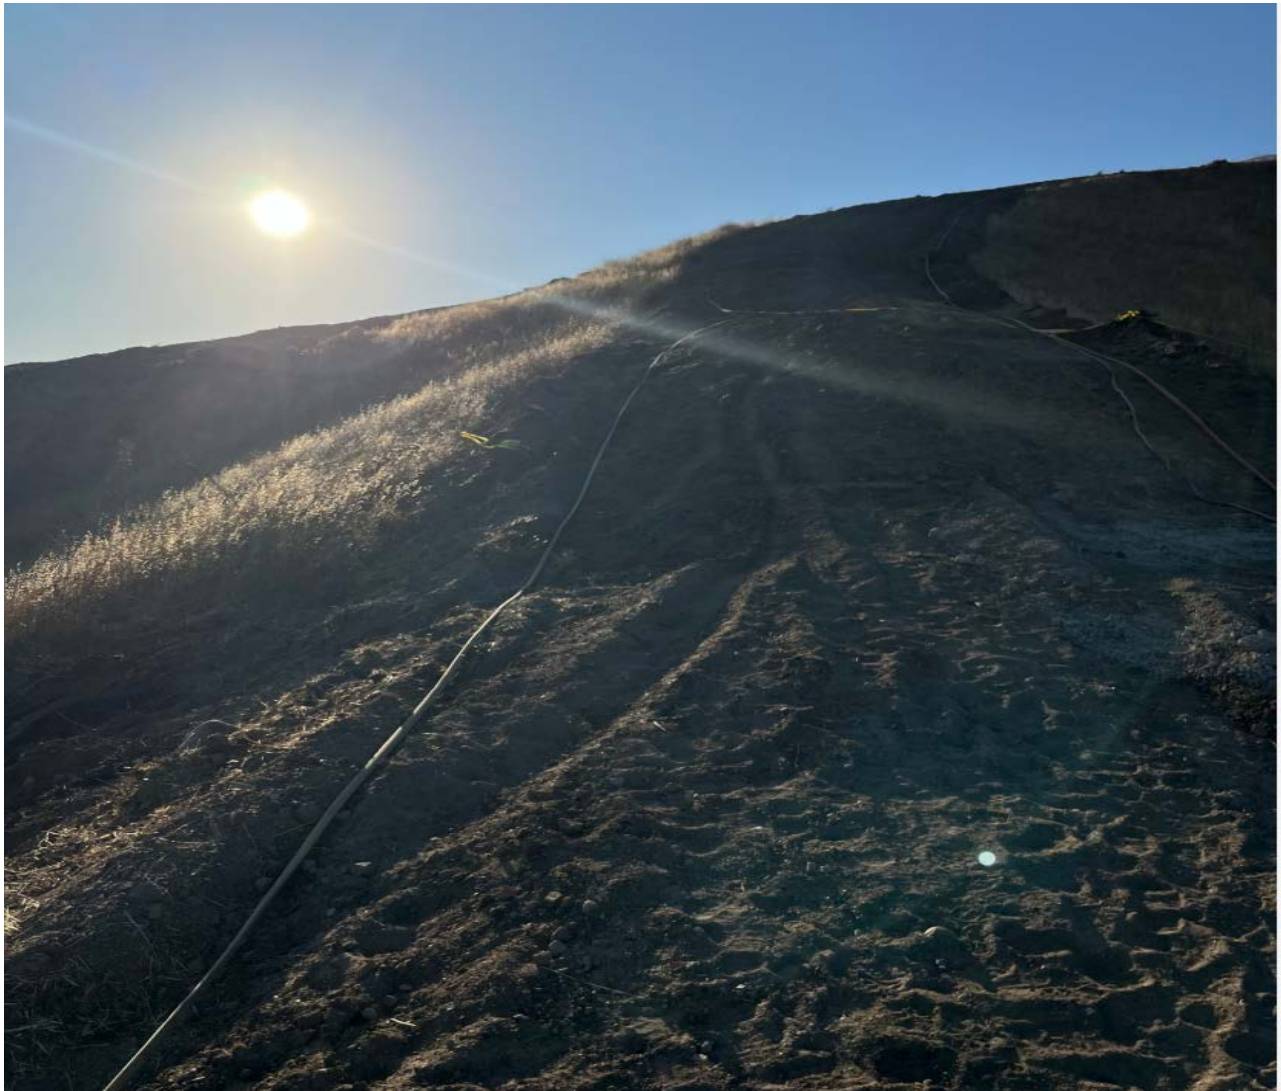
**Surface Conditions:** Dozers extended off of a two-track road, up a prominent ridge previously used as a containment line. The slope of the dozer line at the accident site was recorded at 22 percent. A majority of the surface was dry; however, moisture was present in areas from previous firefighting activities. The area around the tire tracks was soft and had been disturbed due to earlier dozer operations.

*Figure 3: Driver's point of view at 1830 hours*

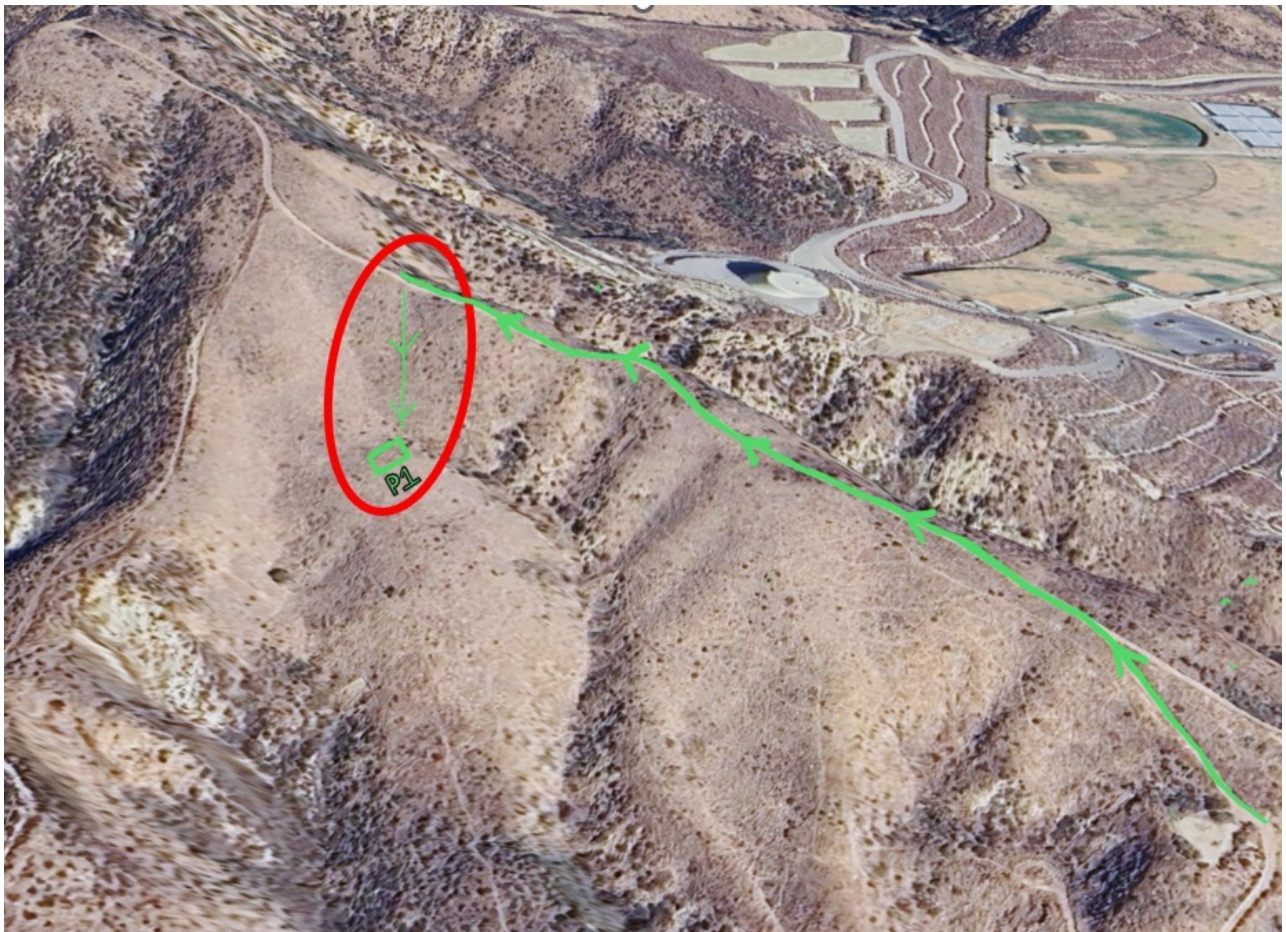
*Figure 5: Accident site map overview*
