# Rapid Lesson Sharing

**Event Type:** Pyro-Vortex Incident

**Date:** July 12, 2025

**Location:** Deer Creek Fire  
Utah

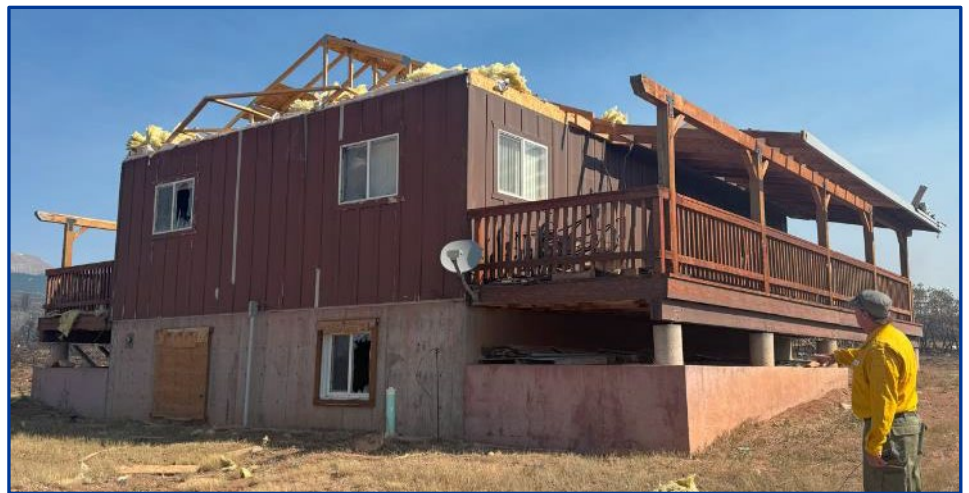
Tornado damage to a structure.

As the fire moved north to south through Hang Dog subdivision, it continued to intensify and pick up speed, engulfing multiple structures with a combination of fire and intense winds. One structure that had a very well-established defensible space that was not directly impacted by the fire had a portion of the roof ripped off and the windows blown out by the tornado. A heavy locked property gate was pulled from the ground and tossed down the road.

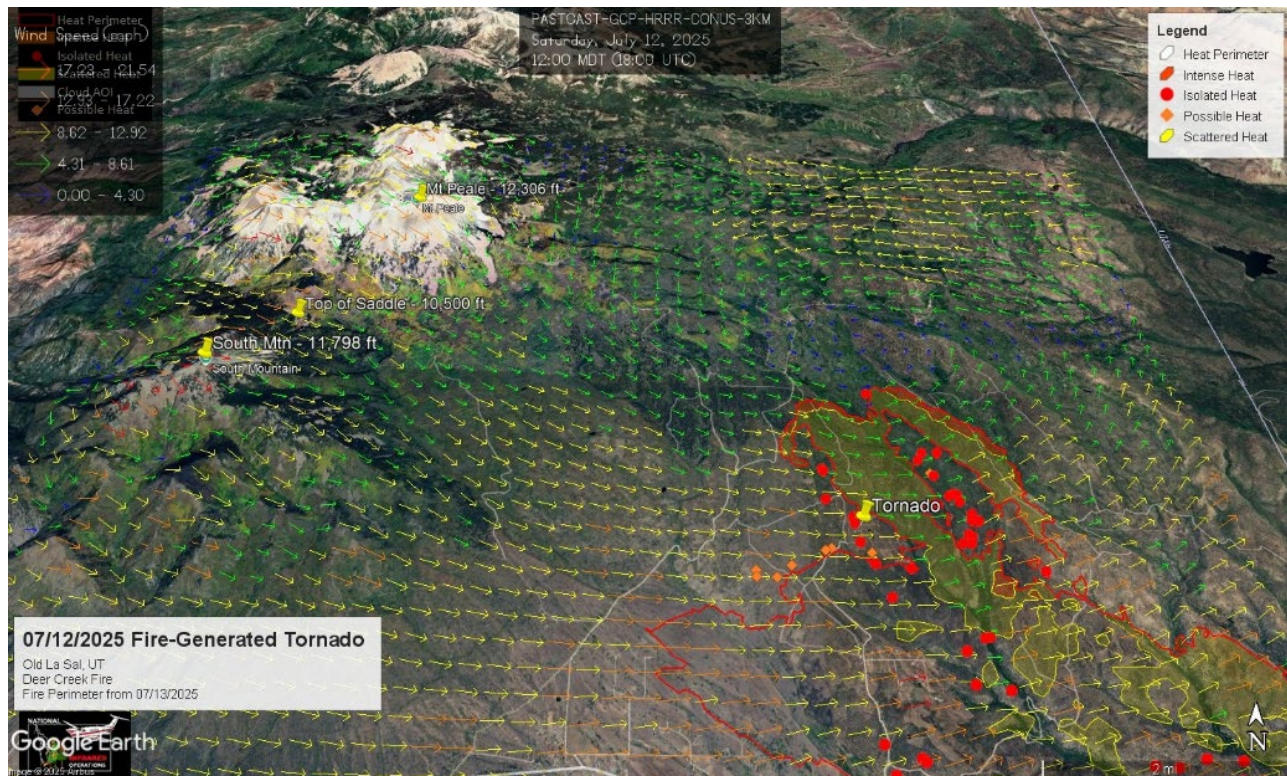
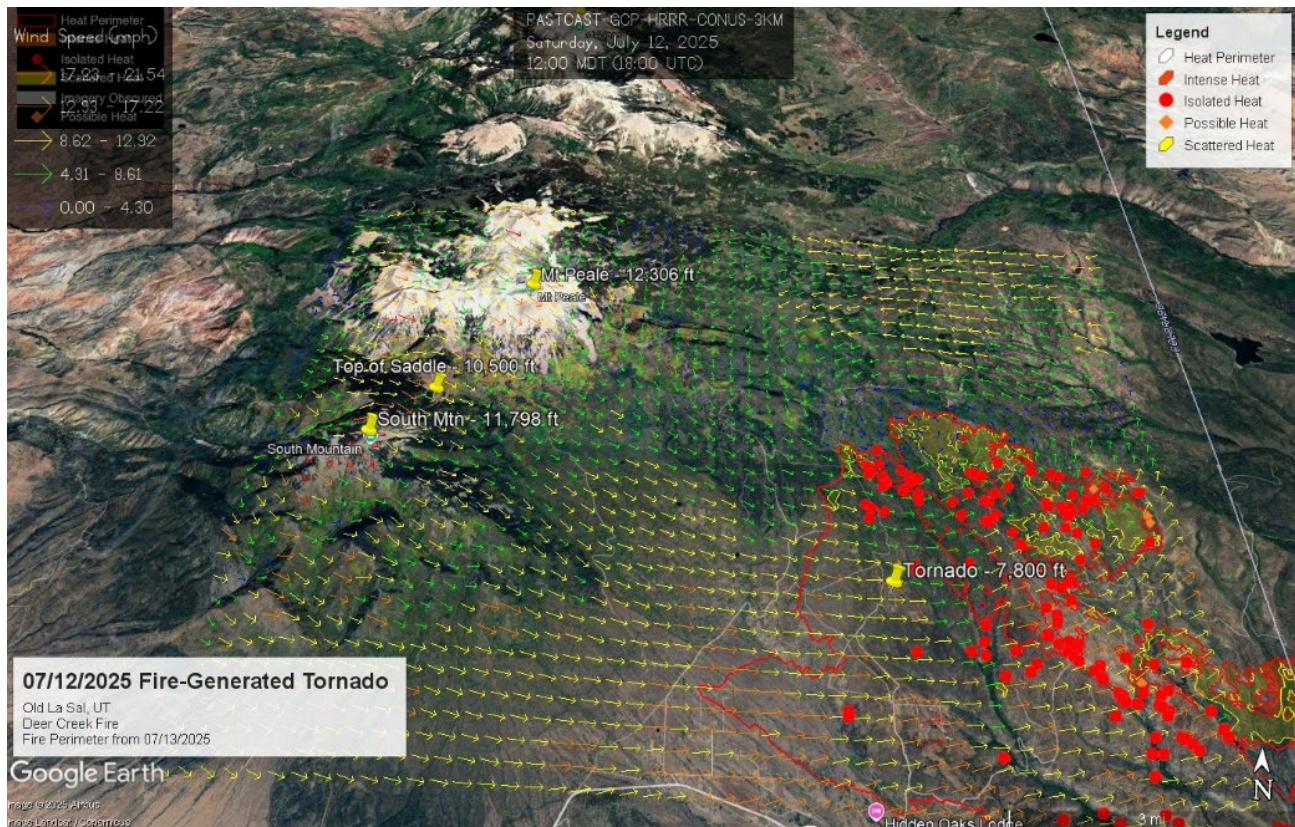
- On July 12, 2025, general northwest winds were in place with some wind acceleration through the saddle between South Mountain and Mt. Peale. Sustained winds were generally 4-11 mph with gusts near 20 mph at 1200.

Modeled representation of the terrain-driven winds using the HRRR model at 1200. Acknowledgement to Natalie Wagenbrenner with the Missoula Fire Sciences Laboratory for the WindNinja run.

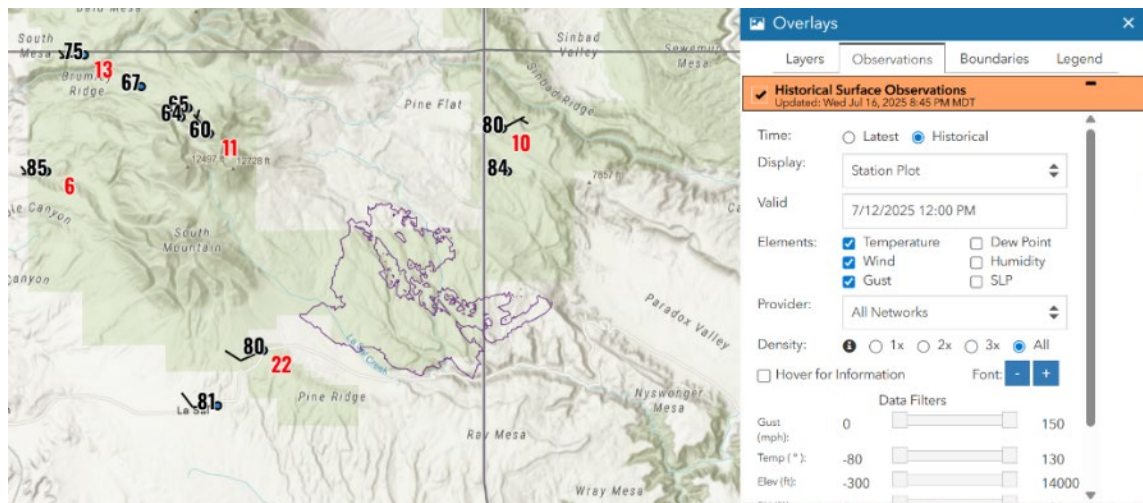
Carpenter Ridge RAWS observation at 1200.

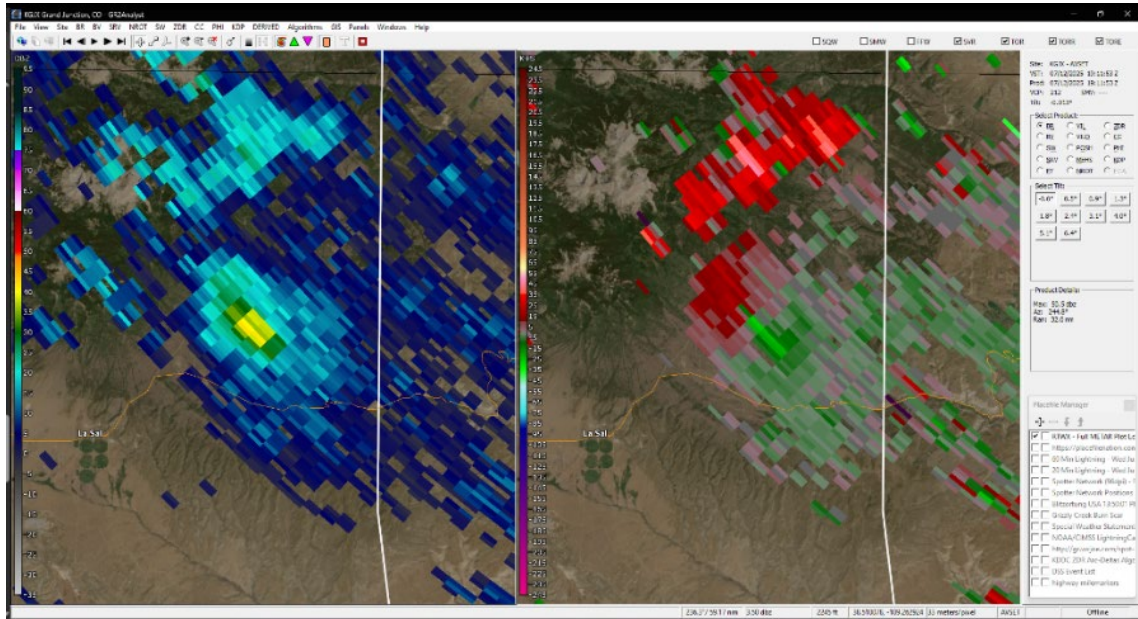
- The tornadic winds occurred 6 miles east-southeast from the apex of the 10,500-foot saddle between South Mountain and Mt. Peale.
- A couple of radar scans from Grand Junction picked up on rotation, but it was extremely difficult for a meteorologist to discern activity as a tornado based on its short life span. Radar showed the smoke plume reaching over 16,700 feet above ground.

Radar and tornado damage assessment at 1311 provided by NWS Grand Junction.
