Rapid Lesson Sharing

Event Type: Gas Polyurethane Line Ignited by Wildfire

Date: July 17, 2025

Location: Colorado

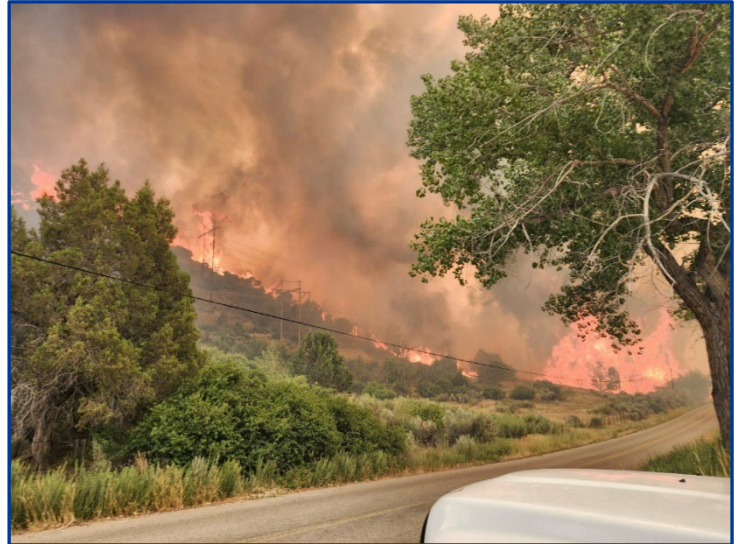
Figure 1 – Fire activity during initial attack.

The photo above (Figure 1) was taken on the fire's east side, or left flank, where most of the growth occurred. The majority of the oil and gas infrastructure is located on the fire's northwest (right) flank. This area received primarily lower-intensity backing and flanking fire.

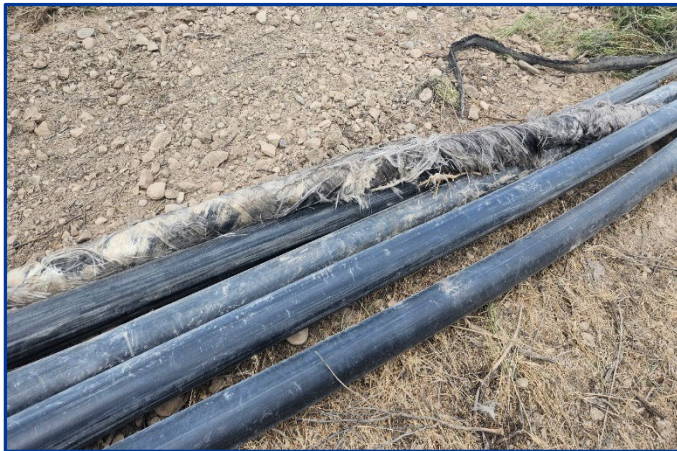
Figure 2 – The FlexSteel pipes that remained intact and the line that breached and burned during the initial attack response to the fire. This burned and ruptured pipe was moved to be compared to the new FlexSteel pipes.

Two above-ground natural gas lines were located near the heel of the fire, one steel and the other a "FlexSteel" pipe (Figure 2 & 3). According to local fire department and oil and gas employees, most gas lines are buried below ground. Figure 2 shows lines that remained intact and the line that breached and burned during the Initial Attack response to the fire.

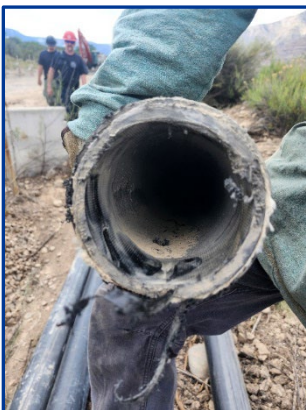
Figure 3 shows the FlexSteel pipe that caused the gas line fire. These are commonly used in petroleum transportation and have a good safety record. However, the maximum

heat threshold they are designed for is 185 F.

Once this pipe was exposed to the high temperatures of the passing wildfire, the outer polyurethane melted away, exposing the steel middle section. This resulted in a natural gas leak and subsequent gas line fire. (See Figure 4 on next page.)

Figure 3 – The FlexSteel pipe that caused the gas line fire.

On public land there are regulations requiring oil and gas lines to be buried. The same rules do not apply on private land.

- ❖ If they are identified above ground in the fire area, notify IC; request assistance from READs (Resource Advisor) and oil and gas personnel; close off area; call local emergency gas phone number; disengage from the area.

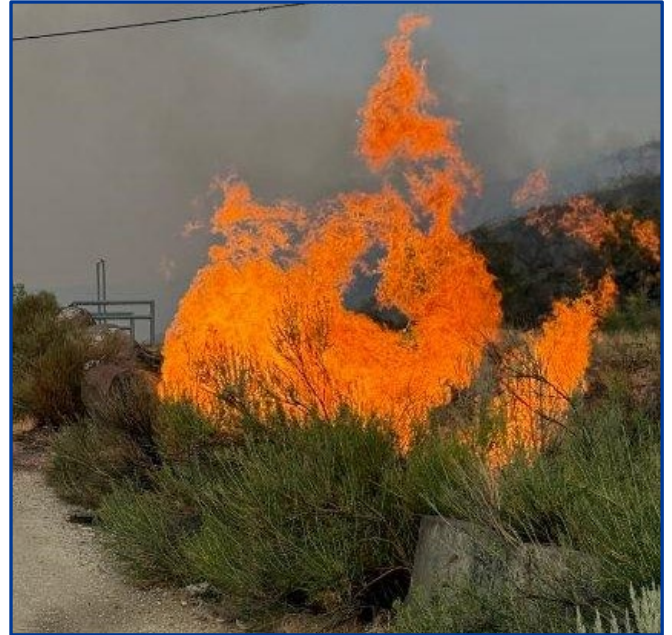
Figure 4 – The natural gas line fire caused by the wildfire.
