Rapid Lesson Sharing

Event Type: Electrical Shock from Wooden Power Pole

Date: August 1, 2025

Location: Oregon

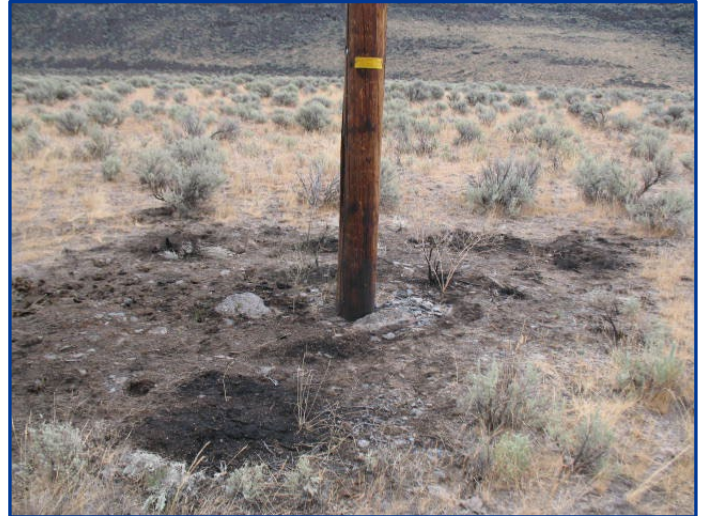
The pole that shocked the Engine Boss.

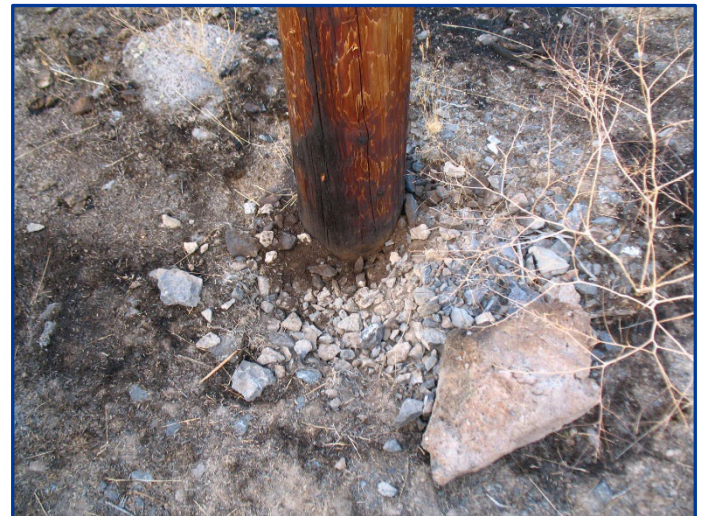
Close-up of the pole that shocked the Engine Boss. Notice the burned creosote and charring on pole. The Engine Boss's footprints can be seen in the lower left of image. This is where he was located when the electrical shock occurred.

1541 – The Wildland Engine checks fires and power poles from the previous day. They find heat and smoke around the power poles—and smoke coming from inside one of the power poles. They proceed to mop-up around the base of one of the poles with their hard-line hose, spraying water. While he was close to the pole, the Engine Boss observed the water boiling around the base of the pole, with some arcing and buzzing.

He went to stand up from a crouch, put his right knee on the ground, braced his right hand against the pole and received a significant shock when his hand made contact with the pole.

1544 – The Wildland Engine reports seeing small sparks emitting from one of the cracks near the grounding cable on the pole. There is smoke and heat at the pole's base and they notice creosote burning. The pole is emitting "a hum" noise. They state they are remaining away from the poles and move upwind due to the odor of burning creosote.

2003 – The Wildland Engine reports that five poles have fire around them and were arcing. After a broader inspection of the entire line, the Utility Company found a short in the substation that transfers power to these lines that was causing the electrical poles to not be grounded. The Utility Company determines that this short caused each of the poles to be energized with approximately 3.5 kilowatts (KW) of electricity. These energized poles were then starting fires in the dry vegetation at the base of the poles. The Utility Company repaired the short in the system.

- ❖ New SOPs created by the local unit: A 20-foot stand-off distance is now given to power poles with wildland fire present. Foam is only directed low to ground to contain wildland fire. Poles will be treated as non-wildland/infrastructure.

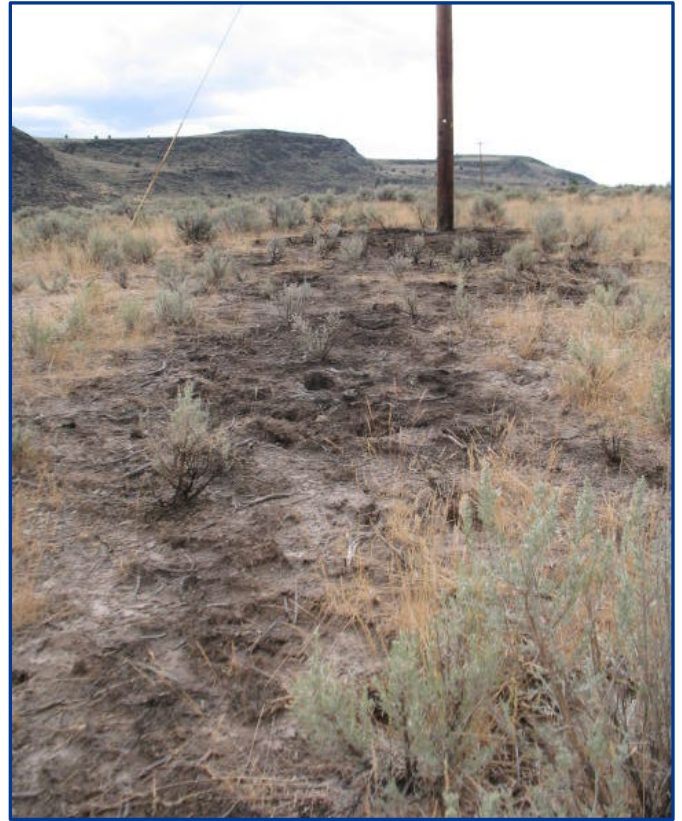
Another power pole with a fire perimeter that started from the electrified pole.
