# **GREEN SHEET**

### **Preliminary Summary Report of Serious CAL FIRE Injuries, Illnesses, Accidents and Near-Miss Incidents**

#### **Traffic Collision with Firefighter Injury**

**Skunk Ranch Road SART**

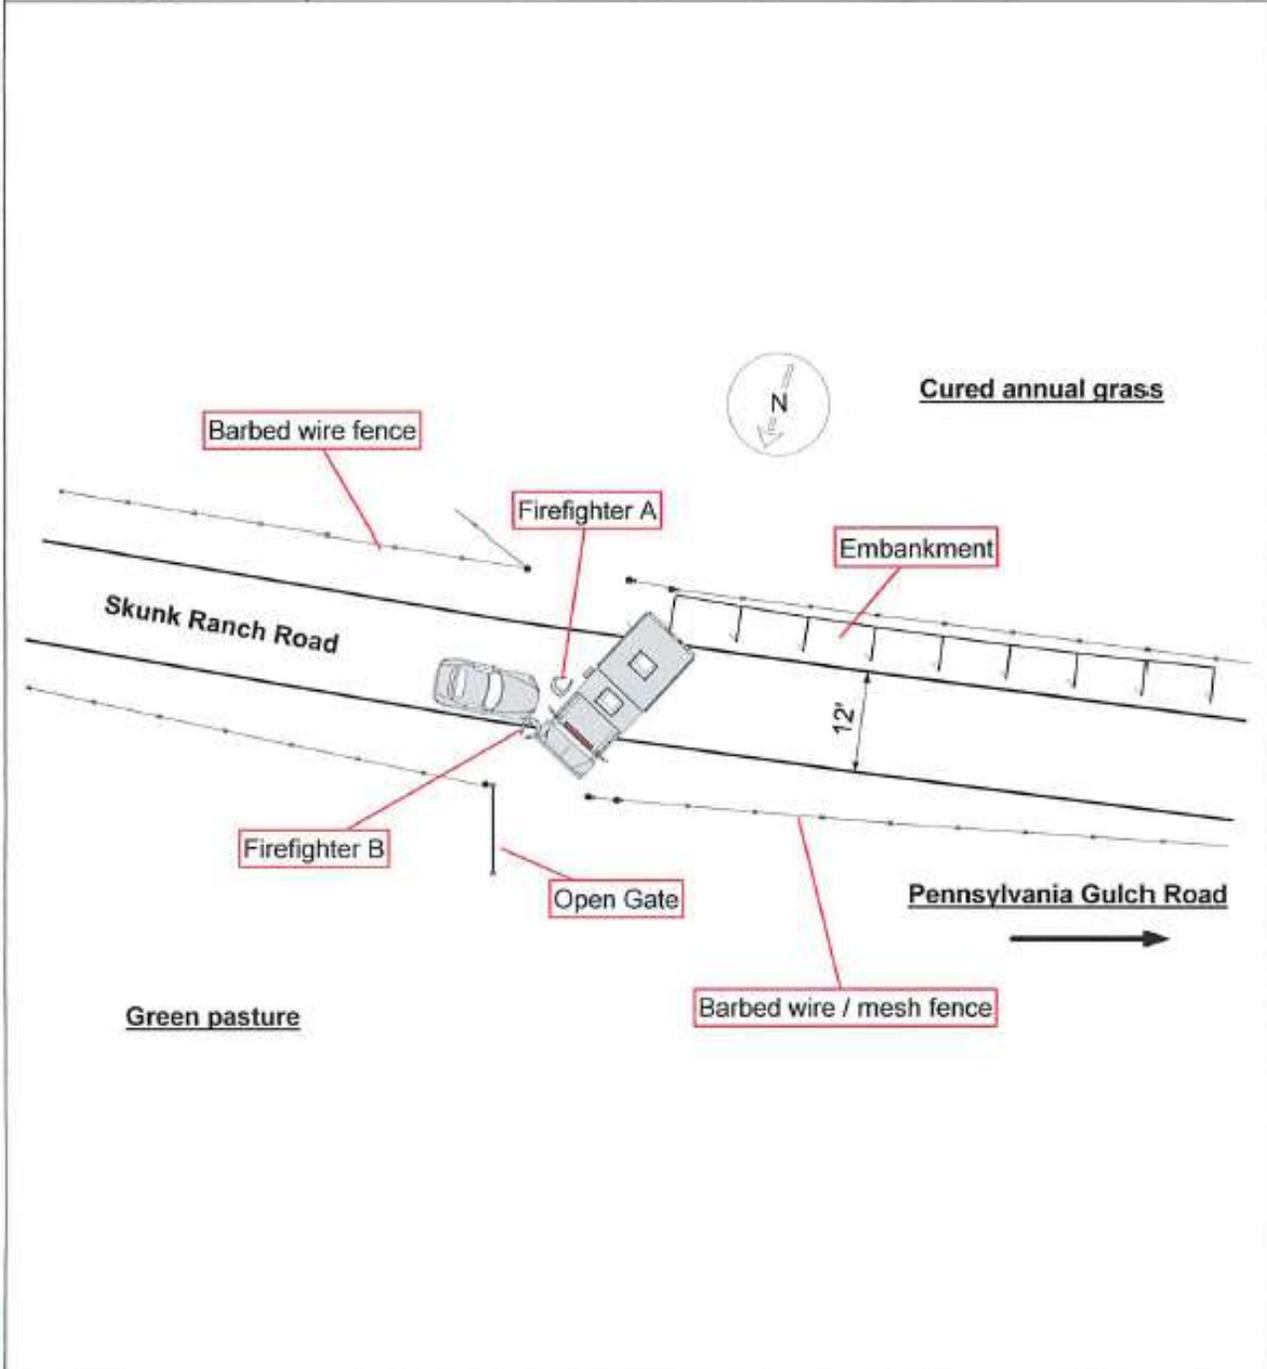
Case Number: 12-CA-CSR-000053 Date: 07/25/12

Description:  
Vehicle accident, .2 miles west of 2983 Skunk Ranch Road
