Rapid Lesson Sharing

Event Type: Fall from Vehicle, Medical Evacuation

Date: July 22, 2025

Location: Pomas Fire
Okanogan-Wenatchee National Forest

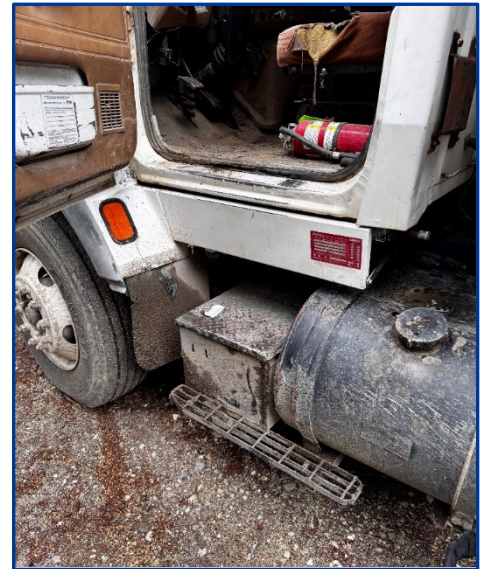
When exiting the water tender, the operator slipped on the diamond-plate step, falling approximately 4 to 4.5 feet. The fall caused an impact to the ribcage on the corner of the diamond plate step.

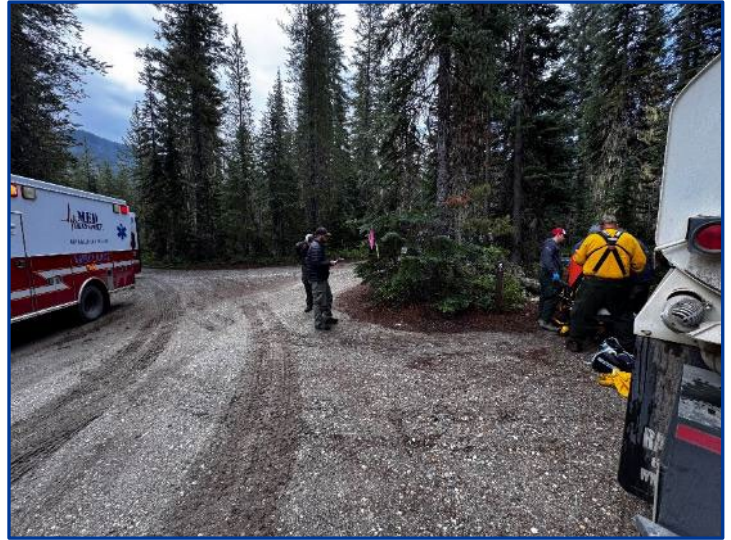
The accident site

On arrival, E-211 nosed into the camping area #5. Upon exiting the vehicle, the operator slipped on a diamond-plate step, falling approximately 4 to 4.5 feet. The fall caused an impact to the ribcage on the corner of a diamond plate step. Recognizing something was wrong, the operator attempted to alert others by partially re-entering the cab and honking the horn, but to no avail. Emergency assistance was then initiated via radio.

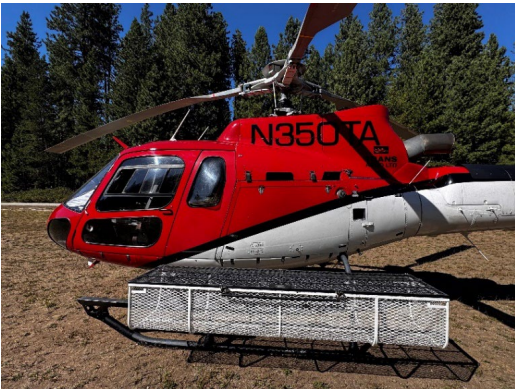
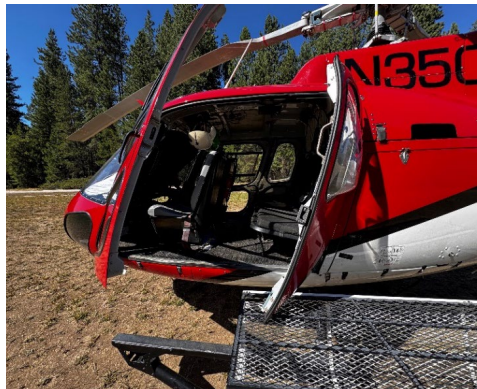
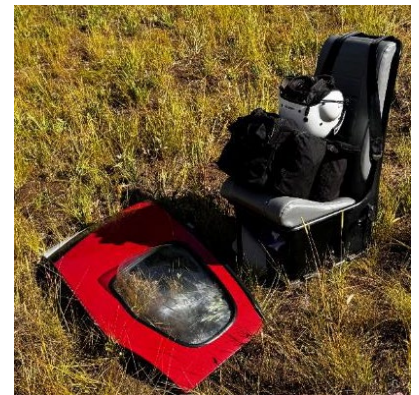
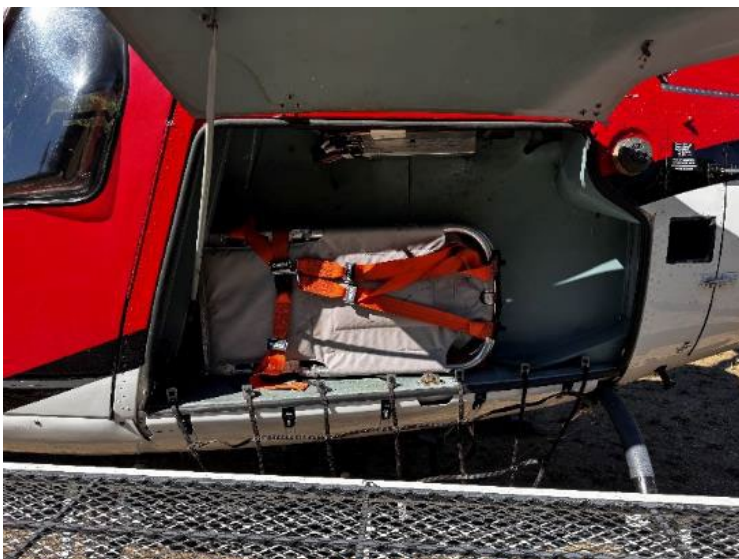
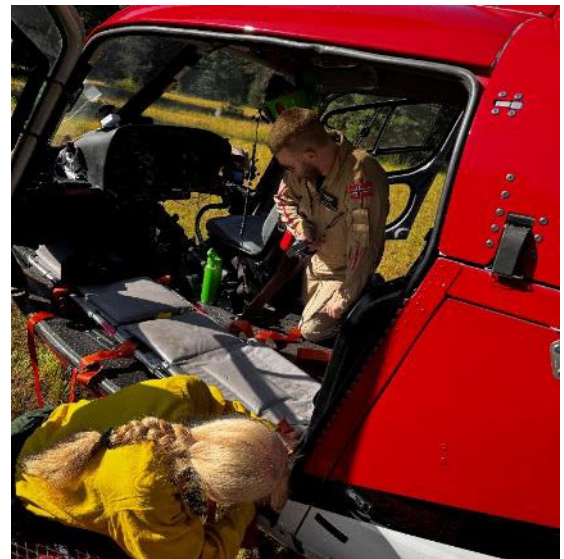
Aircraft Reconfiguration Photos – Adjusting the Type 3 Helicopter to Accommodate the Patient

If an agency aircraft is designated or potentially needs to serve as a medical evacuation platform, it requires prompt reconfiguration prior to patient transfer. Unlike dedicated air ambulances, most agency Type 3 helicopters must be adjusted to accommodate a patient. This involves removing seats near the controls, folding or removing rear seats, and securing a specialized stretcher to the floor with specific retention devices. This process generally takes 5 to 20 minutes, depending on crew training, policies, and available personnel such as a flight mechanic.

Whenever possible, utilizing a Type 2 aircraft is preferable (although each aircraft type has advantages and disadvantages), as it can provide more options for medical transport. A critical gap identified during this incident was the lack of communication regarding the injured individual's height, weight, and preferred transport position (sitting or lying down). Asking these questions early—involving the IWI Incident Commander, medical providers, helibase personnel, and Incident Command Post staff—can streamline configuration, reduce delays, and improve patient safety.

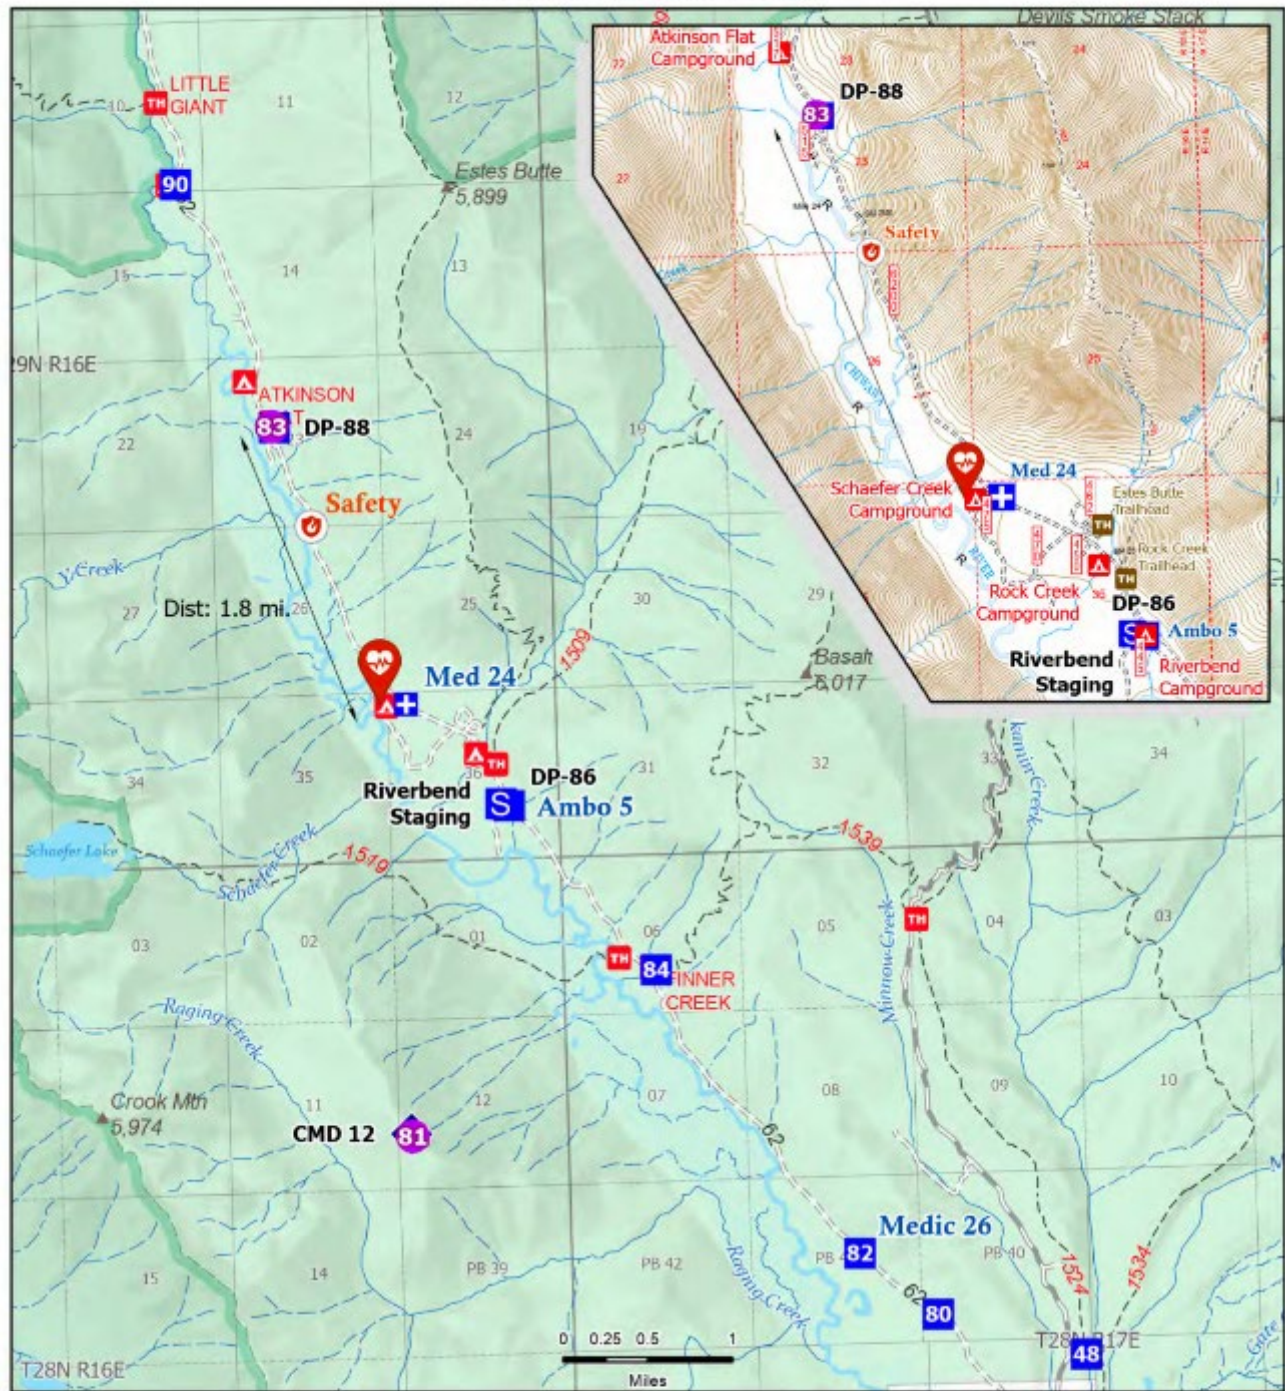
Yellow Medical IWI

One early challenge during this incident was the inability of incident personnel to accurately locate the campground. Despite clear signage to the entrance of the campground on the 6200 Road and an established location, the incident map failed to identify the fill site with a specific name or designated drop point. Efforts to mark locations on the map inadvertently obscured this important landmark, with pump symbols or field site icons, which hindered navigation and coordination.

To address this potential dilemma, always aim to use distinct, clearly labeled landmarks or features when dropping pins or icons on digital maps and make sure they do not obscure existing labels. This clarity ensures quick and accurate location determination, which is vital when declaring an IWI and coordinating rescue efforts in remote areas.
