# **Ninety-eight Fire Facilitated Learning Analysis Airboat Collision July 11, 2025**

## Executive Summary

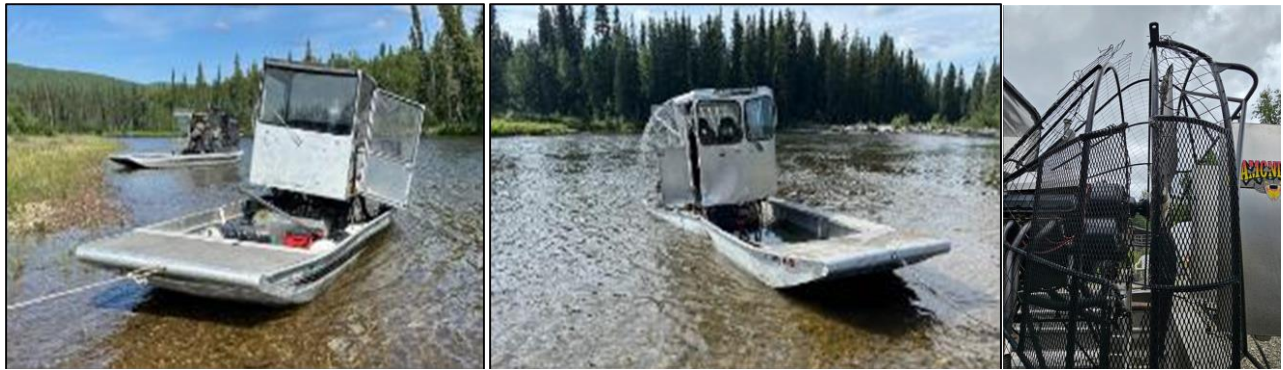
*Images show the damage to both the supply boat (left), transport boat (middle), and damage to the fan (right).*

The crew transport airboat operator and IHC crewmembers saw the supply airboat from several hundred feet away, prior to impact. The crew boat operator made multiple attempts to maneuver out of the way of the oncoming supply airboat. But it seemed as though every time the crew boat adjusted direction, the supply boat mirrored the movement. It would later be discussed that what appeared to be mirrored movements were merely an unfortunate coincidence as the supply boat operator stated he could not see the crew transport due to the sun glare coming off the river—until the very last moment. As soon as he saw the crew boat, the supply boat operator pulled hard to his right, toward the middle channel of the river. At the very last moment, the crew boat pulled hard to the left, also toward the middle channel of the river, as the sandbar was to his immediate right. The result was a very hard, parallel side-to-side impact to the right side of the crew boat and to the left side of the supply boat. As the boats collided, the fan cage of the supply boat was damaged and the fan began to strike the cage.

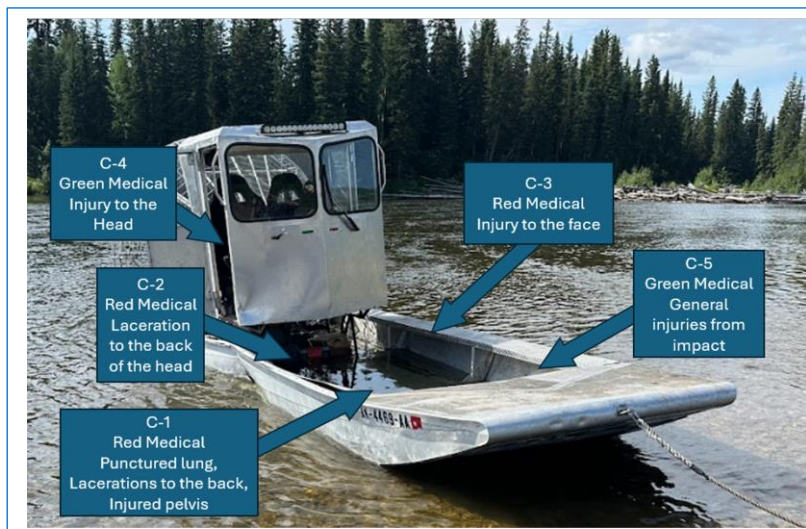
*Image shows where the crew members were sitting at the time of the impact.*

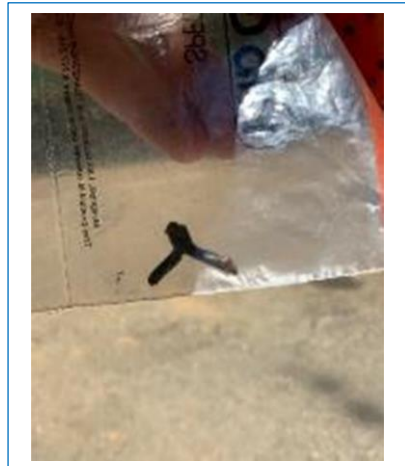
At the hospital, it would later be discovered that this laceration was the result of a quarter-sized piece of “expanded metal” grating, which was likely a projectile from the supply boat’s fan cage when the propeller collided with its protective cage, and both rapidly disassembled into pieces of shrapnel.

*Image shows part of the fan cage that was removed from C-2's head.*
