National Park Service Incident Report:

INCIDENT TYPE: Water Tender Rollover Crash

INCIDENT NUMBER: AZ-GCP-000597

INCIDENT NAME: Dragon Bravo Fire – Type 3 IMT

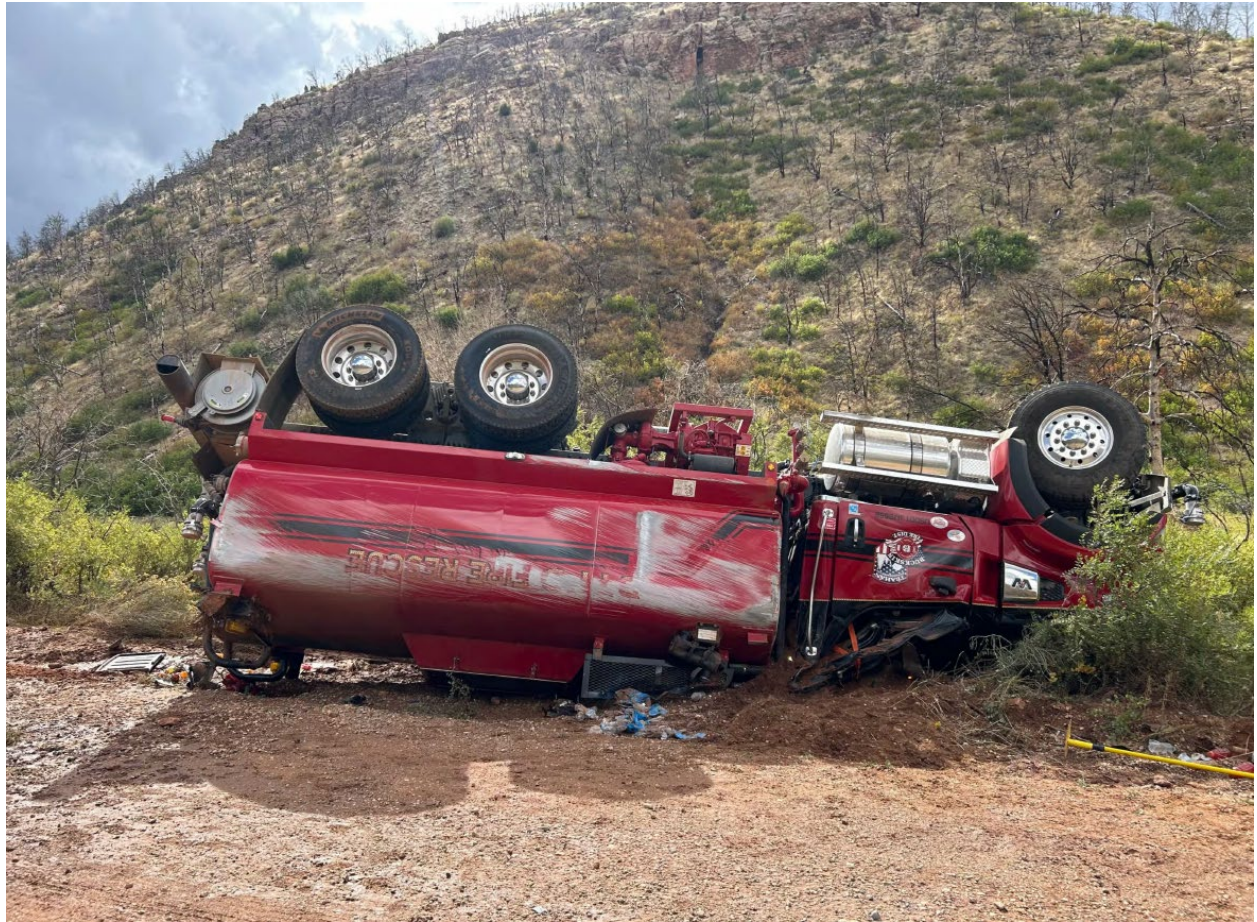
Figure 1: Picture of water tender on its roof with damage to the cab and driver side of the tank.

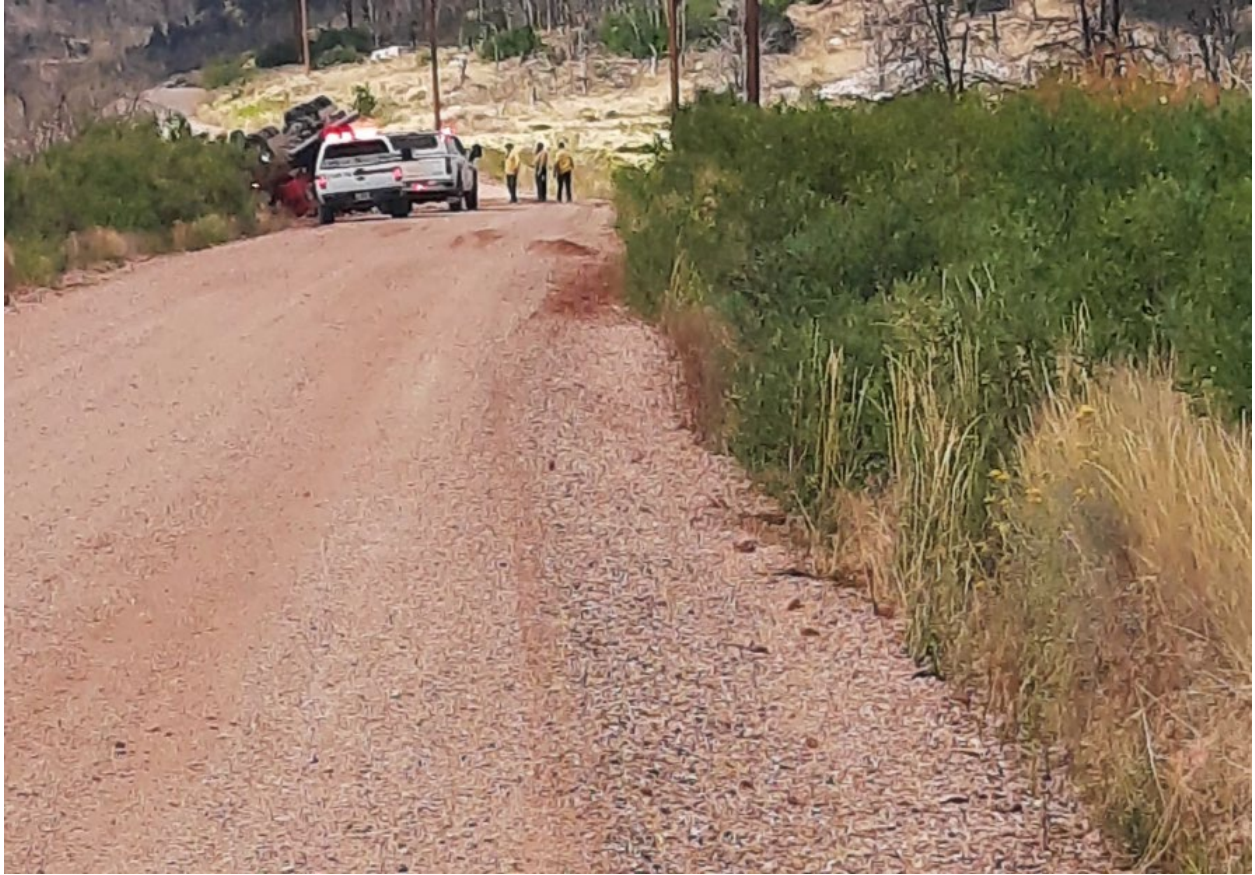
A water tender working the Dragon Bravo Fire was involved in a single vehicle rollover. While driving a recently maintained road, the north bound water tender moved to the right side of the road while driving to provide room for another vehicle to pass southbound. The rear wheels of the tender began to sink into the soft shoulder. The driver felt the sinking and began steering the vehicle out of the soft road material. The rear wheels began coming out of the soft material, they struck a culvert catch basin which “launched” the fully loaded tender out of the ditch causing the driver to lose control. The tender crossed the dirt road and entered the opposite ditch where it began to roll onto the drivers side. The momentum of the vehicle caused it to roll onto its drivers side and the deep borrow ditch on the opposite side of the road caused it to roll completely onto its top. This event caused significant damage to the cab and tank of the vehicle. Another fire resource soon came up on the incident and made contact with the driver who was trapped in the cab but essentially uninjured. The first on scene firefighter could not contact the ICP or Dispatch with their handheld radio from the location. The firefighter used a Starlink to make a call for the IWI. Even the Starlink satellite link was spotty, but the IMT responded to the scene.

Figure 2: Picture of displaced gravel in the road showing where water tender sank into right side of road and final resting place after rollover

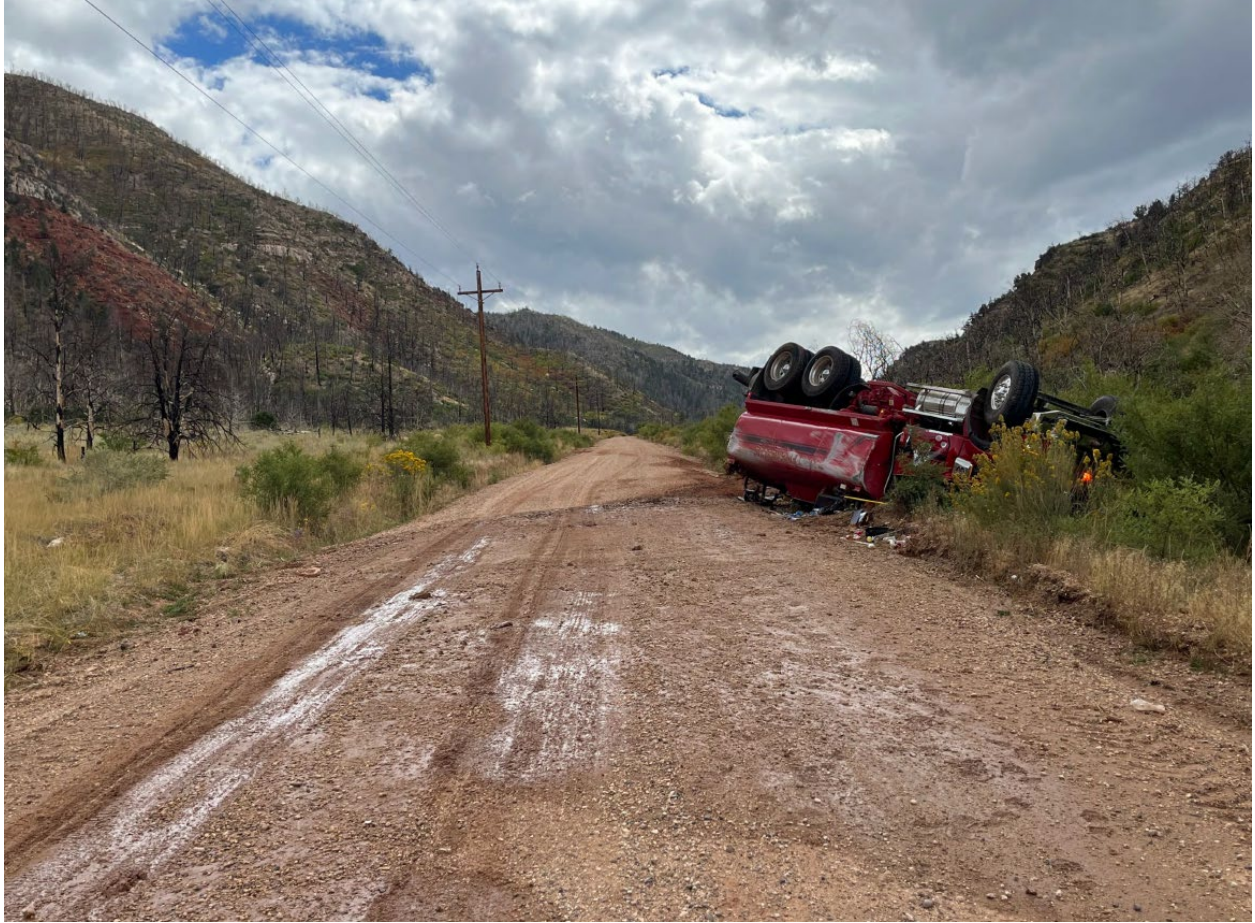
The Driver was able to exit the vehicle by “squeezing through a hole in the cab”. The doors and side windows were inoperable, and the vehicle was on its top. The responding firefighter used a McCloud to excavate soil from around the hood of the vehicle to provide more room for the driver to exit. The vehicle was stable with no risk of further movement.

Figure 3: View looking South of the water tender on its roof in the south bound ditch demonstrating how difficult it was to access the driver compartment due to brush and slope.

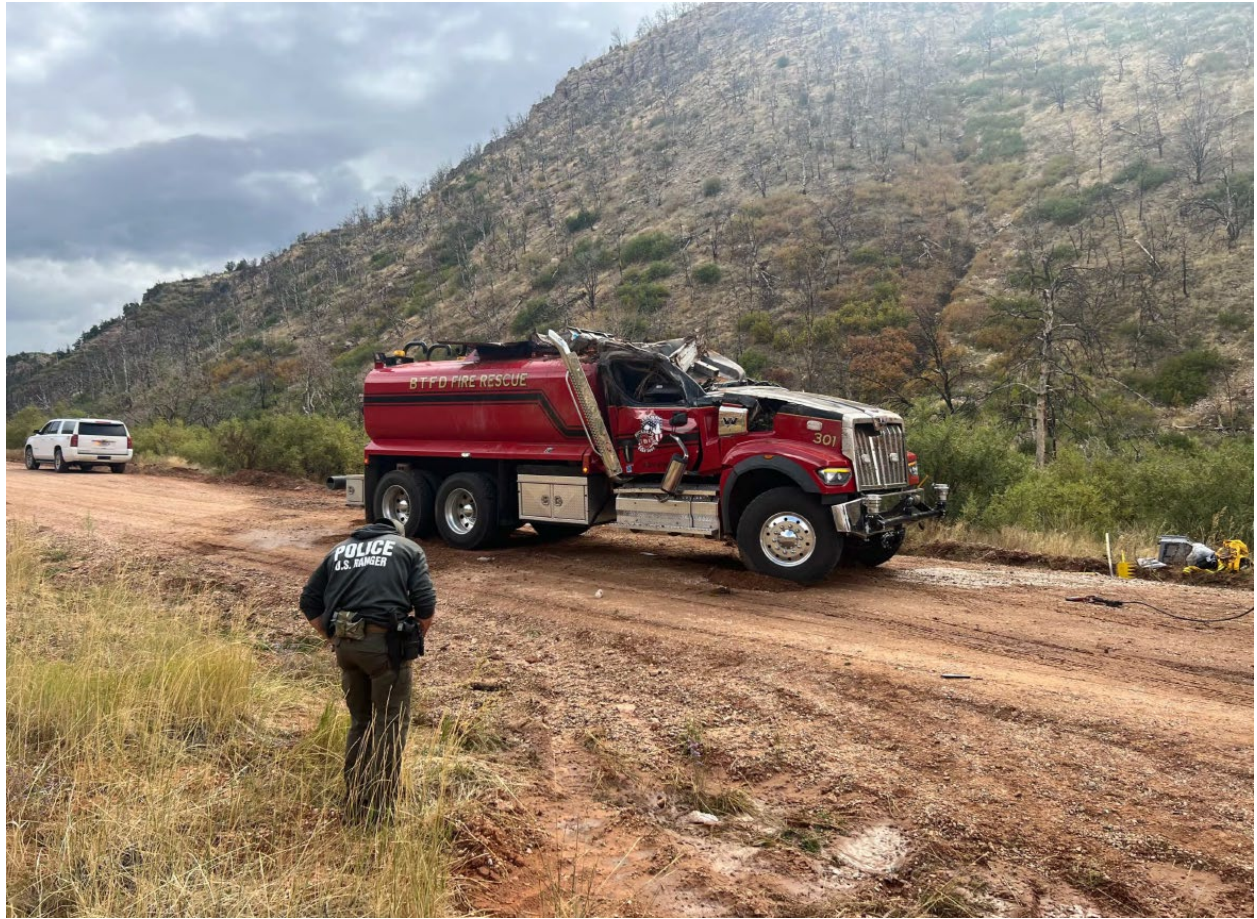
Figure 4: Picture of water tender back on its wheels showing significant damage to the cab
