# Rapid Lesson Sharing

**Event Type:** Engine Dual Tire Incident

**Date:** September 22, 2025

**Location:** Montana

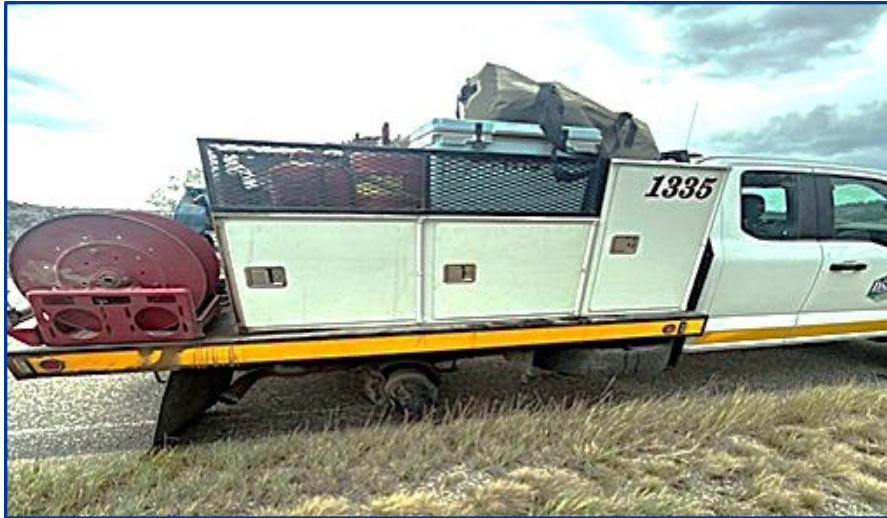
*The engine after the passenger-side outer dual tire “exploded” and the inner dual tire rolled off.*

Driving southeast on I-90 in Montana in a Type 5 wildland fire engine, the driver started to feel the engine “float” — “feeling like it was gliding on ice” — when making slight turns. Shortly after, the passenger-side outer dual tire “exploded” and the inner dual tire rolled off.

Upon inspecting the engine and the rear driveline for damage, the driver noticed that multiple studs had broken off at the base of the right-side wheel hub. In most cases, this can indicate either under- or over-tightening of the lug nuts.

The driver was the only one who had recently tightened the lug nuts on this engine, having replaced the dual tire on that side after a puncture and repair two to three weeks prior.

Conduct thorough walk-around inspections on a daily basis. Check for:

- ❖ Equal thread exposure on all lug nuts and studs, signs of movement or shifting in wheel components.
- ❖ Presence of any metal shards or debris, oblong or odd-shaped wheel stud holes.

After torquing lug nuts to factory specifications:

- ❖ Apply visual indicators such as paint marks across the lug nuts and studs.
- ❖ Alternatively, use plastic lug nut position indicators to detect any loosening.

- ❖ After changing a flat tire, the torque pattern should be completed twice to ensure even tightening.
- ❖ Lug nuts must be rechecked with a torque wrench within 50 miles (or soon after) to confirm they remain at the correct torque specifications.
