U.S. Forest Service, National Technology and Development Program (T&D) Fire Equipment Report

Incident: Juniper Swamp Fire
Date: April 23, 2025

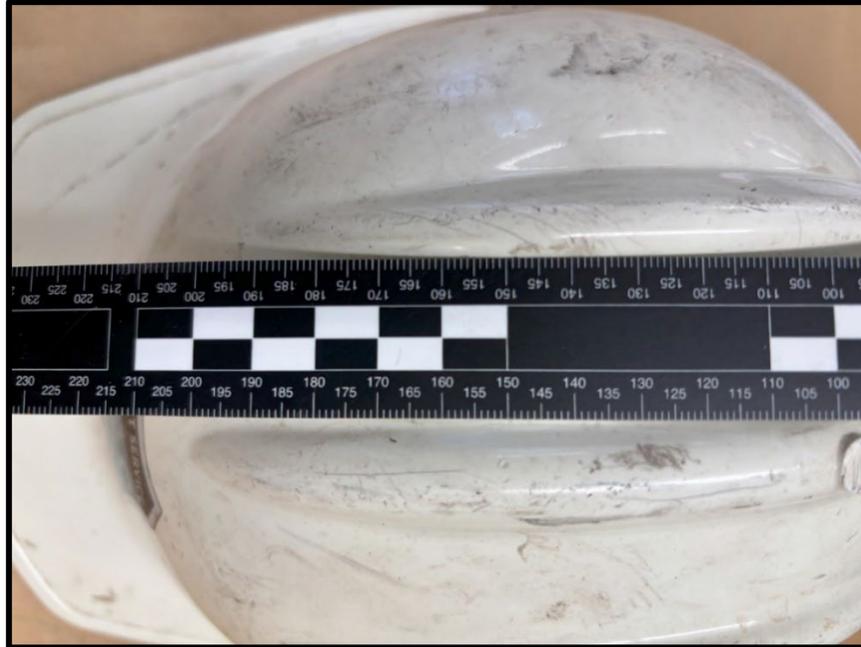
Front – see figure 2.

- Right: crazing present, measurements ranging from 20-26mm
- Center ridge, left aspect: Crazing/scratches ~26mm
- Center ridge, right aspect: Crazing/scratches ~23mm

Figure 2: Crazing and scratches present on helmet front

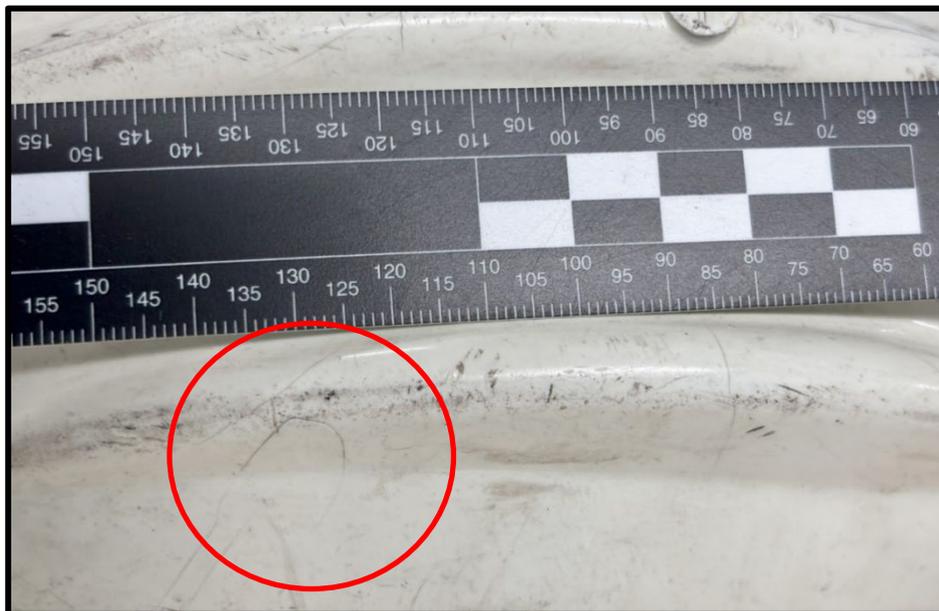
Right side – see figure 3

- Right ridge, center: Crazing/scratches ~10mm
- U shaped scratch: ~20mm total length

Figure 3: Crazing and scratches. U-shaped scratch identified by red circle.

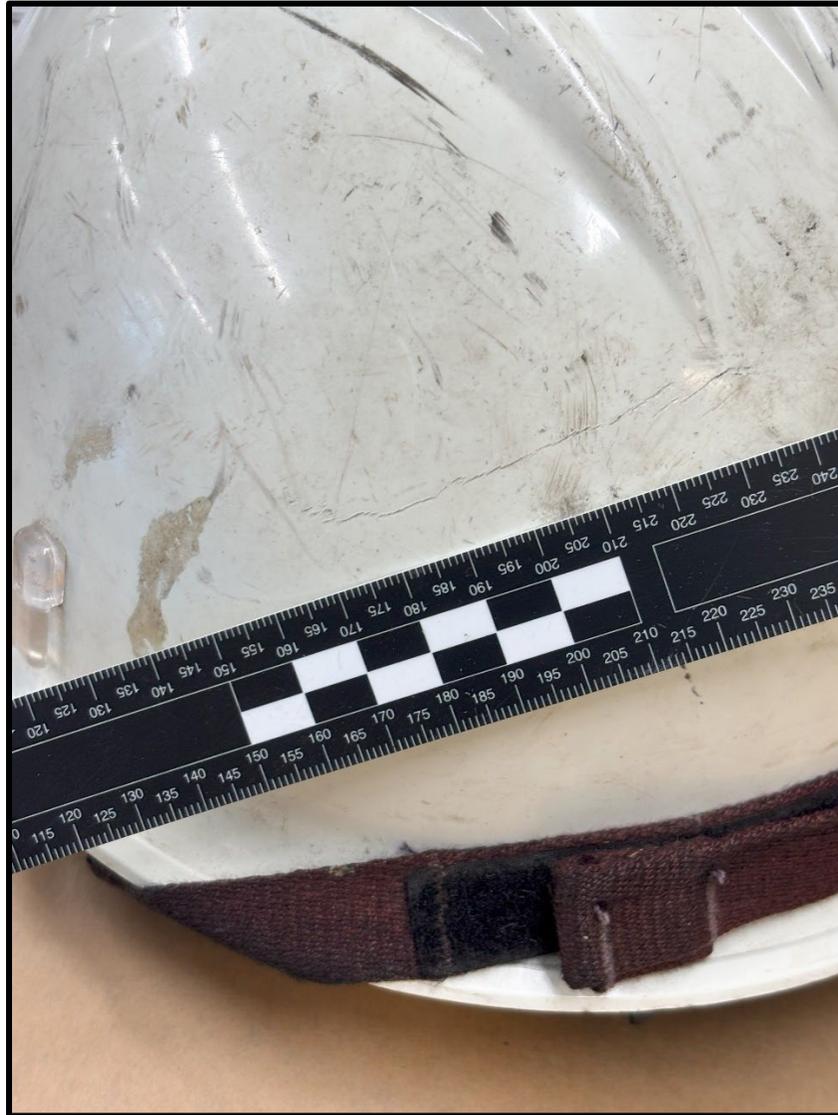
Posterior – see figure 4

- Center ridge: Craziing/scratches ~10mm
- Left posterior: Scratch ~70mm

Figure 3: Left posterior scratch

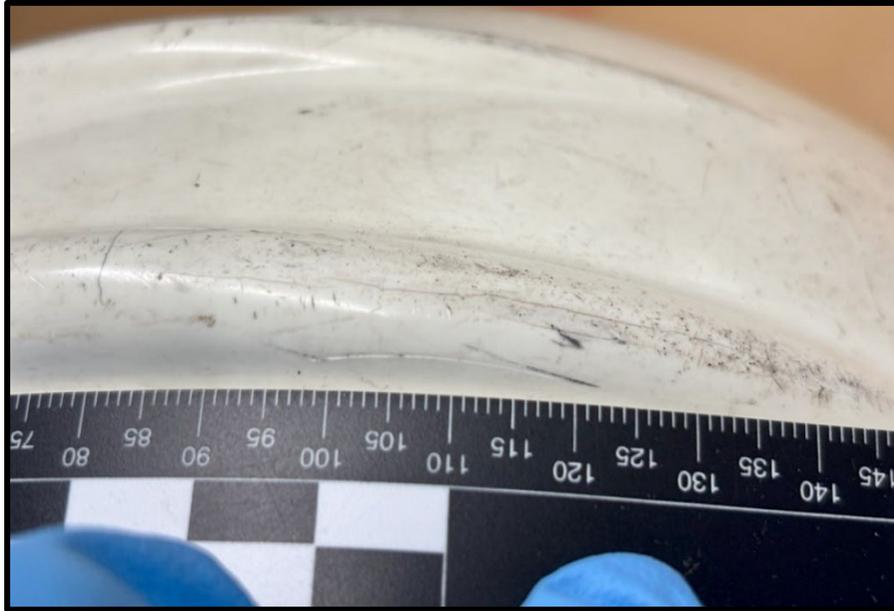
Left side – see figure 5

- Center ridge: Gouge ~22mm

Figure 4: Left side center ridge gouge.

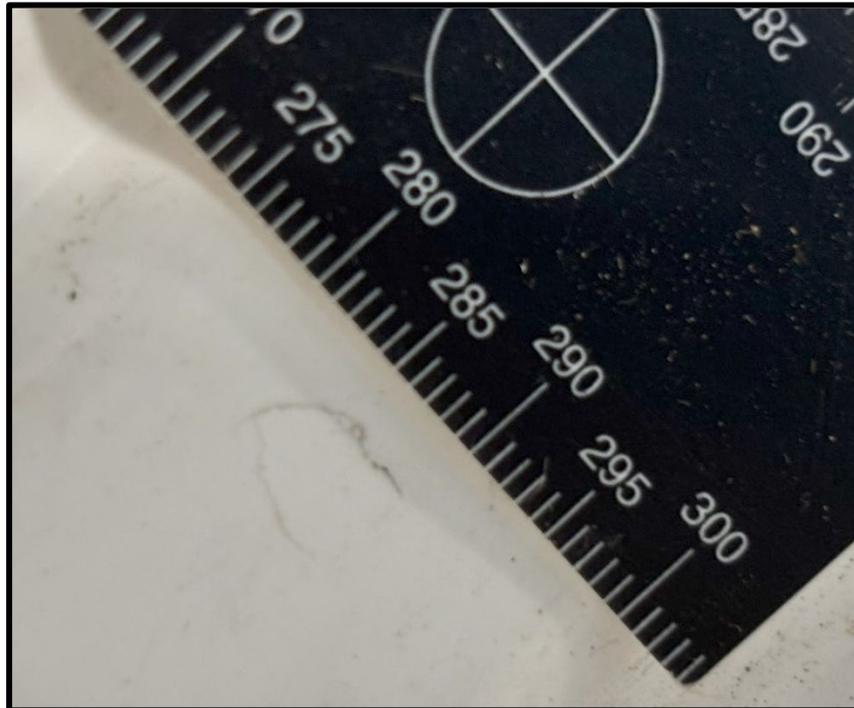
Posterior – see figure 6

- Left Posterior Aspect, Crazing ~15mm

Figure 5: Interior crazing on left posterior aspect.

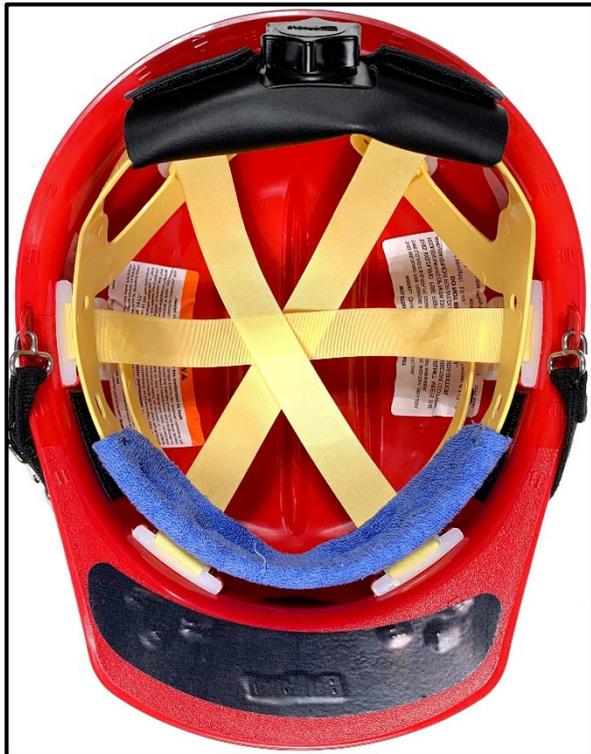
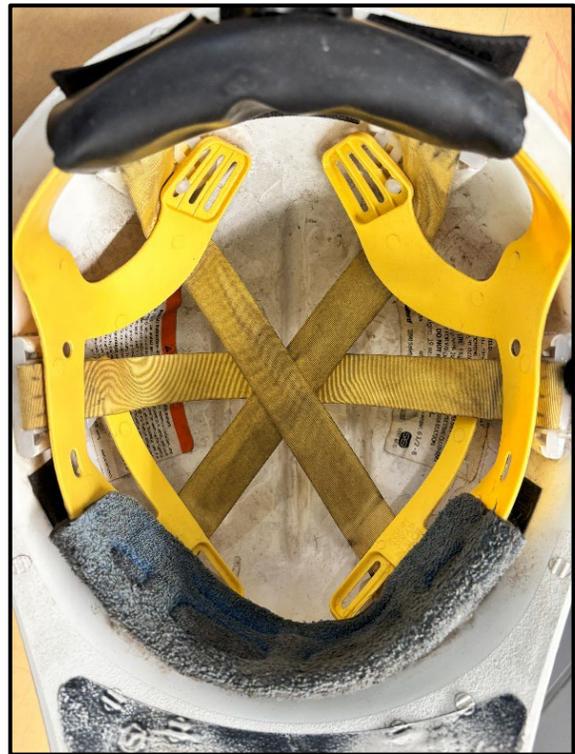
Figure 6: Helmet on left has the suspension correctly installed. Helmet on right is from incident and has the suspension incorrectly installed. Note the headband vertical adjustment slots in front of the webbing and visible on the helmet on right but not the helmet on the left.

Inspection Findings—The helmet suspension was not installed according to the manufacturer’s instructions. The suspension headband’s vertical adjustment slots were placed in front of the suspension webbing, not behind it. Installing the suspension headband in this manner causes the helmet to sit higher on the head by creating tension on the suspension webbing. Impacts or strikes to the helmet shell will most likely exert forces on the key peg/vertical adjustment slots that will increase the likelihood of key pegs coming out of the vertical adjustment slots. This most likely led to the right front vertical adjustment slot disconnecting from the key peg.

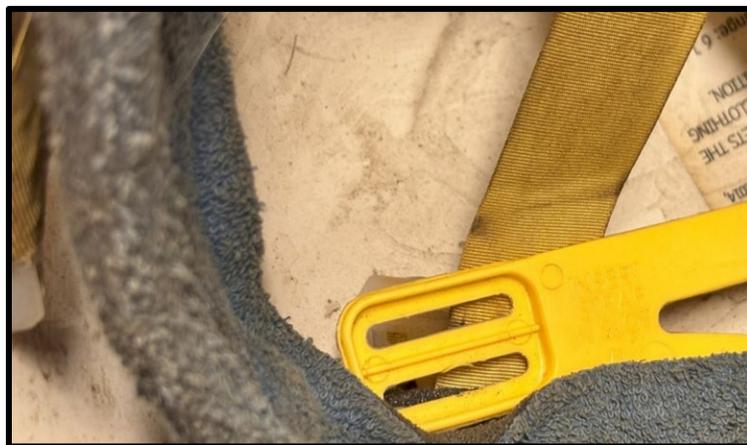
Figure 8: Right front vertical adjustment not attached to the suspension key post.

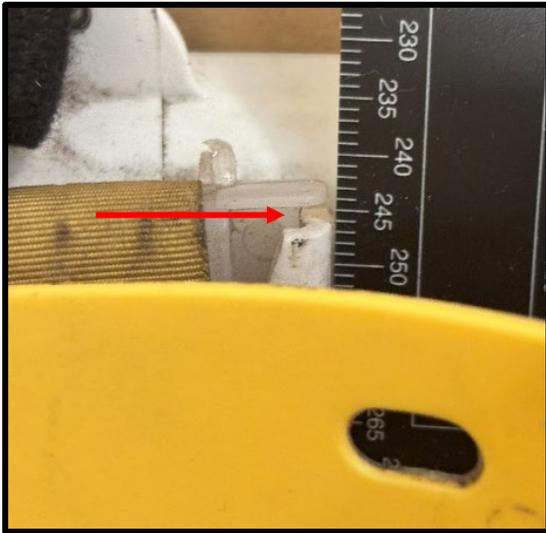
Figure 9: Lateral key not fully seated in key slot

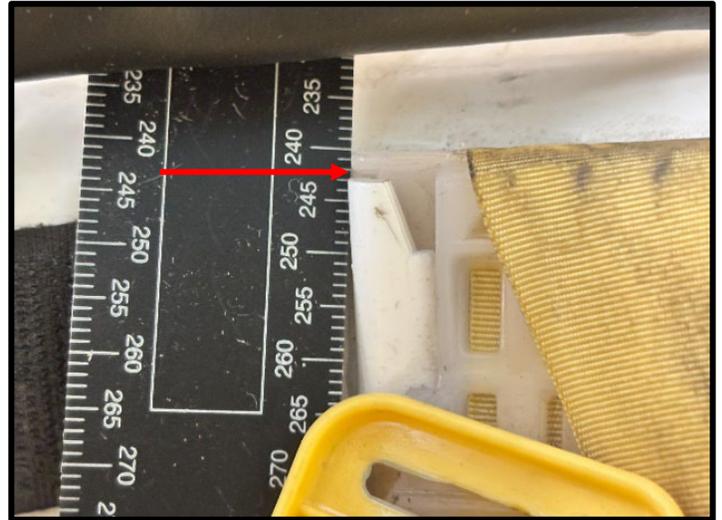
Figure 10: Medial side of back key not fully seated in key slot

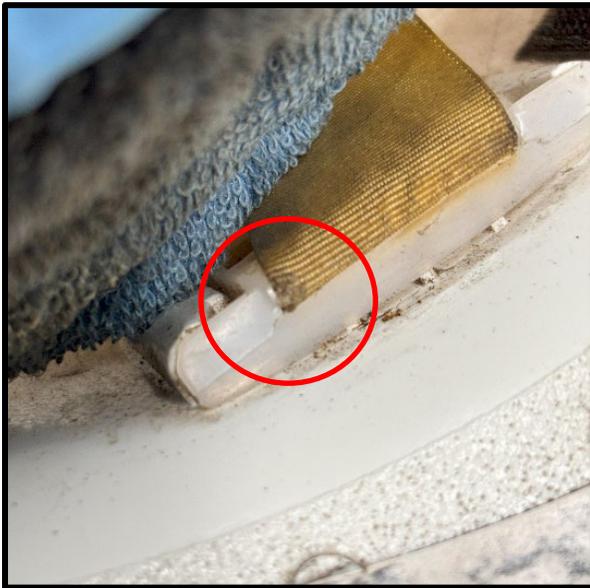
Figure 11: Right front suspension webbing fraying.

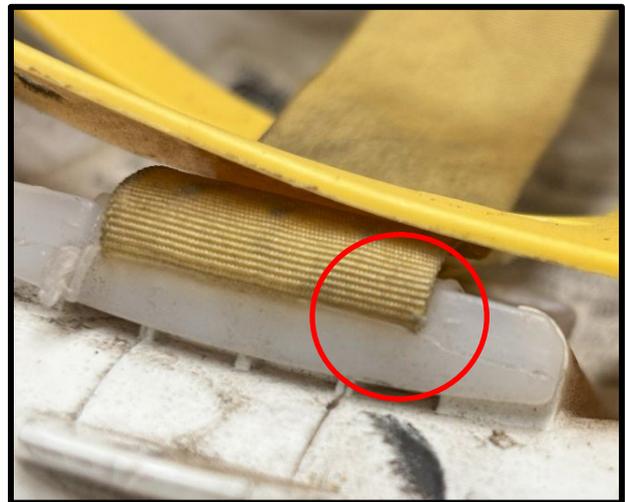
Figure 12: Left lateral suspension webbing fraying.
