Event Type: Tree Felling Tree Strike Injury

Date: December 17, 2025

Location: Olympic National Forest

The Story and Lessons from this Hazard Tree Felling Incident

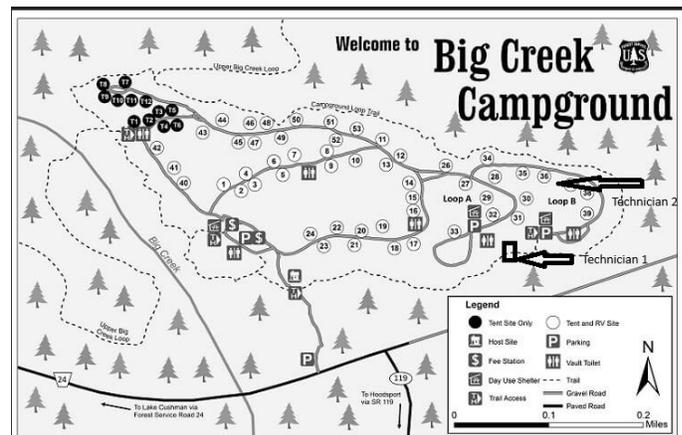
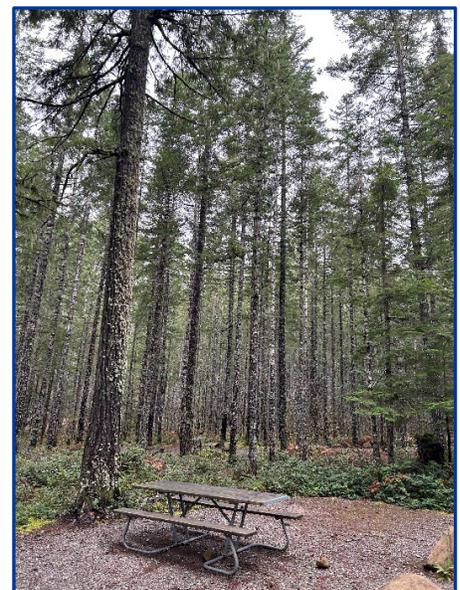
The predominant overstory species in Big Creek Campground is Douglas-fir, with a vine maple and brush component and a moss-covered understory. Most Douglas-fir within Loops A and B of the campground average 10-18 inches in diameter and range from 50-100 feet in height, with larger trees interspersed throughout the perimeter of the stand. The campground area was clearcut prior to its development, resulting in a largely even-aged forest structure with tight spacing.

Laminated root rot (*Phellinus weirii*) is prevalent within this stand and has resulted in elevated levels of tree mortality, increasing the need to manage risk associated with whole-tree and top-failure, particularly during wind events that increase the likelihood of windthrow and breakage. This condition necessitates ongoing hazard tree mitigation efforts, as evidenced by numerous previously felled trees throughout the campground, and contributes to increased complexity during annual treatment activities.

Big Creek Campground campsite showing tree stand condition.

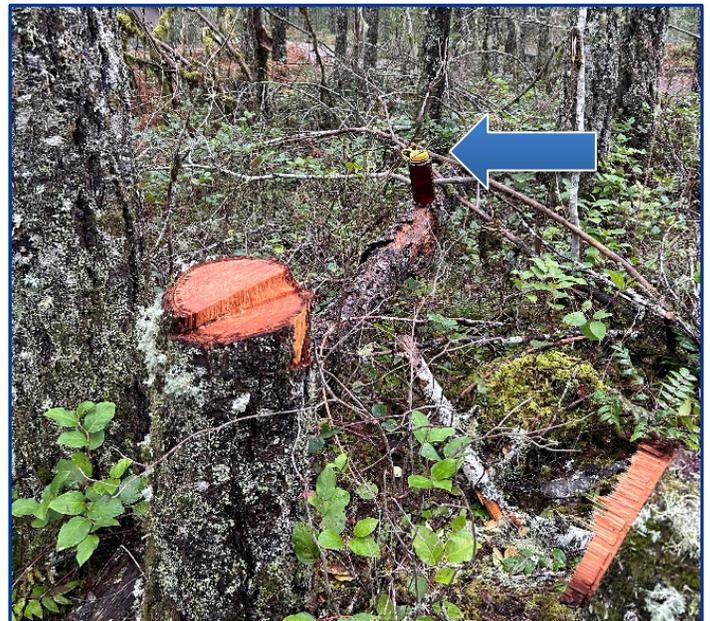
While progressing the backcut, a portion of the hinge on the far side was inadvertently severed. The combination of the remaining bypass and the compromised hinge caused the tree to pull left of the intended lay. As the tree committed to the fall, the top of the dead Douglas-fir snag contacted a lower branch of an adjacent tree.

As the snag continued to fall, the top portion of the tree flexed under compression and fractured approximately one-third of the way up the bole. The broken section folded backward and broke into several pieces as it fell toward the stump and struck Technician 1, resulting in a fracture to the left forearm.

During the site visit conducted as part of the Rapid Lesson Sharing review process, Technician 1 noted that the area around the stump had not been cleared to the extent that they had previously remembered. The image (above right) indicates the approximate location in which the sawyer was standing while observing the top of the tree during its felling.

This image also shows the approximately 10-inch DBH downed log that was located directly behind the stump, along with additional debris in the immediate area. These features limited available movement and effectively constrained the escape path that had been intended for use during the falling operation.

Top: The incident tree. The water bottle (arrow) indicates where the sawyer was standing when struck on the left arm by the broken top.
Left: The small 3-inch DBH 1 ½-foot-long broken top section of the tree top responsible for the injury.

- **Escape path preparation:** Clearing brush, downed material, and other debris from the base of each hazard tree is critical to maintaining effective escape options. When felling outcomes deviate from the intended plan, having multiple unobstructed escape routes increases the ability to move farther—or in unplanned directions—to avoid emerging hazards.

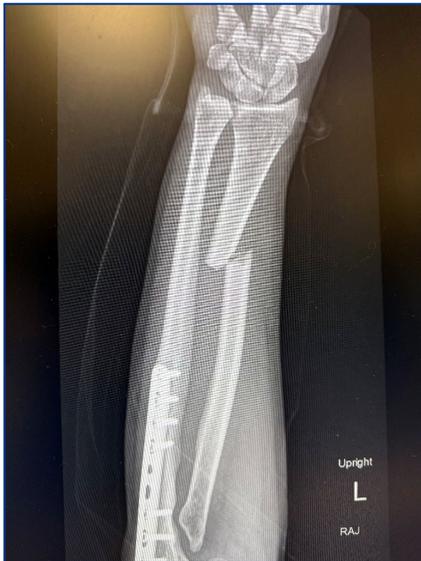
X-ray of the fracture in Technician 1's left forearm.

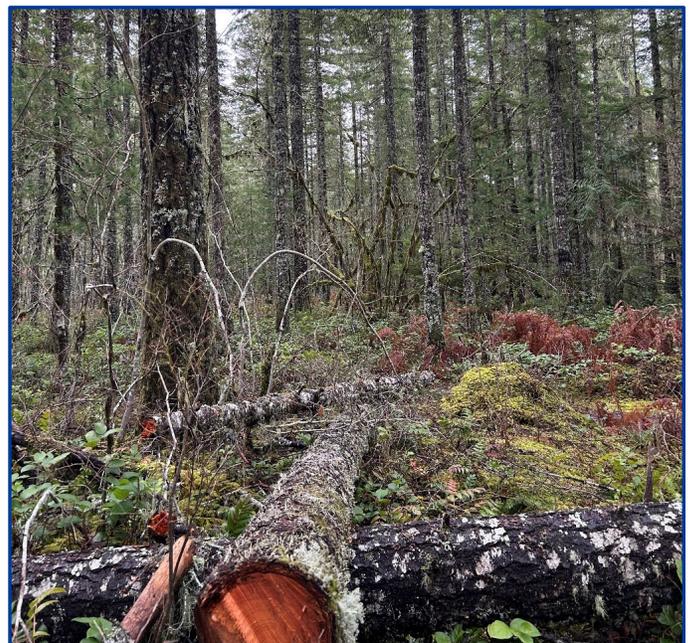
Performing the conventional undercut from this position proved awkward and affected the geometry and alignment of the cuts. Two attempts were required to complete the undercut. An estimated one- to one-and-a-half-inch bypass remained on the stump’s far side that was not observed or fully removed. The tree was aimed at an opening. A standard backcut was initiated without the use of wedges, as the tree exhibited some favorable forward lean toward the intended lay.

Photo of the incident tree taken from the stump that shows the broken top and tree lay.

- **Cutting position and proficiency:** Hazard tree operations may require sawyers to cut from non-preferred or offside positions due to tree defects, terrain, or obstacles. Practicing and maintaining proficiency cutting from both sides of the tree can support better cut alignment, hinge construction, and situational adaptability when ideal positioning is not available.

- **Bypass detection during undercut completion:** After removing the undercut, placing the saw bar back into the initial gunning cut can help confirm whether a bypass remains. This technique is particularly useful when awkward positioning or limited visibility prevents a clear view of the tree's far side.
