Rapid Lesson Sharing

Event Type: Marsh Master Towing Accident

Date: February 7, 2026

Location: Interstate 10 in Mississippi

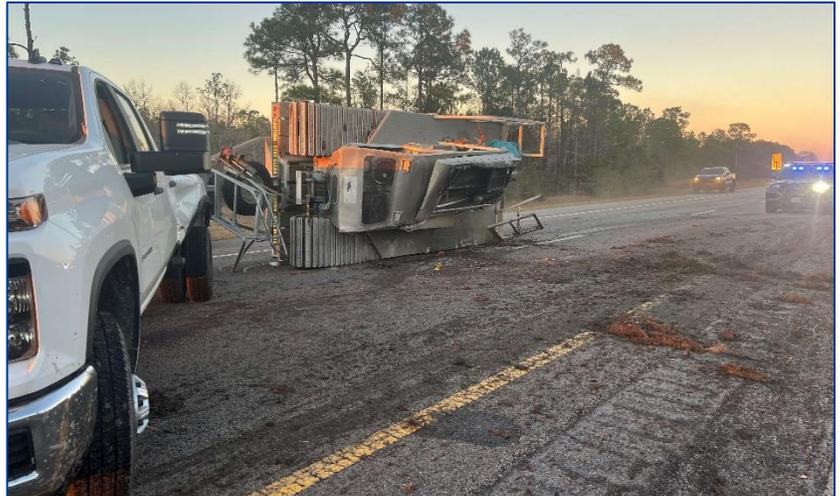
Figure 1 – The overturned trailer carrying the Marsh Master Type 2 with mower blocking both westbound lanes of Interstate 10.

The trailer was on its left side and the MM2 with mower was still attached to the trailer. The MM2 roof was collapsed and the smell of gas was noticeable. The gasoline smell was discovered as a leaking drip torch and drip torch mix can that had been damaged when the MM2 overturned.

1. The employee indicated that mud had accumulated on the mower deck from the tracks during the operations of mowing firelines. The employee did not clean the mud off the mower deck prior to loading the machine and mobilizing back to the Fire Center. At the incident site it was clear that a heavy accumulation of mud was present on the pavement. The mud was concentrated on the mower deck in the very back of the trailer. This likely offset the weight distribution, contributing to fishtailing.
2. The center of gravity for tilt bed trailers might be altered because of implements. When towing a Marsh Master with an implement, a different trailer design may be needed.

1. A station review of the Job Hazard Analysis (JHA) will be conducted and amended to include safe trailering guidelines and requirements to remove dirt/debris from rear implements prior to towing.
2. All trailers and equipment will be evaluated to ensure that proper tie-downs are present and that all accessories are secured to ensure that safe trailering continues.
3. The U.S. Wildland Fire Service transition notification tree of potential accidents and serious accident processes will be identified to ensure that reporting will be conducted properly.
4. The Marsh Master Type 2 manufacturer will be contacted to determine safe towing corrections while hauling attachments that could impact trailer weight distributions.

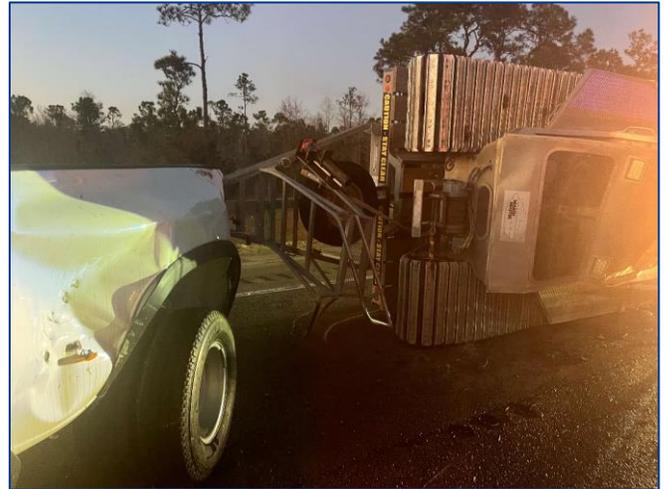
The trailer hitch was disconnected but the safety chains remained solidly connected. Three of the 4-point tie-downs were solid and holding the MM2 and mower snugly on the trailer. After close inspection, the truck tank was not punctured nor leaking diesel. MM2 did not have any fuel or fluid leaks. There were no flat tires on the truck or trailer. Several areas of mud and grass were present on the pavement.

Figure 2 – The trailer hitch was disconnected but the safety chains remained solidly connected.

4. The trailer hitch was correctly fitted as recommended at 2 5/16 inches. The hitch did disengage when the trailer turned over, however the safety chains were securely attached and kept the trailer from detaching and becoming a projectile. In studying the paint marks on the MM2 tracks and the jack located on the trailer, the trailer did overturn completely which crushed the cab on the MM2. The paint marks indicated the right track of the MM2 hit the left side of the truck. The jack, also located on the right side, punctured the truck on the driver's side rear quarter panel. If the safety chains had not held, it appears the trajectory would have hit the driver's side of the vehicle with increased momentum and force.
