# East Ute Plaza Fire Lessons Learned Review

**Incident # UT-UOA-100037**

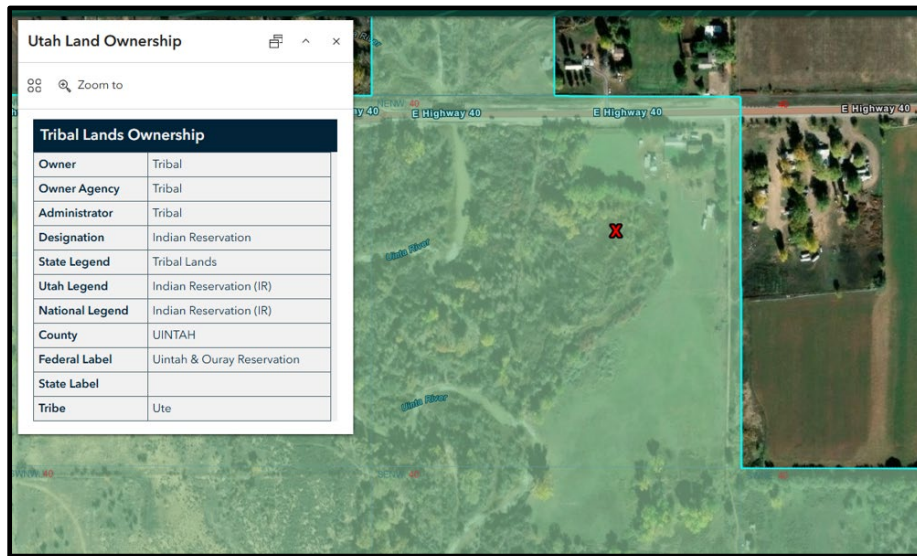
**Figure 1: Land ownership and estimated (original) point of origin for the East Ute Plaza Fire.**

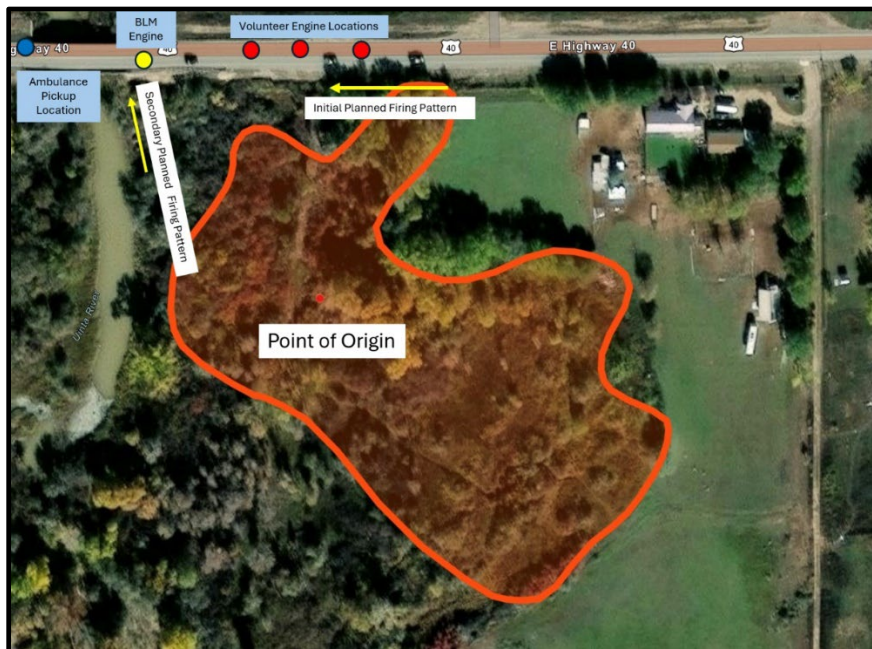
The plan was to burn two sections of control line (see Figure 2). The first was a small section from east to west along the highway toward the Uintah River to stop the northerly progression. The second section was from the main fire along the river back toward the highway to the north, securing the corner and stopping the fire from going under the bridge.

**Figure 2: Estimated fire size (approx. 5.5 acres) when burn out operation began.**

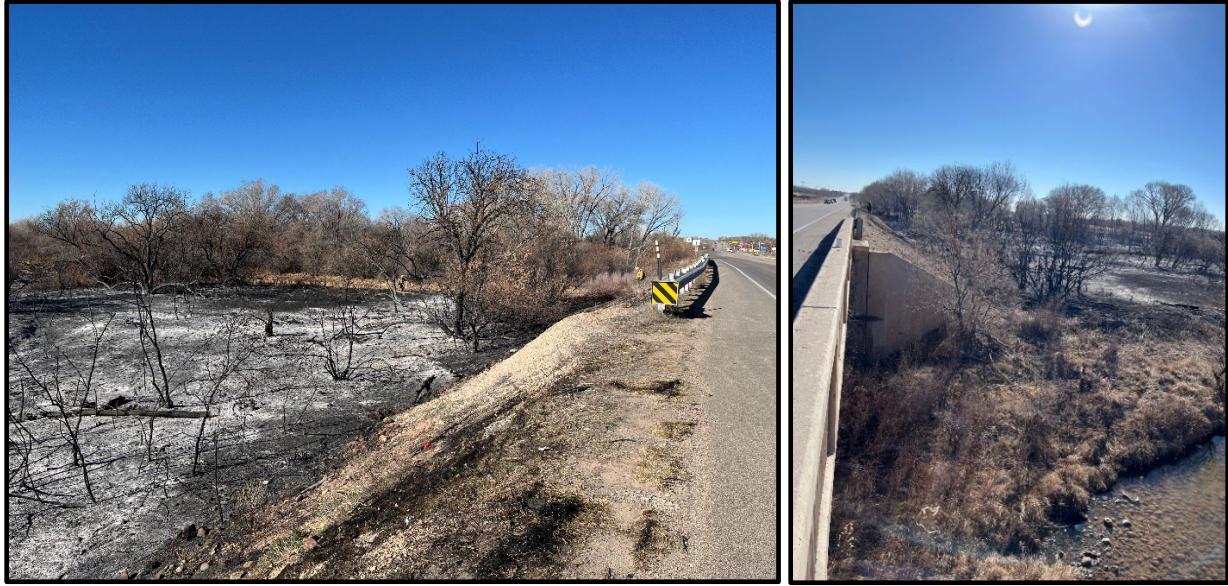
**Figure 3: Left – View from the roadway looking toward the Uintah River bridge. Right – Looking east from the Uintah River bridge.**

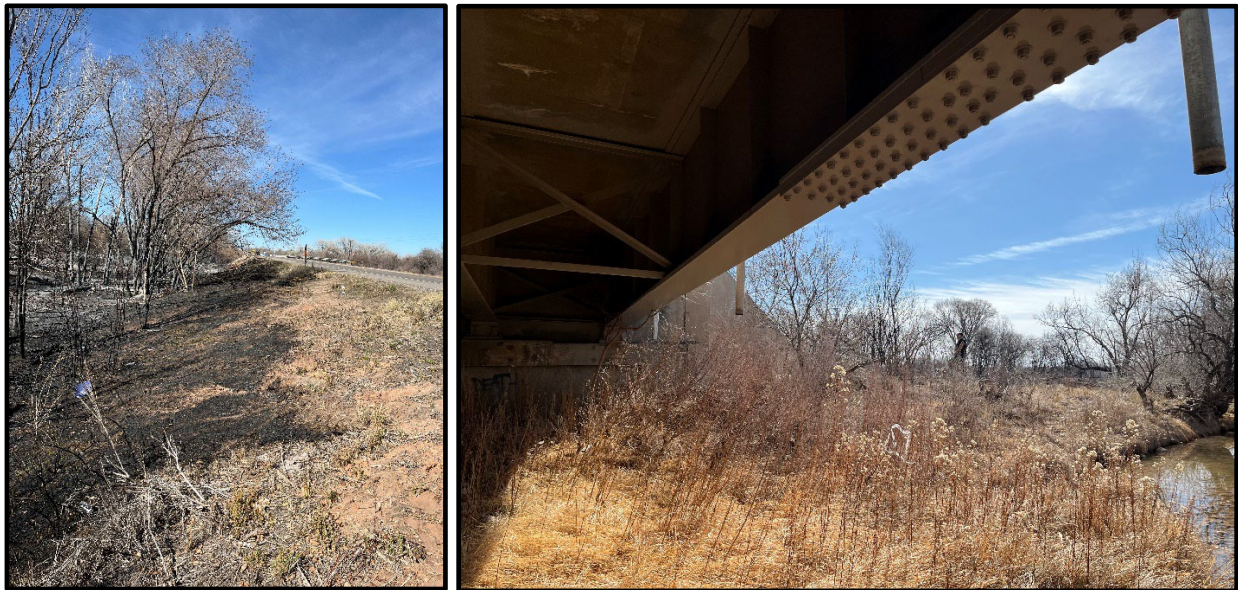
**Figure 4: Left – View from the northeast corner looking toward the Uintah River bridge. Right – Looking southeast toward the fire from under the Uintah River bridge, showing the continuous fuel concern.**

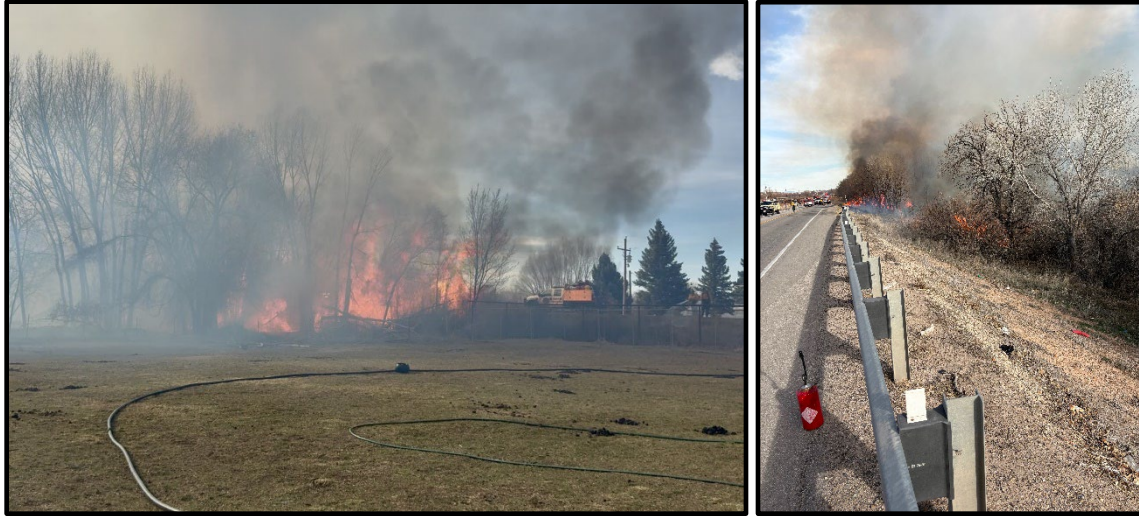
The Firing Boss, the igniter, and the other WFS ENGB walked to the vulnerable west corner of the fire near the bridge. While the Firing Boss and the other WFS ENGB walked out the planned ignition line to reaffirm the plan, the igniter took a photo (see Figure 5). They liked what they saw, so they hiked back to the highway and began briefing the igniter. They asked the igniter if he was comfortable lighting that section. He replied that while he didn't have much burning experience, he could do it.

**Figure 5: Left – Image depicts fire activity near the northeast corner just prior to burning. Right – Photo taken by injured firefighter just before he started burning. Time stamp on both images is 17:11 (5:11 p.m.).**

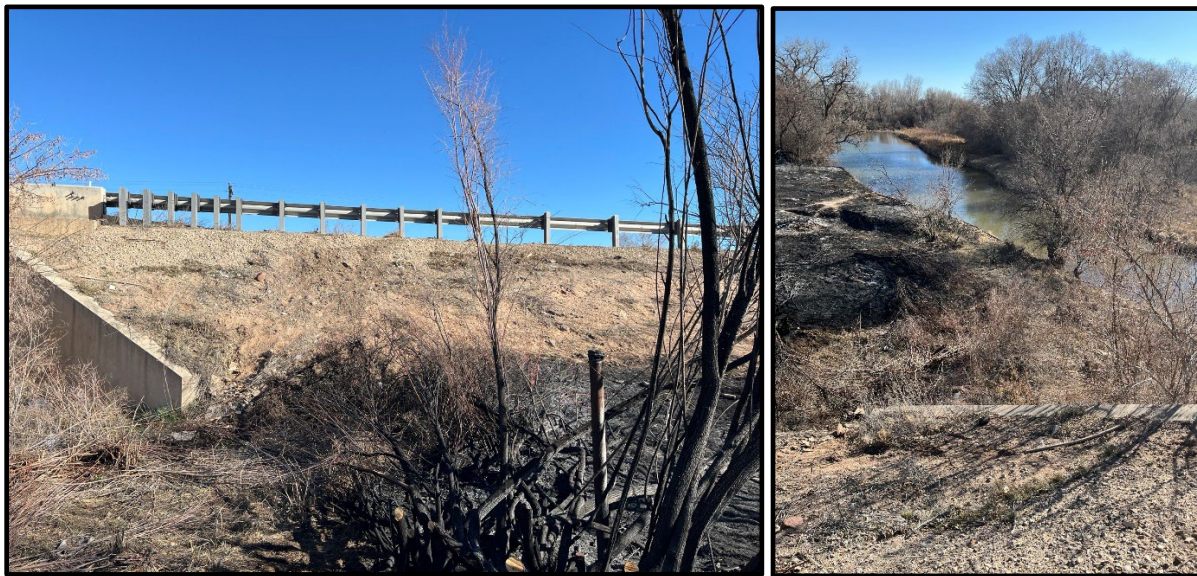
**Figure 6: Left – View of the embankment from the northwest corner of the fire. Right – View from the roadway looking down the same embankment.**

Once he rounded the corner, the Firing Boss told him to quit firing and come up the embankment. The igniter did not hear this order and kept firing to the east toward the end of the guard rail as he had originally planned. The embankment was steep with no vegetation (see Figure 6). The Firing Boss, at the top of the embankment near the roadway, again yelled for the igniter to cease igniting and come up to the road. But the igniter kept lighting to the east.

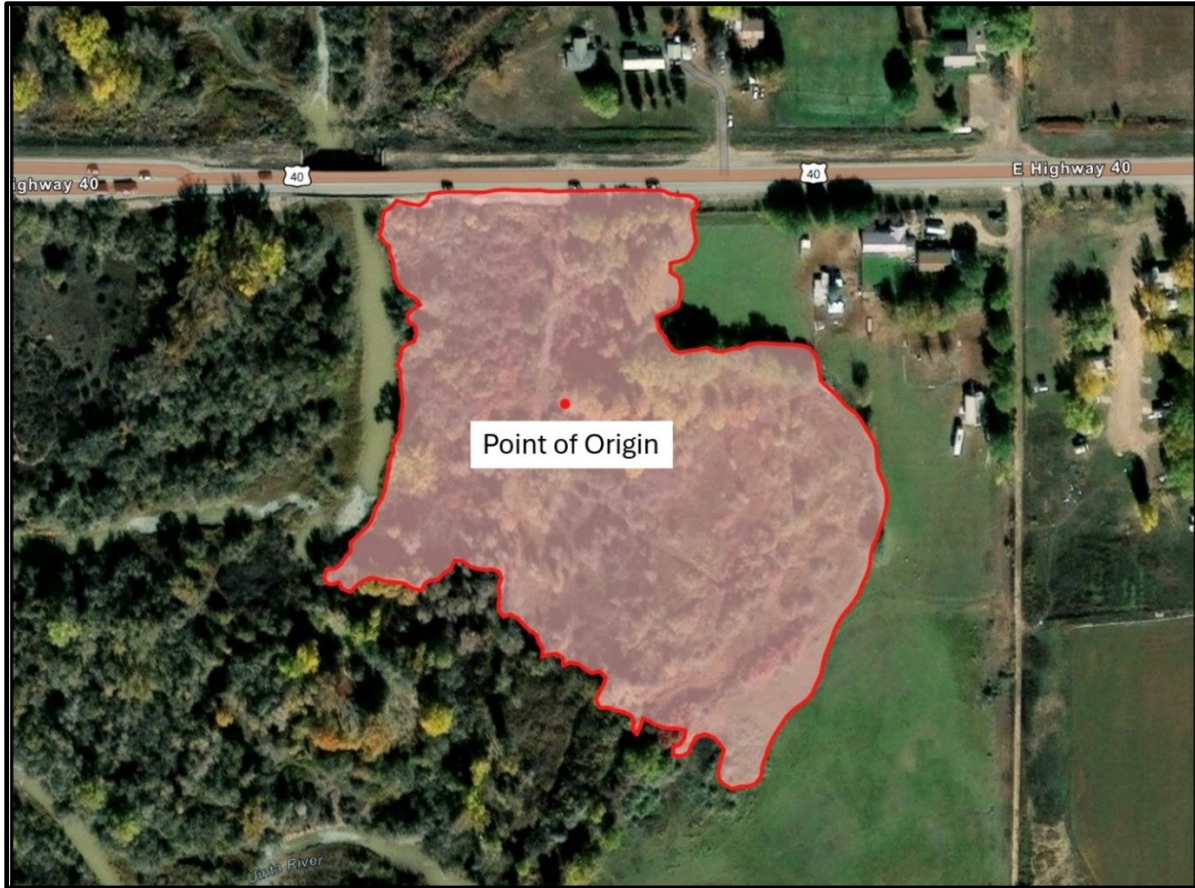
Figure 7: Final fire perimeter after containment (9.58 acres).
