## The Story and Lessons from this Mobile Cache Support Van Driving Incident

By Salvador E. Gamez

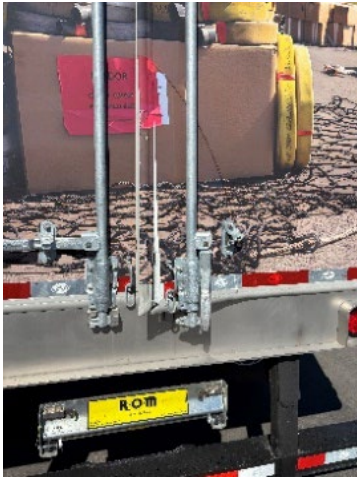
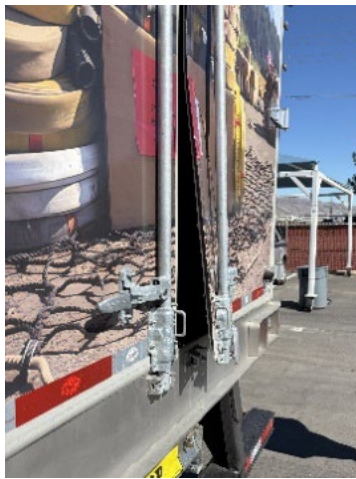
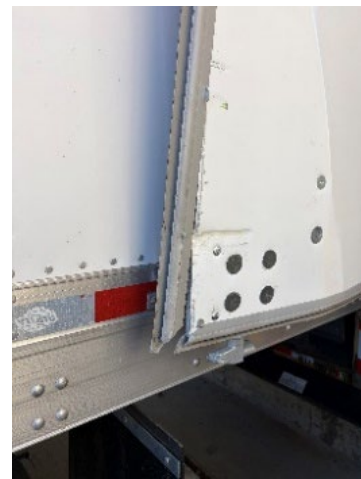
After stopping for an ID check, as I continued forward, I soon heard a noise coming from the rear of the vehicle. Investigating, I found the right rear door was open and its bottom left corner was damaged. The bottom left corner was bent up and outward with scratches to the door. I inspected the trailer for any additional damage and secured the door as best I could.

***Three images depicting damage to the lower left corner of the right trailer door.***

First, when conducting the walk-around inspection before leaving, I should always make sure that the trailer is equipped with a locking device on the doorlatch and that the door is properly seated and secured. Ensuring the doors are seated and latched with a locking device will ensure that any jarring from the road or crossing railroad tracks would prevent doors from unlatching. This will greatly reduce the risk of accidental openings.

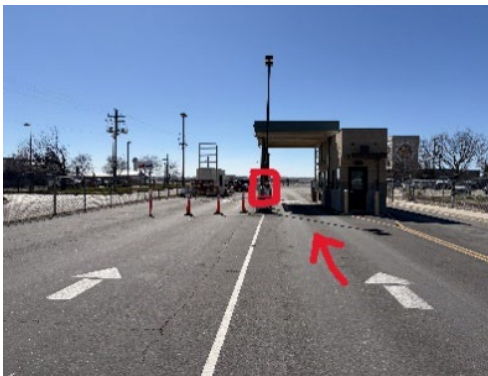
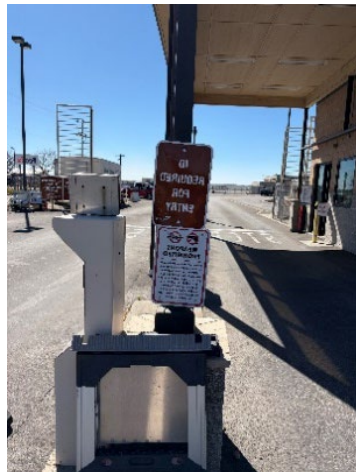
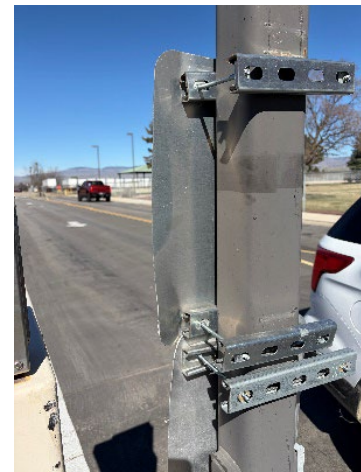
Upon further examination, I discovered that as I had driven through NIFC's security gate, this open door had struck a pole which supports signage at NIFC's security building's entrance. Both the signs and the pole received scrape marks and were slightly bent. I then proceeded to the warehouse, docked the trailer, and documented the damage accordingly.

***Left – The approach to the NIFC security entrance, with the awning and narrow entrance shown. The post that was struck is boxed in red. Middle – A closer image of the damage to the signs. Right – Where the sign was cut by the open trailer door.***

Additionally, while driving, it's important to thoroughly check your mirrors, especially in areas where space is tight or entryways have limited height.

Taking a little extra time to double-check these details can make a significant difference. Ensuring the proper height and width of an entryway—prior to moving forward—should be a priority to mitigate any damage occurring to both vehicles and infrastructure.
