Event Type: Bulldozer Fire
Date: March 22, 2026
**Location: Ouachita National Forest,
Region 8**

Ouachita National Forest Bulldozer Fire Facilitated Learning Analysis

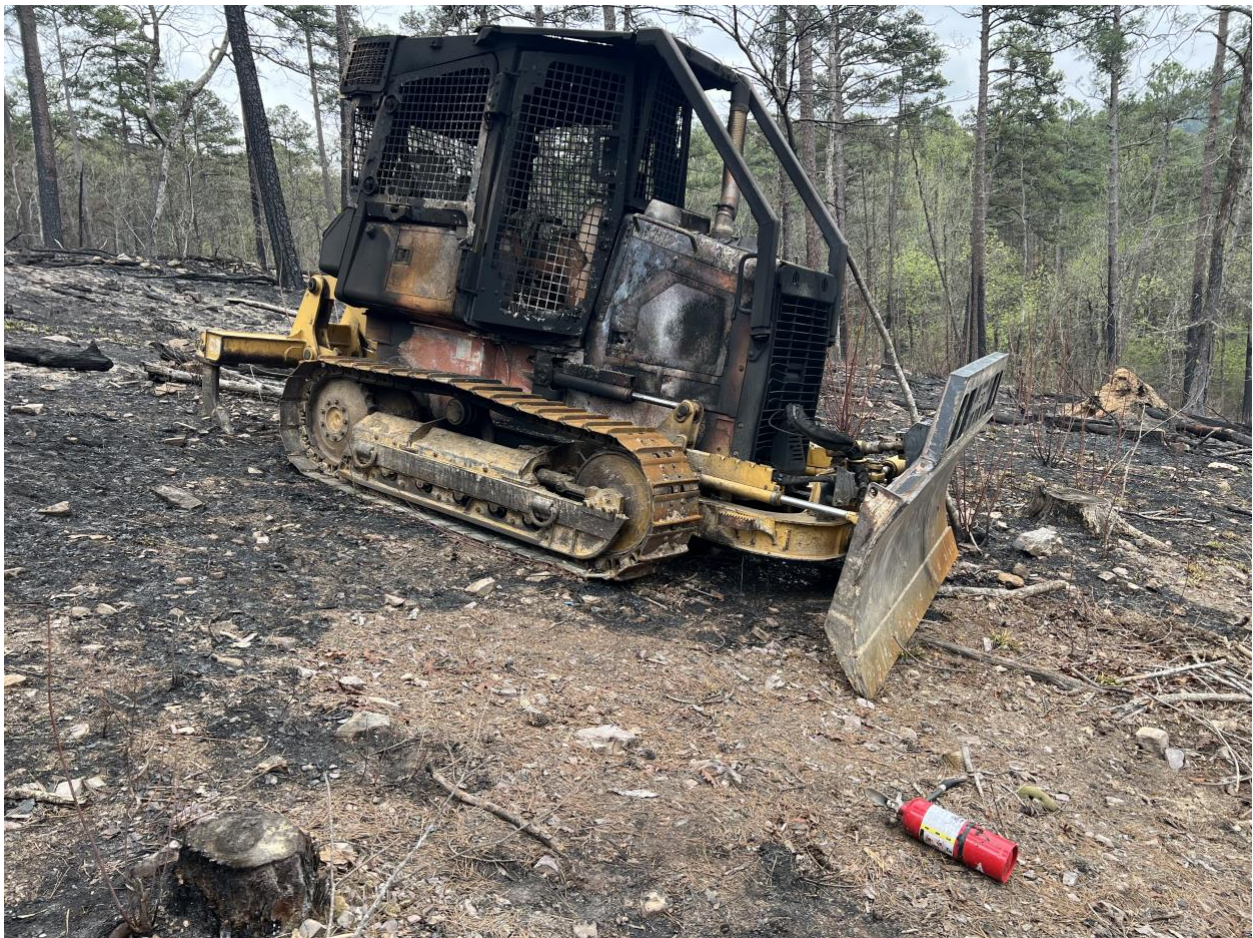
Photo 1: Burned John Deere 450 J Fire Tractor Crawler on the Ouachita National Forest

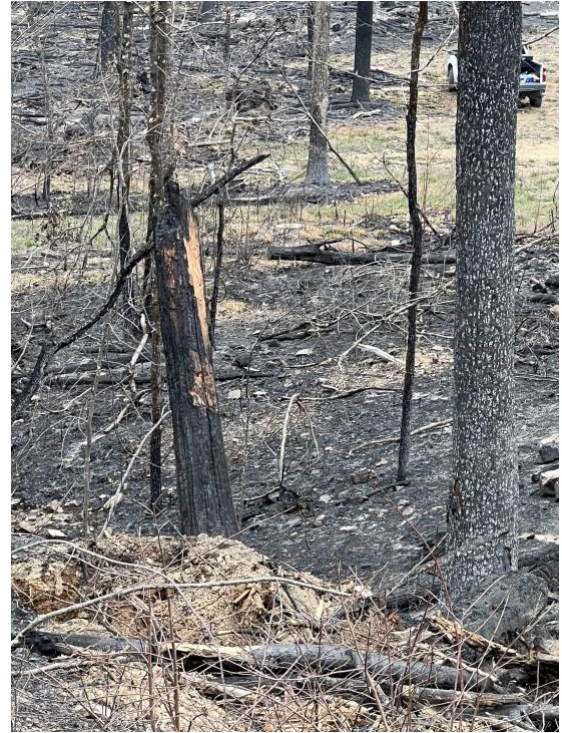
Photo 2: Dirt and Rock Ramp in Front of Snag

spot fire of about 20 by 20 feet in a draw above him. He engaged with the dozer, intending to keep this fire from spreading into the rough terrain uphill by removing a burning snag along the north edge within the spot. He "ramped" the area leading up to the snag by pushing dirt and rocks downhill to create a nonflammable platform on which the dozer could sit while he pushed the snag. As he pushed the flaming snag, burning embers floated and fell.

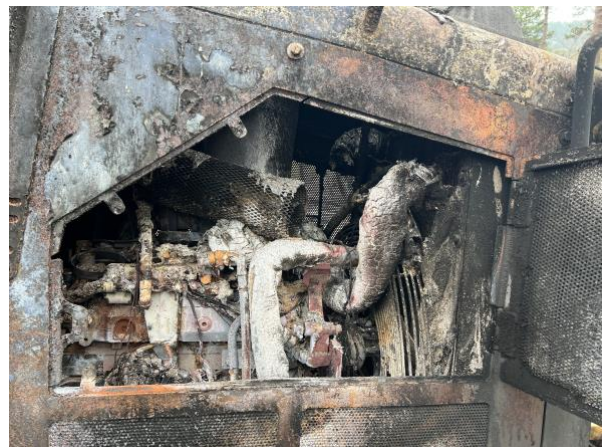
The fire was contained at 433 acres that same evening with the help of additional Forest firefighting resources. The strategy maximized the use of natural features and contained the fire both within the project area and National Forest System lands. It is outside the scope of this analysis to determine the cause of the fire in the dozer motor compartment. Given the DZIA’s observations of the fire within the air assembly, however, it is probable that an ember was drawn into the air intake of the dozer.

Photo 4: Access Point to Air Filter Housing

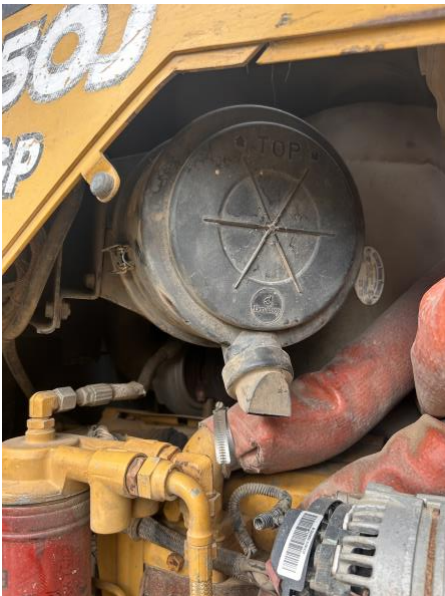
To understand this process, consider first the anatomy of a dozer air filter assembly. The factory-installed air cleaner assembly is made of a plastic composite material which contains both inner and outer paper filters. All items are combustible. The air cleaner assembly functions just like a standard automobile but is more robust with a two-filter system providing the clean air necessary for engine combustion.

Photo 5: Air Cleaner Assembly

While the DZIA followed best practices to minimize the danger of an ember entering the air filter, the fact remains that this is a volatile environment. One expert likened the motor to a “backwards leaf blower” as the engine sucks in air and feeds the components of the engine through the air filter assembly. If an ember reaches the filter, the fire can intensify quickly—much like blowing on dry paper in a campfire. Replacing the flammable components of the filter with non-flammable components can mitigate this vulnerability.

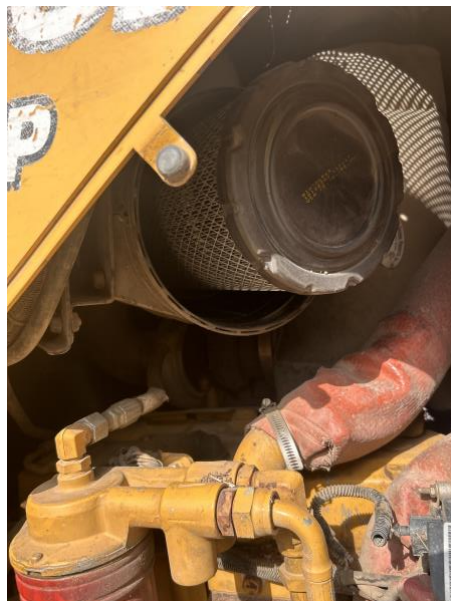
Photo 6: Outer Air Filter

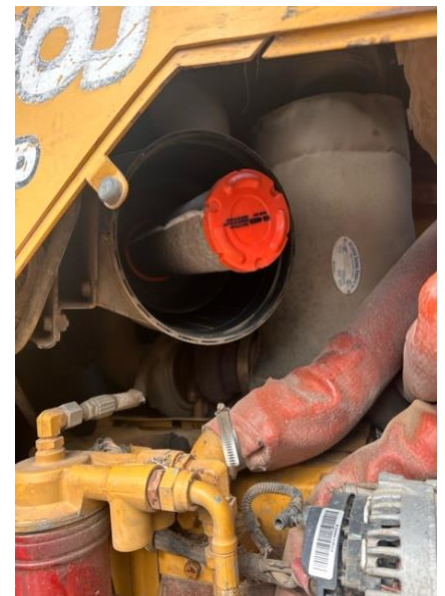
Photo 7: Inner Air Filter

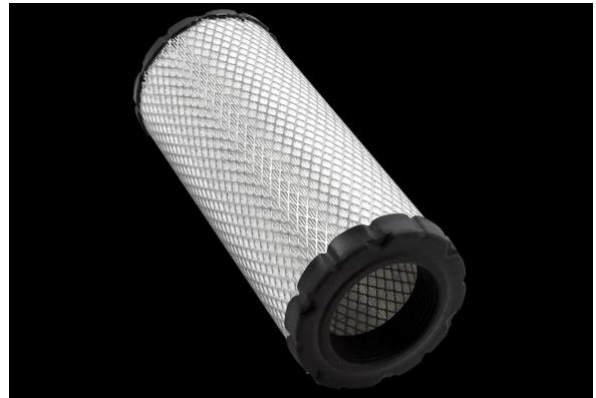
Photo 8: Fire-Resistant Air Filter

While options exist for after-market replacement of combustible items, the process for requesting these items is currently approved on a case-by-case basis. The Vehicle Modification Request process starts with operators informing their Fire Management Officers (FMO) of a Modification Request. The FMO completes the Vehicle Modification Form (VMF) and submits it to the Forest Fleet Manager (FFM). The FFM then coordinates with the Regional Fleet Manager. The VMF serves as a communication document throughout the process.

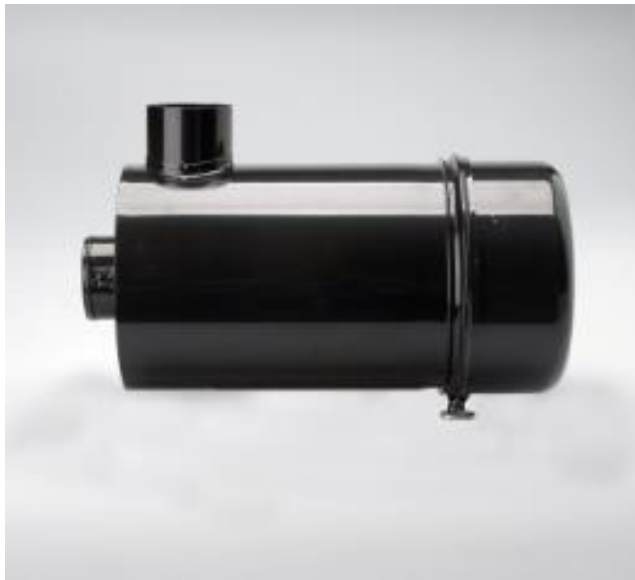
Photo 9: Metal Air Filter Housing

Streamlining and standardizing this after-market equipment on all Region 8 (R8) dozers would take a significant burden off the shoulders of equipment operators. The R8 Mobile Fire Equipment Committee (MFEC) has been discussing the installation of flame-resistant air filters and pre-cleaners. The firefighters interviewed supported R8's initiative to implement these improvements. Region 5 has successfully implemented these changes on their dozers and can advise on best practices for sourcing and installing these after market components.

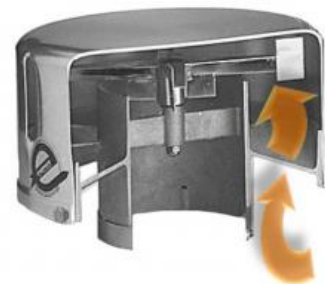
Photo 11: Metal Pre-Cleaner, Inside View

Note: Pre-cleaners use centrifugal force to spin out heavier dust and debris from the air intake system before they can reach the air filter system.
