Potamus Fire Engine Burn-over Fact Finding Report

Incident Date: August 7, 2008

Report Date: October 27, 2008

USDA Forest Service
Umatilla National Forest
North Fork John Day Ranger District

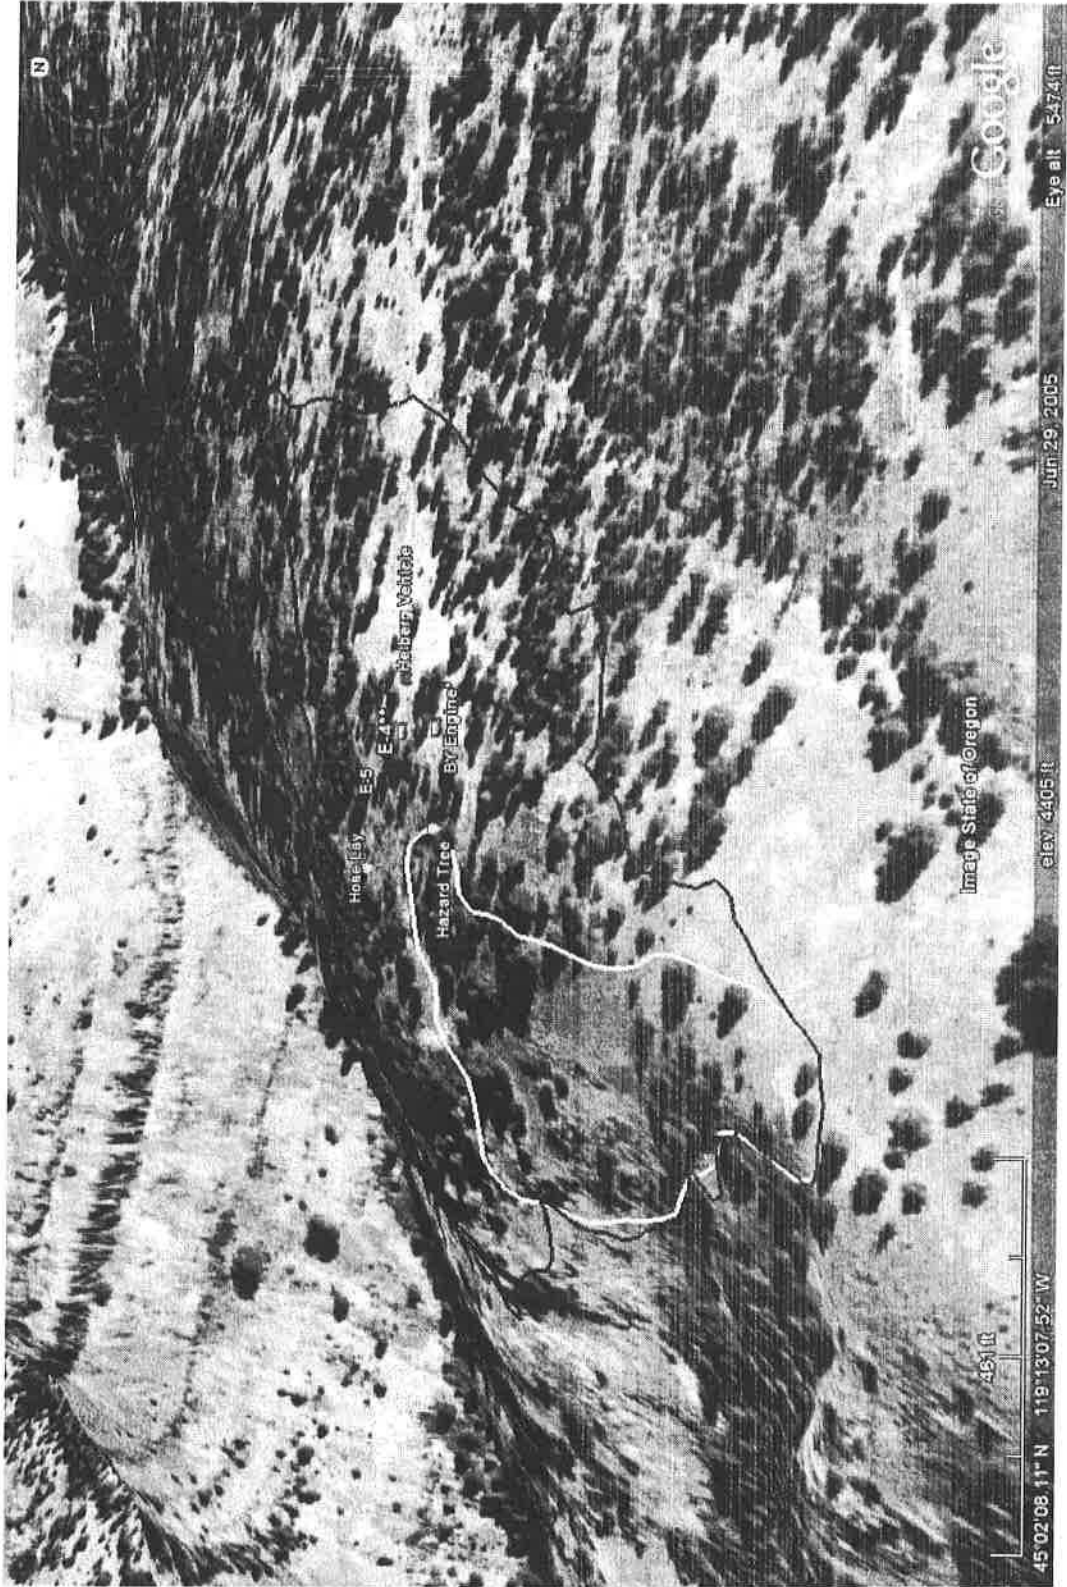
Figure II
Aerial Photo of Fire Area

Engine E-1 was assisting IHC members cool down a large standing pine tree with a burning bole, located diagonally down slope from E-1. E-1 personnel then needed to take the engine out to Road 5316 to refill. E-1 personnel requested the E-4 engine to replace them and assist the sawyers cool down the burning pine tree bole. Engine E-1 left to refill and engine E-4 relocated to E-1's site near the large pine tree. E-4 began using E-1's hose-lay on the pine tree. E-4 (STEN thinks) reported to STEN that the northeast corner was heating up (Figure 2, aerial photo of fire area).
