Tree Strike to a Type 6 Engine on a Prescribed Fire

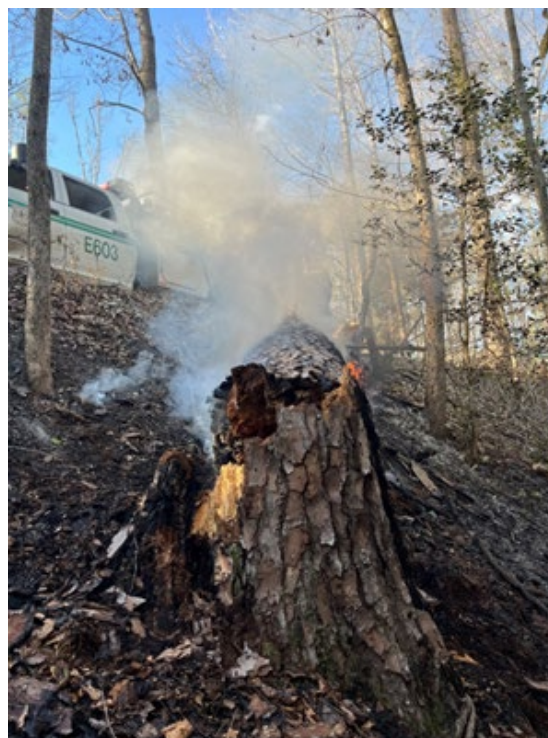
The bole of the hazard tree after it had fallen.

This 55- to 60-foot tall pine had a broken top. It had no limbs and appeared to be very straight. Its lean could not be determined from the road. One firefighter later stated the lean was "undiscernible" unless you were standing directly beneath the tree.

The tree had fire in a crack about three feet above the smoldering cat face at its base. The engine remained in its initial position on the road after extinguishing the smoldering base and was within falling distance of the tree. The tree was in an area that is known to remain wet with streams, Carolina Bays, and swampy areas. This

moisture can lead dead trees to rot at the base more quickly than normal. Also, it is possible that recent freezing temperatures may have contributed to weakening the tree.

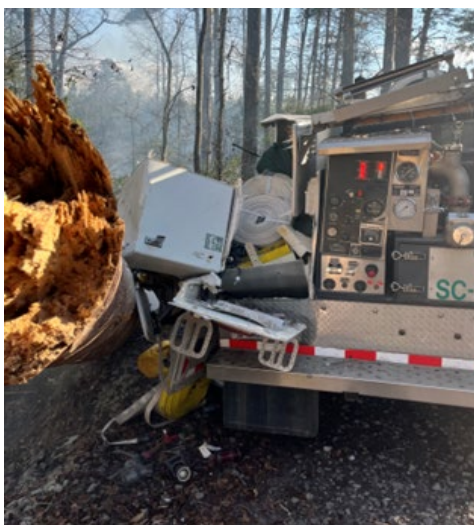
Image shows the angle at which the tree struck the engine.

The 29-inch DBH dead pine tree struck the engine at an approximate 45-degree angle, contacting the rear box compartments—causing significant damage to the box body.

Engine 603’s rear driver-side compartment sustained damage. However, there were no injuries to the involved firefighters. Engine 603 was found to be safely drivable and was relocated (~¼ mile away) and secured for removal during the next day’s shift. Operations concluded without further incident.

- 1.) **Ensure apparatus are positioned outside the potential fall zones when assessing hazard trees.** Once the snag was identified as a hazard that needed to be mitigated and after the tree had been cooled, the apparatus could have been repositioned outside potential fall zones while further assessment was ongoing. Firefighters appropriately **recognized the tree as a hazard** and requested supervisory assessment when it exceeded their comfort level. This positive action reinforces the importance of engaging qualified personnel early and aligns with the lesson to ensure apparatus are positioned outside potential fall zones when assessing hazard trees
