# *SERIOUS ACCIDENT INVESTIGATION REPORT*

*Bald Knob Prescribed Burn Incident/Beech Grove Road*

*March 25, 2026*

*Big South Fork National River and Recreation Area*

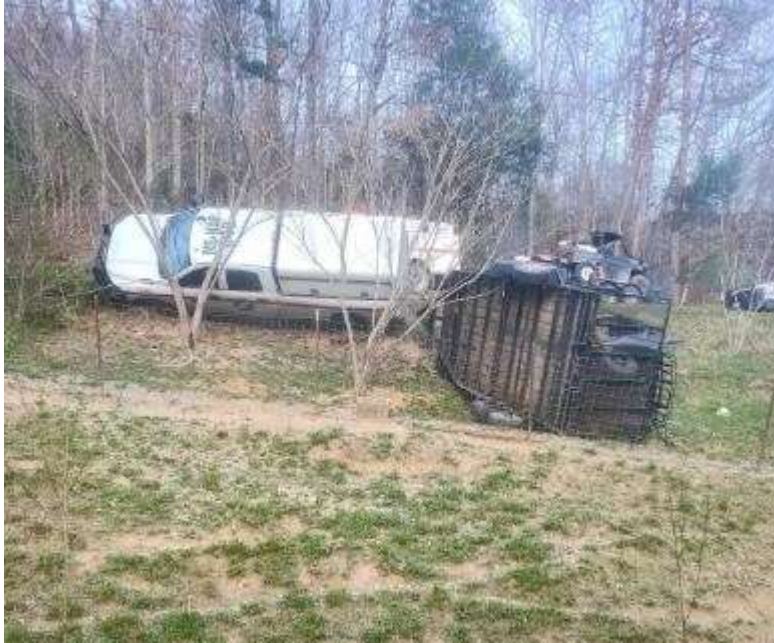
Vehicle in homeowner's yard.

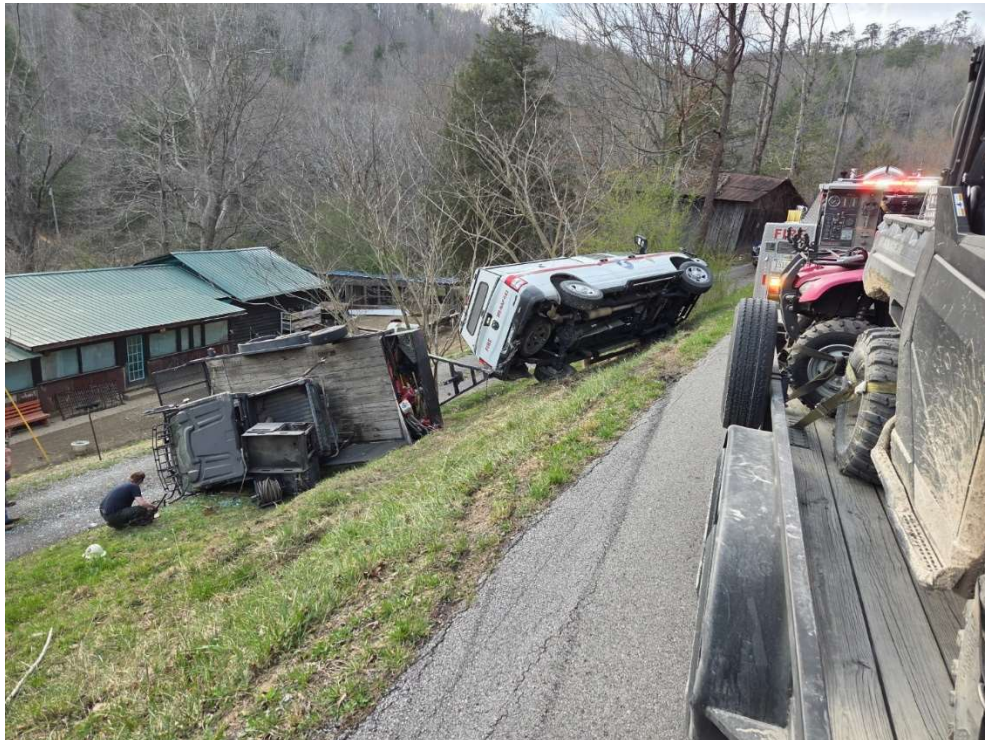
Accident scene from road, with tire/vehicle marks leading off the road.

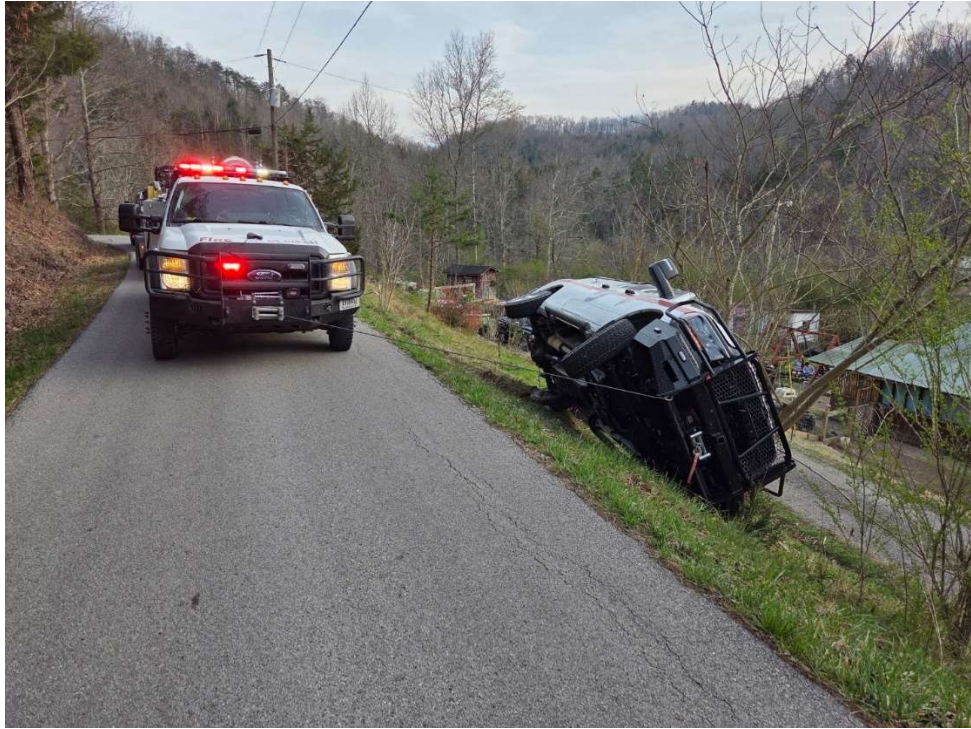
Second truck winching the accident vehicle.

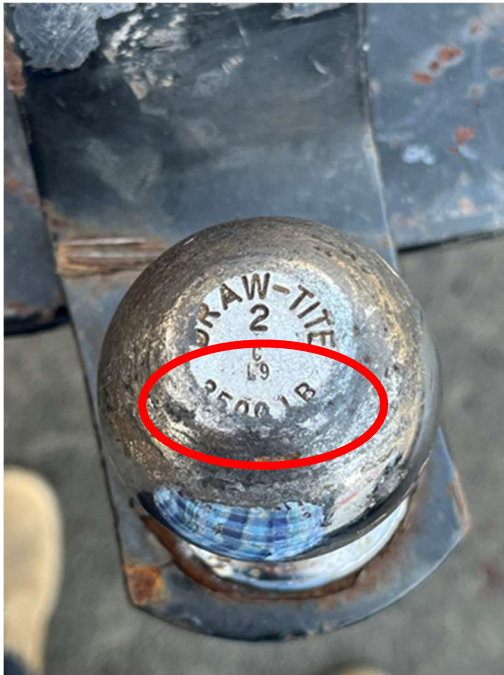
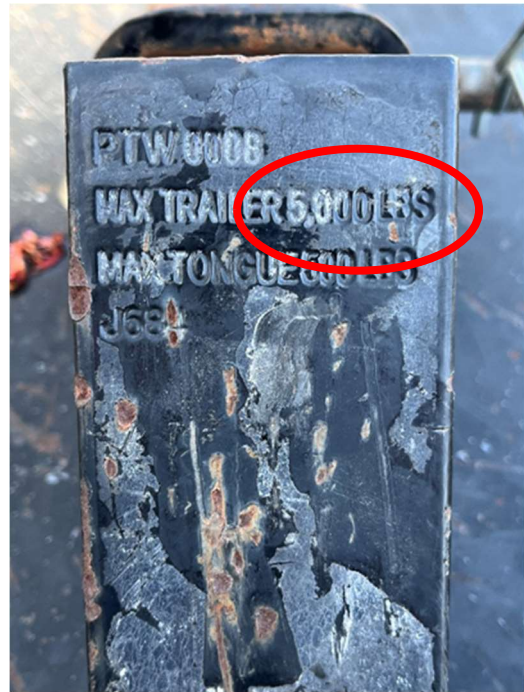
12. Towing capacity was exceeded in two locations. The ball was rated at 3,500 lbs. and the hitch was rated at 5,000 lbs.

Trailer-	1,500 lbs
UTV with fuel-	2,100 lbs
Slip-in unit	950 lbs
Slip-in water 70 gal	560 lbs
Extra tools/storage	200lbs
<b>TOTAL</b>	<b>5,310 lbs</b>

Maximum loads of ball and hitch, 3,500 and 5,000 lbs.

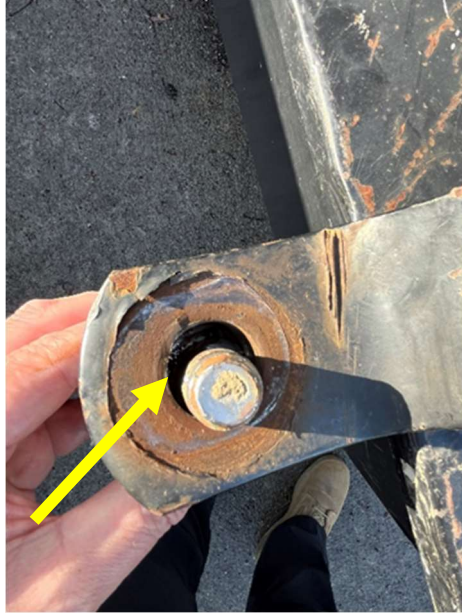
13. The ball shank was the incorrect size for the hitch. There was a gap between the shank of the ball and the hitch opening. Damage is seen between the ball and its seat in the hitch, consistent with a history of movement.

Gap between ball shank and hitch opening.
