## Executive Summary

On March 19, 2026, a snag struck a sawyer during attempted mitigation efforts as part of prescribed fire operations on the Blue Buck Unit on the Mark Twain National Forest.

### **Tree Strike Incident**

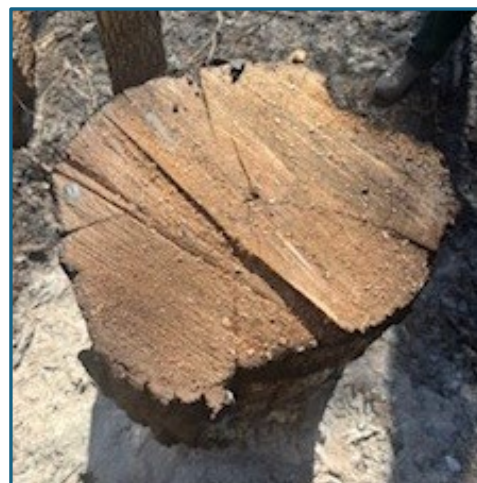
The undercut, which remained present at the stump at the time of the FLA Team’s site visit, appeared to create an opening of approximately 45 degrees but less than 70 degrees. This falls within acceptable limits for softwoods, though it is somewhat a shallow angle relative to typical hardwood best practices.

It is inferred that the back cut was completed on the downhill side of the stump, beneath the lean of the tree, effectively placing the sawyer on the “bad side” (under the lean).

The end of the tree stem was located approximately six feet from the stump and at an angle just greater than 90 degrees when compared to the gunning lines of the undercut.

The hinge wood was fully severed across the stump.

*The black oak stump cut by FAL1 that resulted in the tree strike.*

No clearing of surrounding timber was completed to establish an unobstructed lay, which would have improved sawyer safety and operational effectiveness during felling operations. Several adjacent trees, each approximately 4-6 inches DBH, were near the stump. These included one within the intended lay and another directly adjacent to the stump on the downhill side, both of which would likely have impeded aspects of the felling operation.

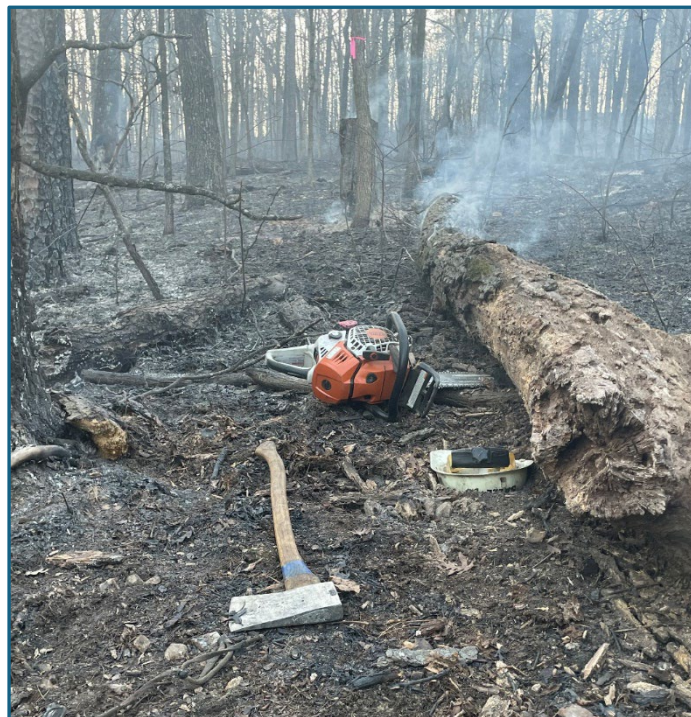
*Looking uphill at accident site just above the cutbank off of Missouri Highway 181. This image was taken immediately following the tree strike incident, showing equipment and helmet placement after FAL1 was transported to the ambulance.*

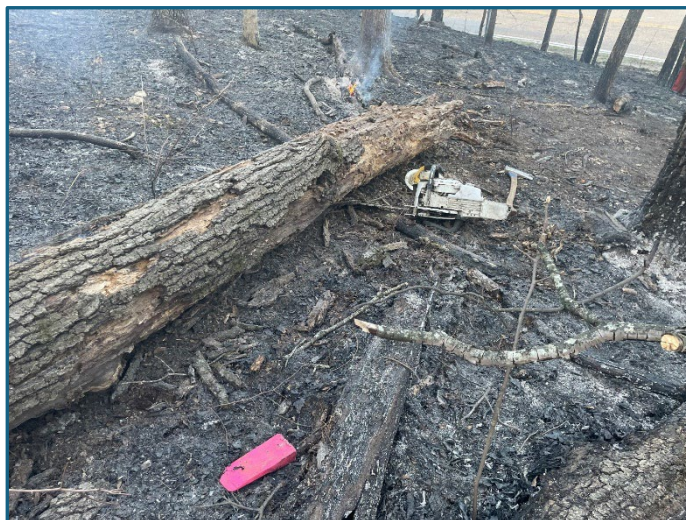
*The accident site looking downhill with Missouri Highway 181 in the background.*

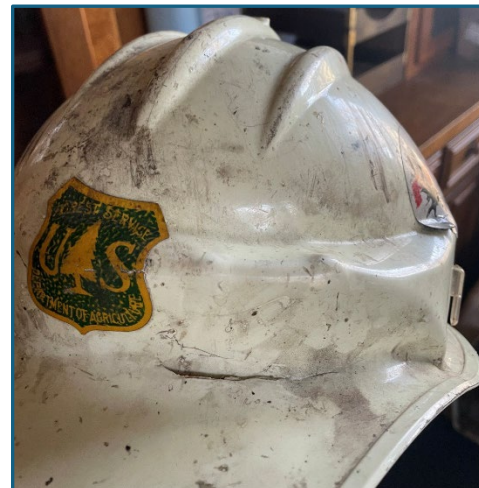
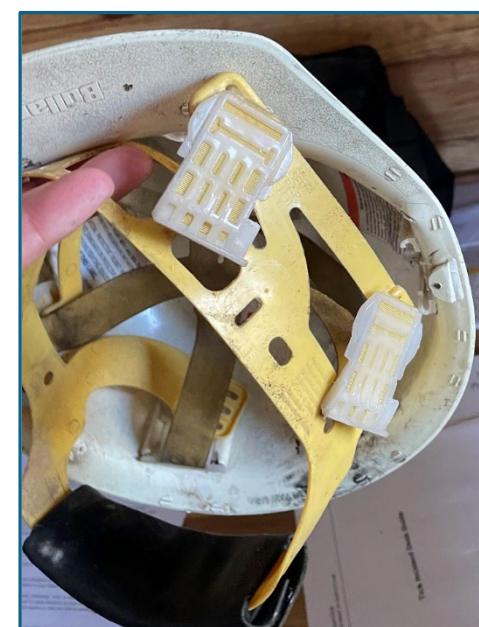
The patient sustained multiple traumatic injuries, including multiple fractured vertebrae and contusions, lacerations, and small avulsions to the head, neck, and back. Following air transport to a trauma center, the patient was evaluated, treated, and hospitalized for several days prior to release. On March 24, 2026, the patient returned to their home unit via agency transport.

***Top – FAL1's helmet showing external damage to its shell.  
Bottom – FAL1's helmet showing its internal damage.***

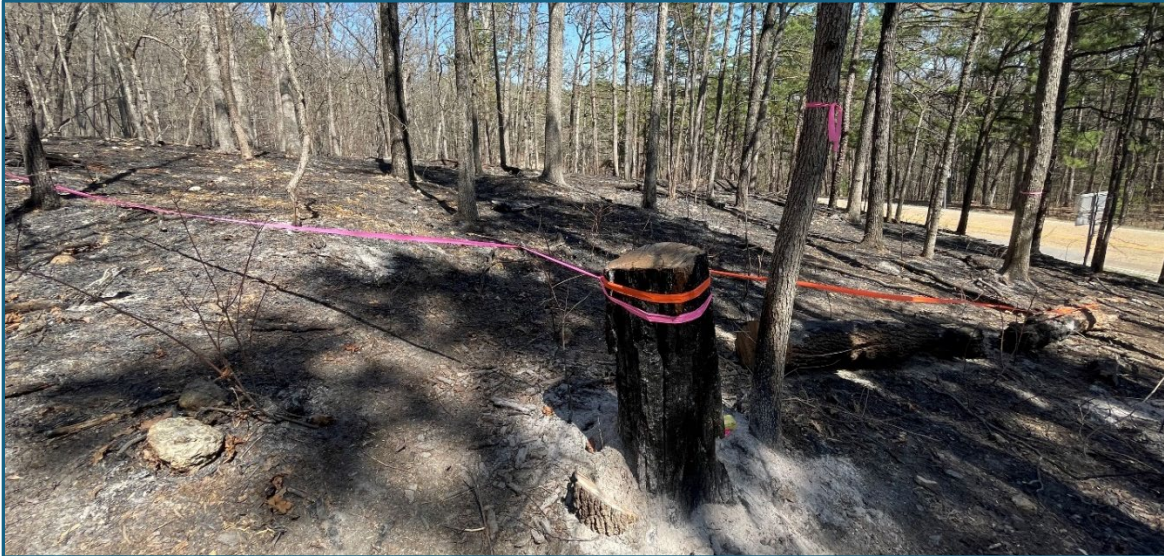
*The black oak stump showing the intended lay (identified by pink flagging) and the unintended lay (identified by orange flagging). Missouri Highway 181 can be seen in the background. This image was taken weeks after the tree strike incident during the FLA Team's site visit.*
