# Rapid Lesson Sharing

**Event Type:** Non-Fire, Engine Rollover

**Date:** February 26, 2023

**Location:** Tuba City, Arizona

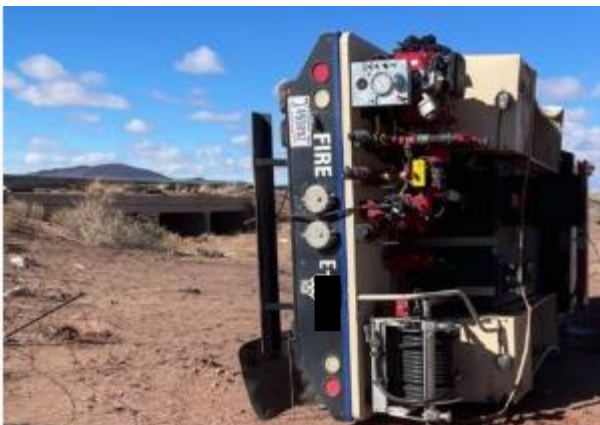
1. Culvert, in background, where vehicle exited the roadway.
