# Aviation Investigation Final Report

| <b>Location:</b> | Clear, Alaska | <b>Accident Number:</b> | ANC22FA047 |
| <b>Date &amp; Time:</b> | June 26, 2022, 19:38 Local | <b>Registration:</b> | N9970F |
| <b>Aircraft:</b> | Bell UH1B | <b>Aircraft Damage:</b> | Destroyed |

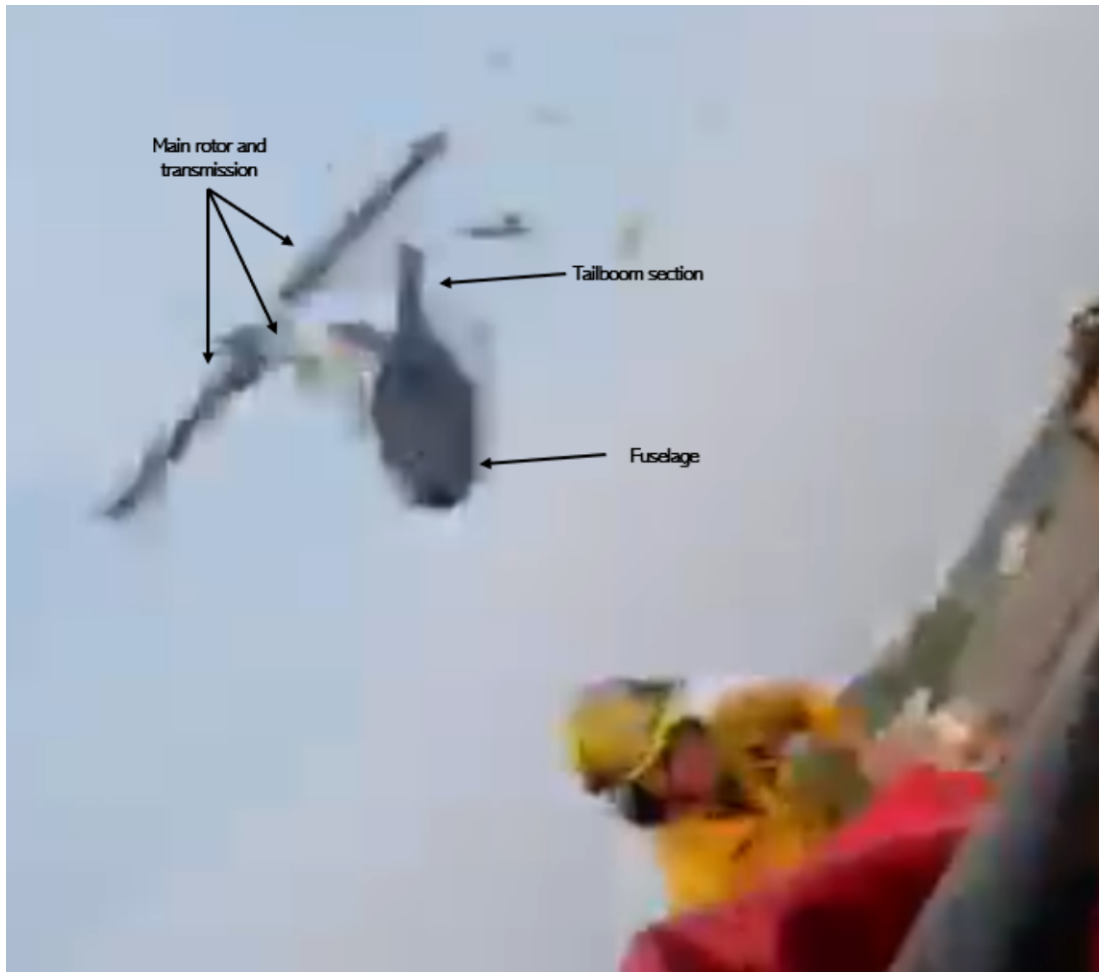
The sudden drop in altitude, combined with the forward pitch and right roll, enabled a mast bump condition that bent the rotor mast and caused an imbalance in the rotor system. This imbalance likely overloaded the transmission pylon structure, separating the transmission and main rotor from the rest of the airframe. The following out-of-plane divergence of the main rotor precipitated the tail boom separation.

A witness video camera captured the helicopter’s final seconds before impact with the ground. A review of the recording revealed that that the helicopter was hovering with the 125-ft longline fully extended below the helicopter, and the hook at the end of the line was about 15 ft above the ground. As the pilot maneuvered the helicopter to hook up to the external load, a loud mechanical noise could be heard, after which a shudder is seen radiating through the helicopter’s airframe, followed by an extreme roll to the right past 90°, and a nose-low descent. As the descent continued, the transmission (with the rotor head and blades attached) along with the tail boom separated from the fuselage before ground impact. (See figure 1.)

*Figure 1 - Screen capture of the end of the video showing the separation of the main rotor and transmission from the airframe before ground impact.*

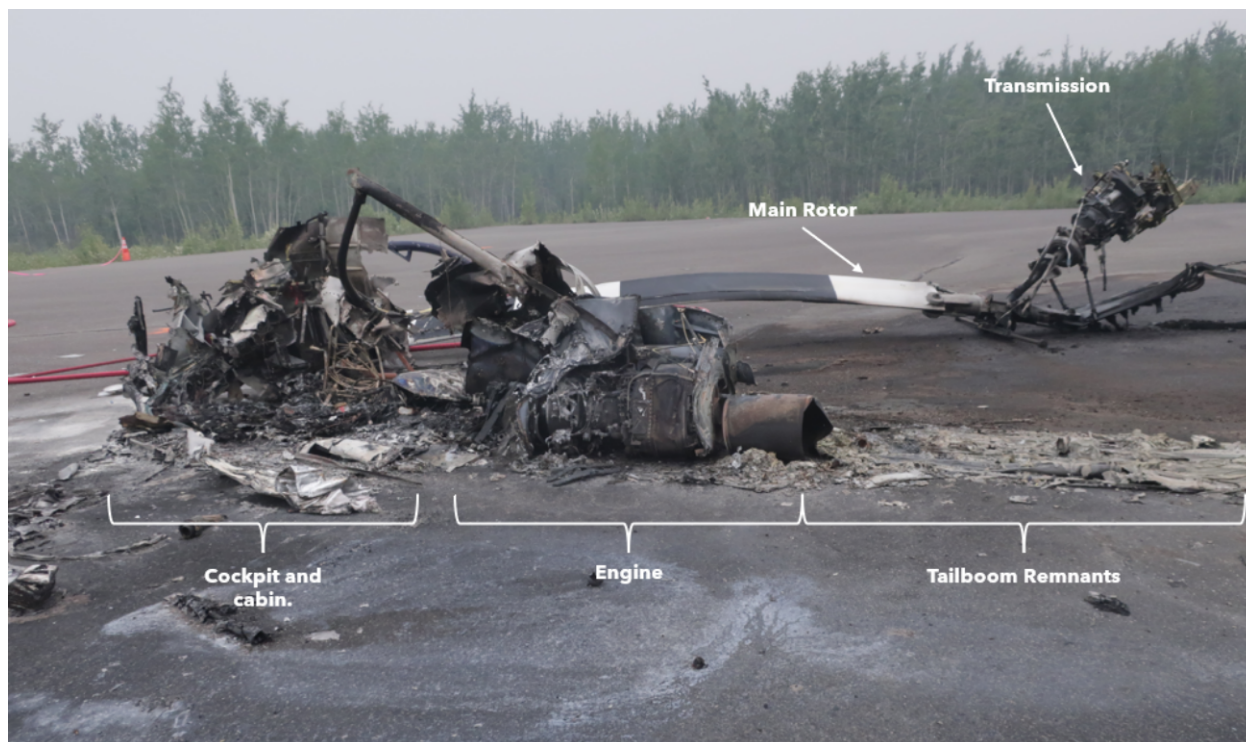
The helicopter impacted the asphalt on the north ramp area of Z84 on its left side in a nose-low attitude and was largely consumed by postcrash fire. The engine's transmission, with the rotor head and blades still attached, was found about 30 ft from the main wreckage. (See figure 2.)

*Figure 2 - Main wreckage*

The NTSB Materials Laboratory examination revealed that the transmission case was fractured on the right side near the aft support. The forward pylon support legs were fractured through the rivets attaching the isolation mount pad to the vertical faces of the legs. The aft left support leg was fractured at the lower attachment bracket for the friction damper, and the aft right support leg was fractured at its lower end. The main transmission and pylon structure likely separated due to overstress fracture. The aft isolation mounts and friction dampers showed evidence of substantial overtravel in the upward direction.
