## UTV and Powerline Tree Strike

The Oconee National Forest in Georgia conducted the Compartment 111 Prescribed Fire (Rx) in Monticello, Georgia on February 16, 2023. Resources from Chattahoochee-Oconee National Forests, various District personnel, as well as an 8-person Off-Forest Fuels Module (OFUTVM) with a UTV (Utility Terrain Vehicle) were on site to assist with the prescribed fire. That day, the Off-Forest Fuels UTV Module consisted of a three-person crew: the Crew Boss (CRWB), FFT1 and FFT2. The OFUTVM was assigned to a 2020 Polaris Ranger XP 1000, to include a front and back seat configuration.

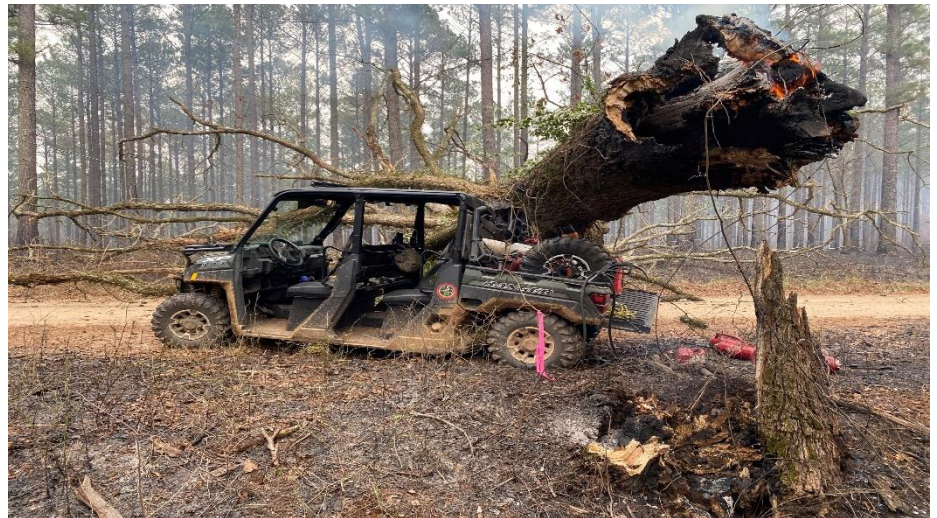
**The 2020 Polaris Ranger UTV after tree strike.**

While attempting to flag the hazard tree, a “Crack” and “Pop” was heard. Both OFUTVM CRWB and FFT1 shouted “RUN!” FFT2 was sitting in the driver side rear UTV seat with his seat belt on. The two firefighters shouted at him to “Run!” He was able to quickly unbuckle and exit the vehicle just before the tree trunk struck the UTV’s roof. As the tree came down it also struck the power lines on the opposite side of the road—causing them to arc and break, knocking out the power to the local area.

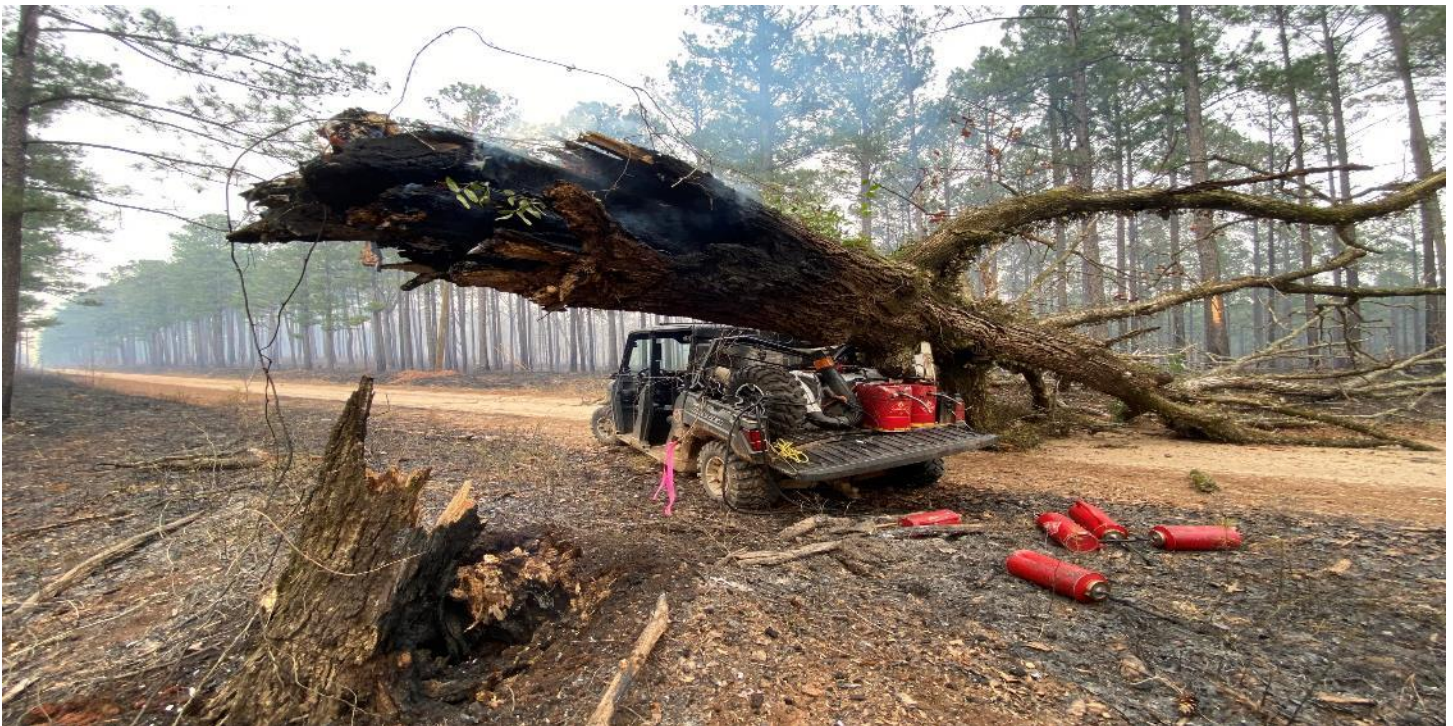
Once the tree was on the ground, the OFUTVM module quickly made sure that they were all OK and safe. Because the tree was laying on the powerlines and they weren’t sure if the wires were still live or not, they maintained their distance from the UTV.

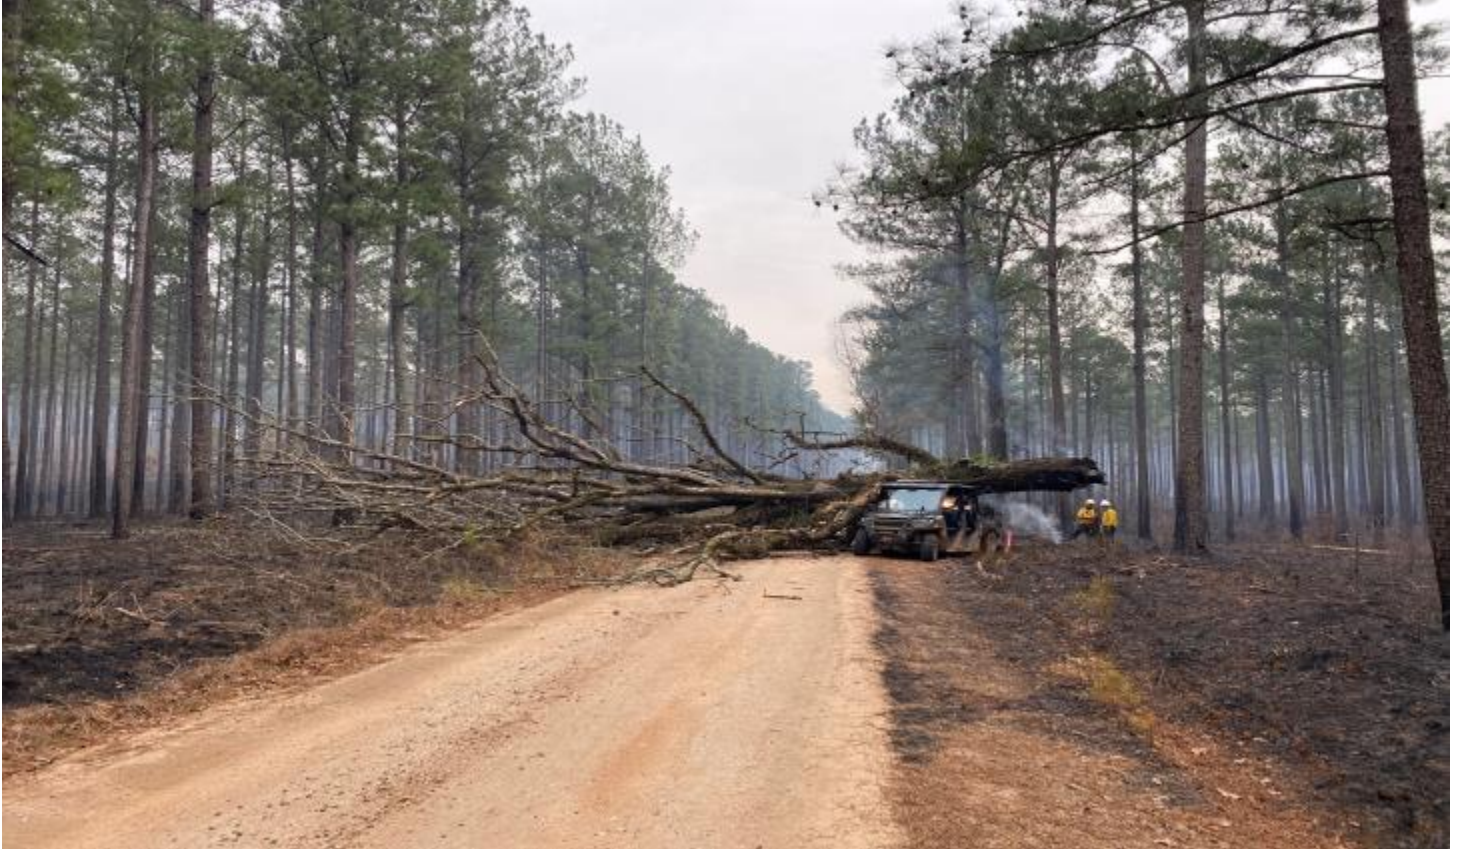
The OFUTVM CRWB and FFT1 began to buck and cut the tree to enable the Oconee Ranger District Dozer Operator to remove it from the UTV without causing further damage. The UTV was inspected for additional damages or any hazardous leaks. Finding no serious mechanical issues, the UTV was driven back to the staging area and loaded onto the trailer. The CRWB contacted their Chain of Command and advised them of the incident, confirmed that they were safe, and that they would be working with the local unit for reporting. At approximately 1730, all the resources gathered to conclude the day's operations and completed a comprehensive AAR.
