# Informational Summary Report of Serious or Near Serious CAL FIRE Injuries, Illnesses and Accidents

# GREEN SHEET

## Bulldozer Rollover

Joses Incident

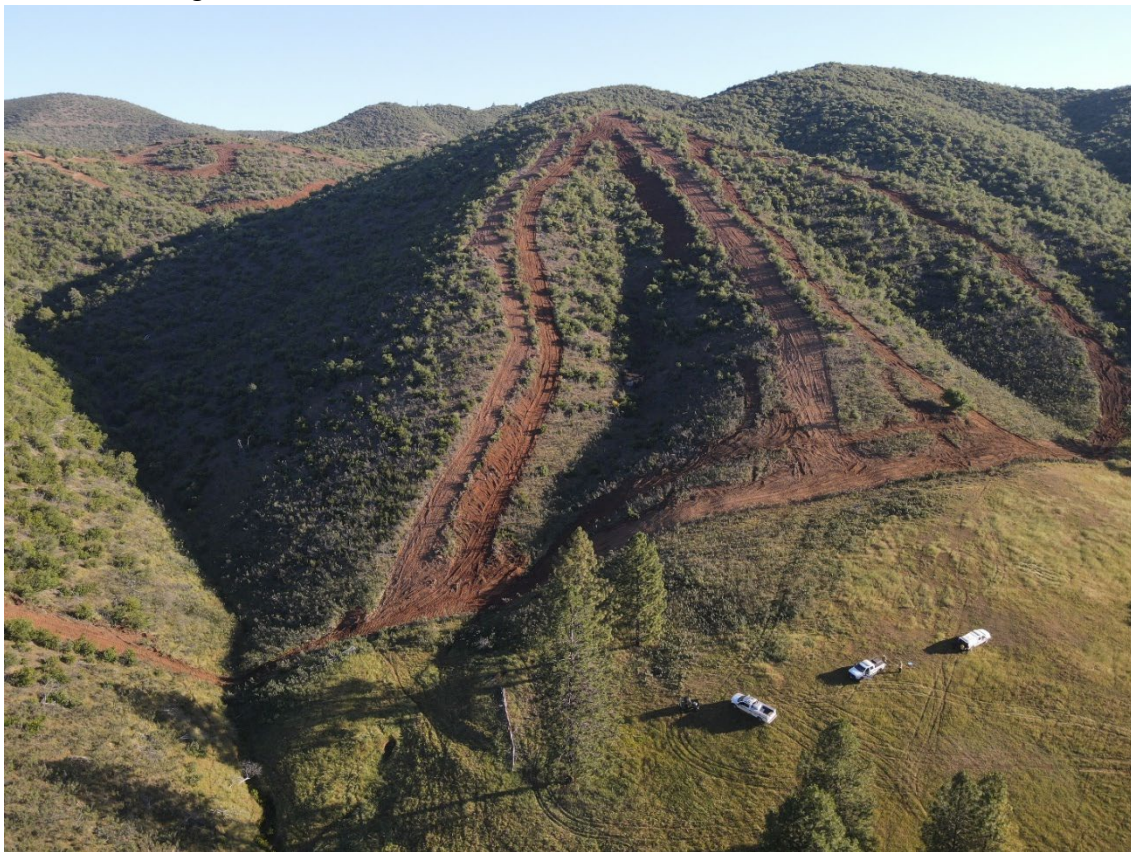
*Figure 1: Accident Site Overview*

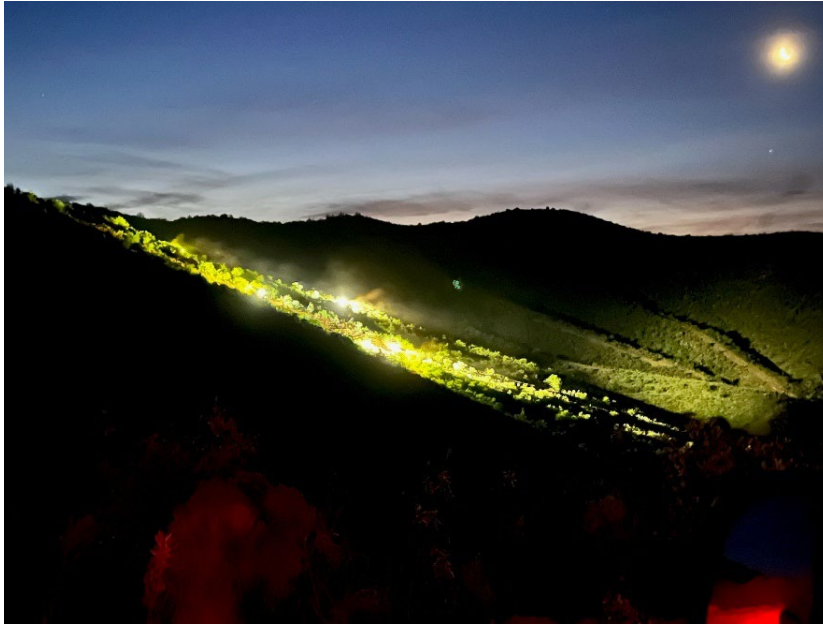
*Figure 2: View looking towards Division Charlie (C) immediately prior to the rollover. Photo taken from ridge where BC1 was located.*

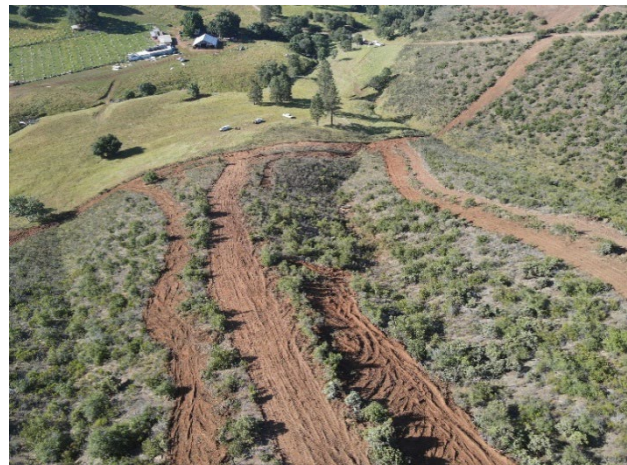
S1 began their operation at the top of the ridge when HFEO1 advised that they were beginning in the incorrect location and cutting into Division M where additional bulldozers were working. HFEO1 stopped S1, asked for a face-to-face for additional clarification, and showed S1 exactly where the line was to be placed. HFEO1 and HFEO2 ensured the assignment was understood and S1 began the assignment again.

Figure 3: Location where S1 began to create downhill fire line.

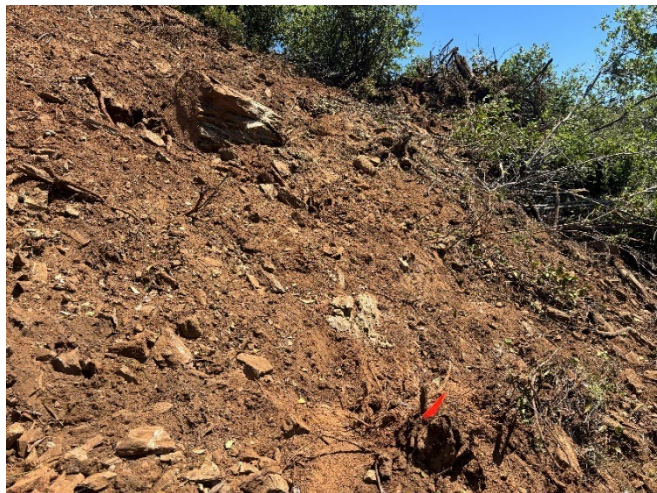
- Soils in the immediate vicinity of the accident location were 30-60 percent slopes, consisting of loam to clay loam, with a recorded minimum depth to bedrock of approximately 30 inches.
- Numerous large shale shelves were observed in the accident vicinity, with a single large boulder (24" diameter) noted to be dislodged near the top of the rollover sequence.

S1 constructed approximately 100 feet of line before encountering some rocks in the fire line. S1 asked S2 to bring soil down with him as they were improving the line in an effort to cover the rocks. Continuing further downhill, S1 faced increasingly difficult terrain, including more rocks and a steeper side hill. At one point, S1 began to experience sliding. To regain control, S1 attempted to turn the bulldozer uphill. S1 made three or four more passes continuing to face the bulldozer uphill.

In these attempts, S1 stated that left track was not moving and that the right track was trying to turn the bulldozer, but it would not turn. S1 tried to regain control by pushing up the side hill but reported that the bulldozer nosed down into a hole. S1 put the bulldozer in reverse and noted that the right track was turning, however they could not turn the tractor. The result of these attempts to regain control positioned the right side of the bulldozer downhill. While attempting to adjust their bulldozer, S1 experienced an unexpected shift, causing the bulldozer to roll onto its right side.

*Figure 4: Terrain at point of rollover*

S1 and S2 had constructed 359 feet of fire line when the roll sequence initiated. The area where the bulldozer began to roll was found to have a general slope of 58% and a side slope of 23%. D1 rolled six and a quarter times, traveling 221 feet before coming to rest.

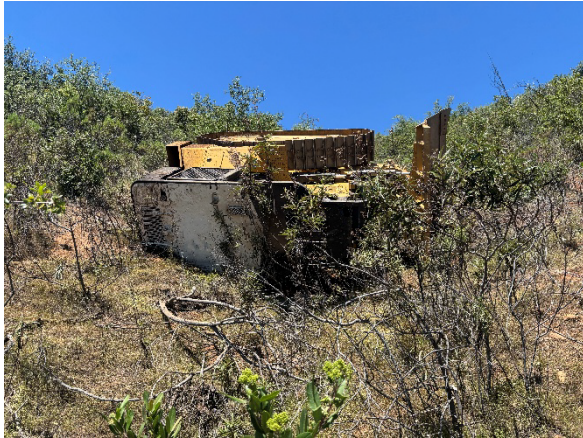
Figure 5: Top of bulldozer after rollover.

- S1 suffered a fractured rib, contusions to their arms and head, and minor lacerations.
- D1 sustained major damage.

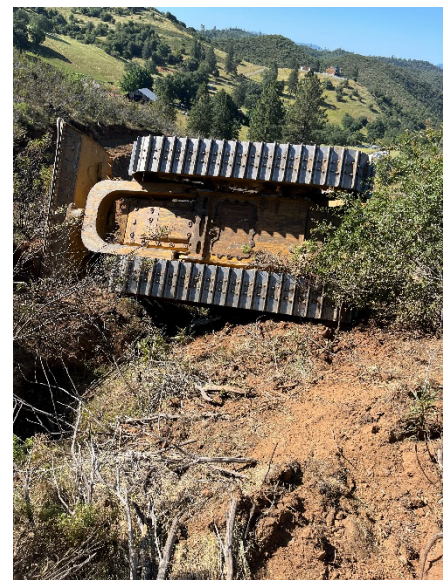
Figure 6: Bottom of bulldozer after rollover.

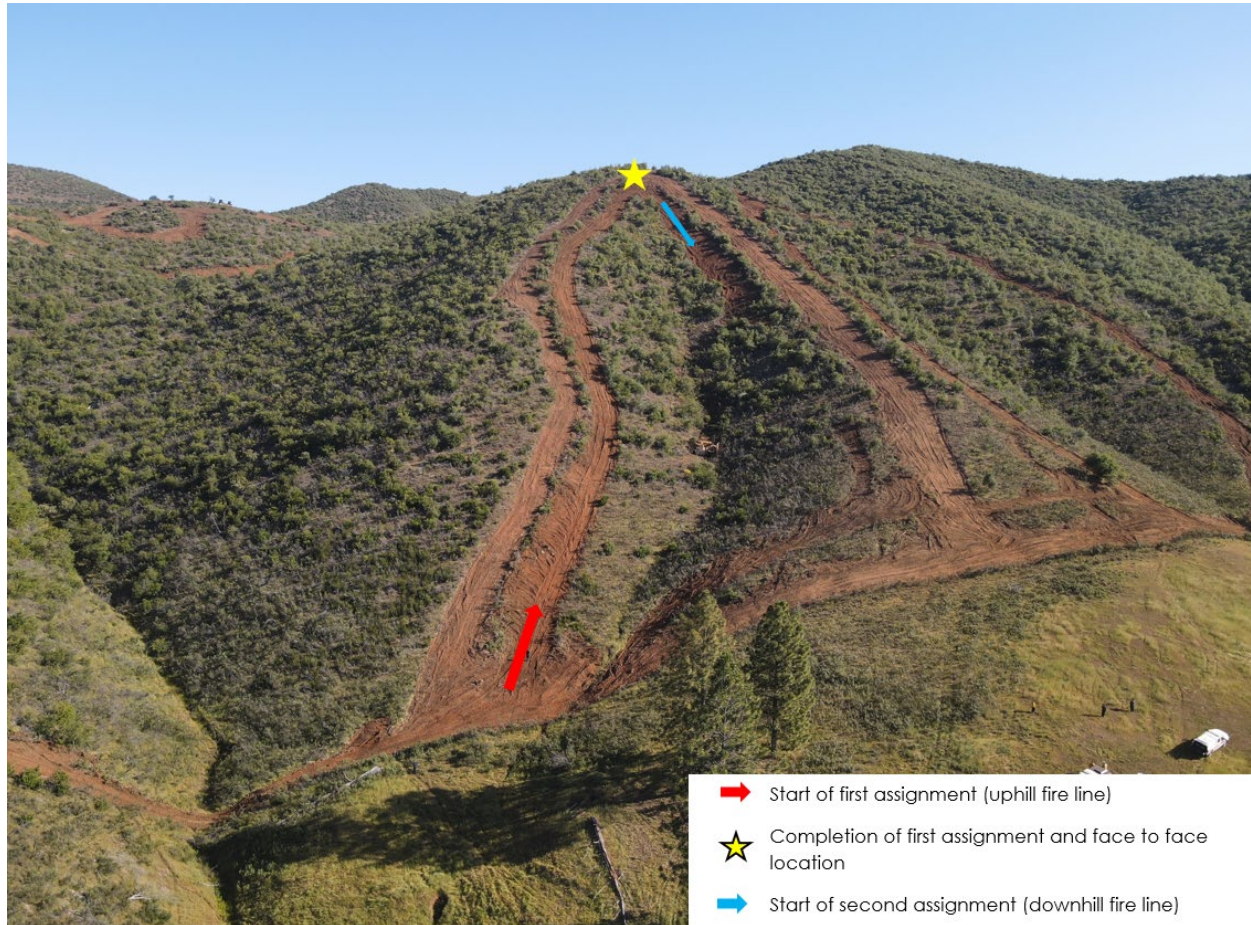
*Figure 7: Accident site with key locations identified.*

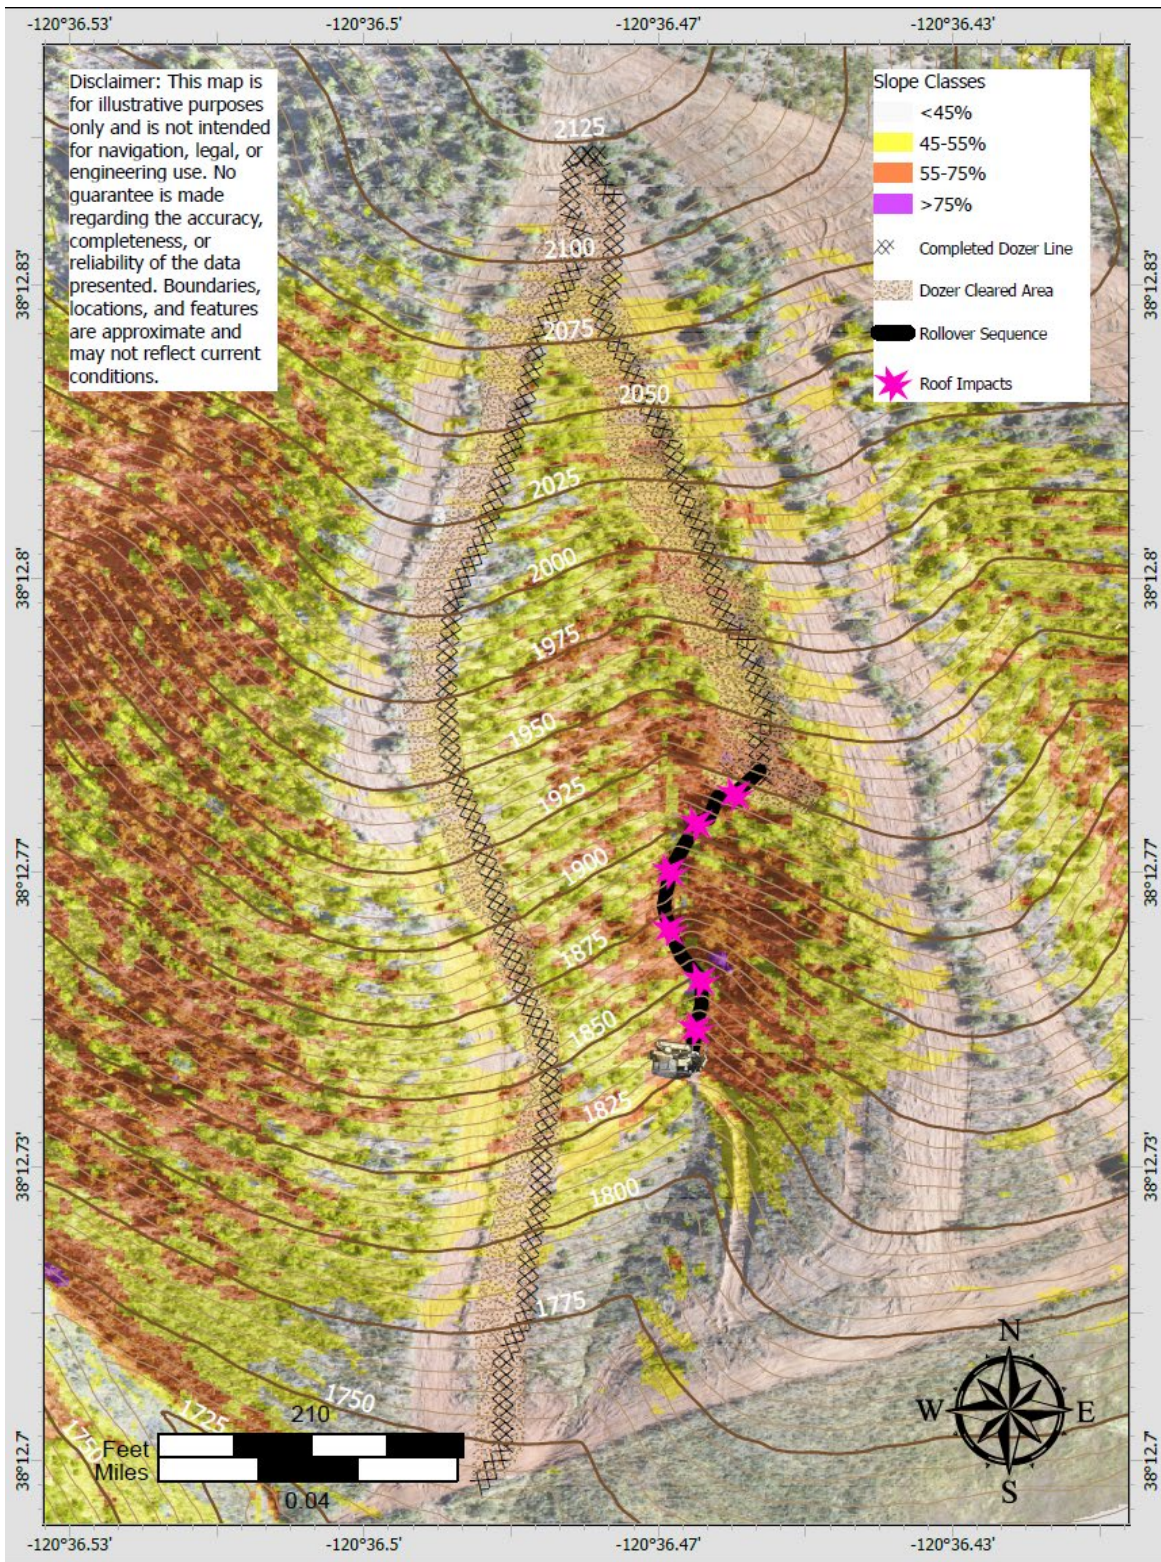
Figure 8: Accident site with slope and rollover path identified.
